Weldability of Underwater Wet-Welded HSLA Steel: Effects of Electrode Hydrophobic Coatings

Abstract: The paper presents the effects of waterproof coatings use to cover electrodes on the weldability of high-strength, low-alloy (HSLA) steel in water. With the aim of improving the weldability of S460N HSLA steel in water, modifications of welding filler material were chosen. The surfaces of electrodes were covered by different hydrophobic substances. The aim of the controlled thermal severity (CTS) test was to check the influence of these substances on the HSLA steel weldability in the wet welding conditions. The visual test, metallographic tests, and hardness Vickers HV10 measurements were performed during investigations. The results proved that hydrophobic coatings can reduce the hardness of welded joints in the heat-affected zone by 40–50 HV10. Additionally, the number of cold cracks can be significantly reduced by application of waterproof coatings on the filler material. The obtained results showed that electrode hydrophobic coatings can be used to improve the weldability of HSLA steel in underwater conditions.

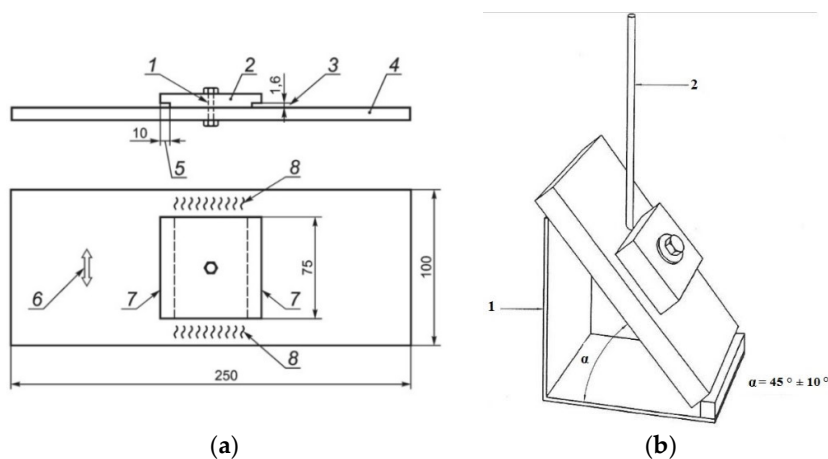
Figure 1. Control thermal severity (CTS) specimen: (a) scheme of CTS test; 1—hole 13 mm diameter, 2—top plate, 3—root notch gap, 4—bottom plate, 5—root notch depth, 6—rolling direction, 7—test welds, 8—anchor welds; (b) the location of the specimen during welding; 1—jig, 2—covered electrode.

For this research, the control thermal severity (CTS) test was selected, which resulted from the fact that fillet welds are the most commonly used in underwater-welded structures. Additionally, the CTS test assesses susceptibility to cold cracking in all regions of welded joints. A scheme of the CTS specimens is presented in Figure 1a. The specimen was housed in a special jig. The test welds were deposited symmetrically in the flat position (PA) in a single pass and in a single direction, across the full width of the block (Figure 1b).

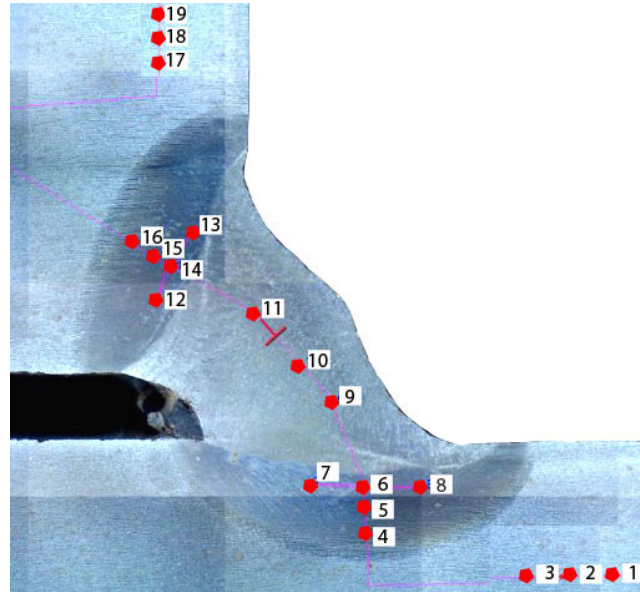
Figure 4. The distribution of measurement points.

Hardness measurements were performed in one cross-section from the test weld at 19 points: 3 in the weld metal, 6 in the BM, and 10 in the HAZ (5 in each side of the joint). A schematic of the distribution of the measurement points is presented in Figure 4.

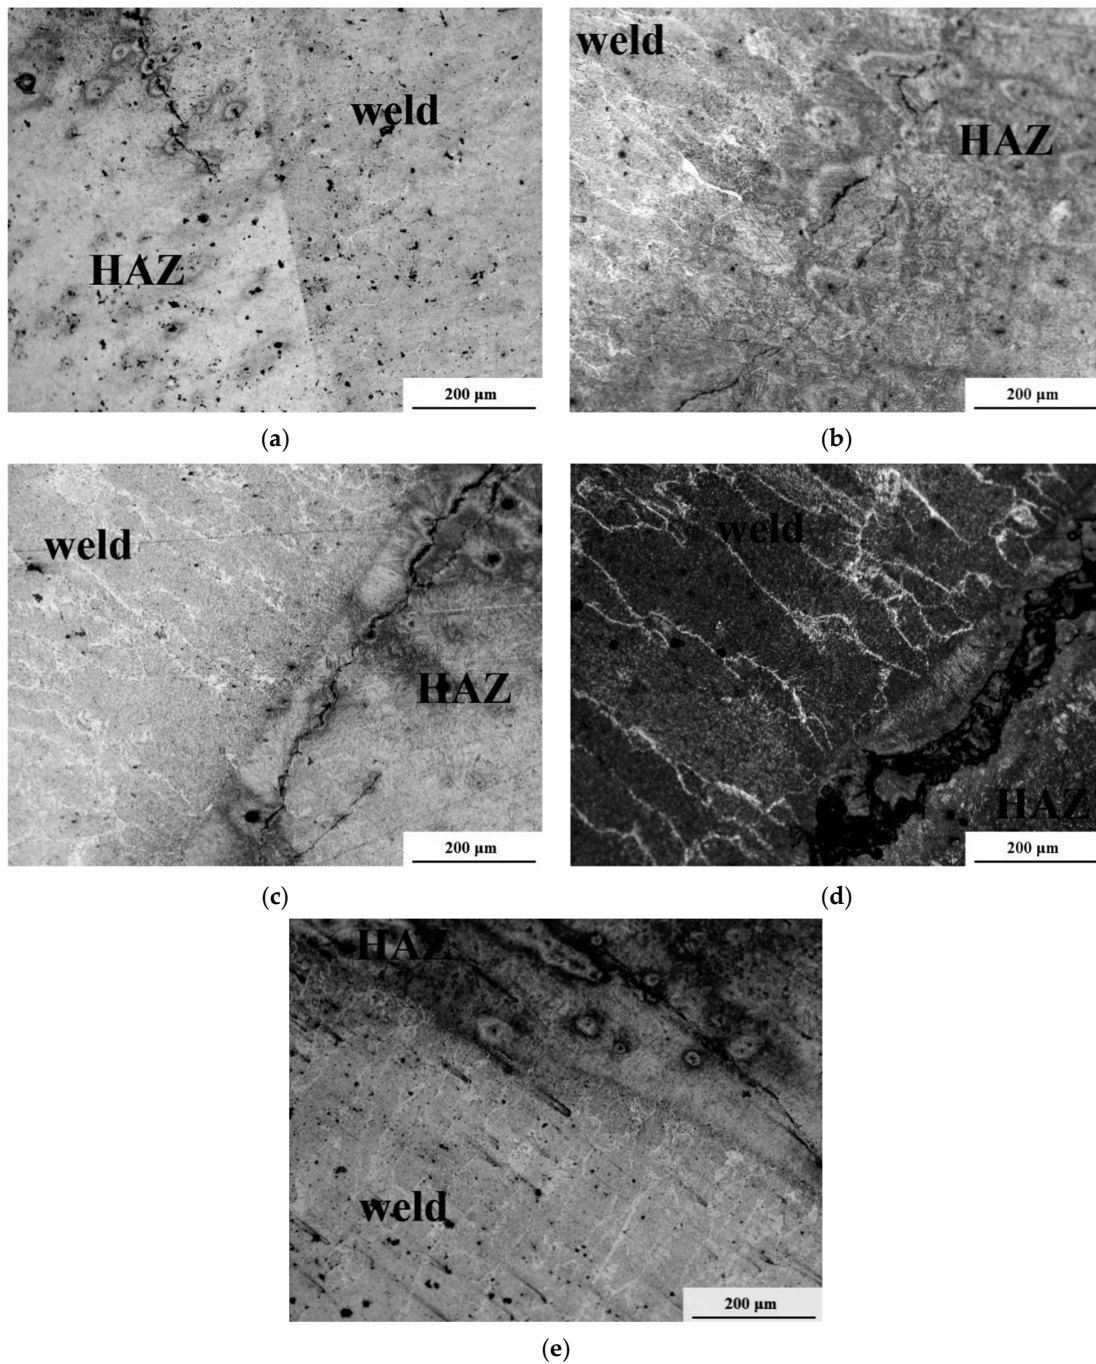
Figure 6. Optical micrographs of: (a) specimen 1 (non-modified electrode); (b) specimen 2 (underwater electrode); (c) scheme 3 (concrete impregnate); (d) specimen 4 (liquid foil); (e) specimen 5 (paraffin wax).

The microstructures are shown in Figure 6. The main aim of the microscopic test was to evaluate the specimens for the occurrence of cold cracks. It had been proven in previous investigations [39] that the use of electrodes coated with concrete impregnate and liquid foil generated 85–95 mL/100g diffusible hydrogen in deposited metal. In comparison, the non-modified electrode generated 75 and the underwater electrode 65 mL/100g diffusible hydrogen. However, the use of paraffin wax decreased the hydrogenation below 50 mL/100g diffusible hydrogen. These results and the hardness measurements presented in Section 3.3 suggest differences in specimens welded with different filler materials. From each specimen, four cross-sections were observed in the HAZ and in the weld metal. Each joint was characterized by typical microstructures for the underwater-welded HSLA joints [5,9,25]. The weld metal presented a dendritic structure. The HAZ consists of brittle structures such as martensite and bainite. There were no significant microstructural differences in specimens 1–4. In specimen 5, the dimension of coarse-grained martensite area in HAZ was the lowest. Microscopic observations of specimen 1, which was welded with non-modified electrodes, showed long cracks in the HAZ running parallel to the fusion line along 30–40% of its length. (Figure 6a). Additionally, short cracks were found

in the weld metal. Lower numbers of cracks were observed in the HAZ of the specimen welded using underwater electrodes (Figure 6b). These cracks ran through 15–20% of the fusion line length. Both specimens were characterized by similar hardness in the HAZ. The differences in the number of cracks resulted from different hydrogen amounts in the deposited metal [38]. No cracks were found in the weld metal. Microscopic tests showed that concrete impregnate as an electrode coating leads to increased numbers of cracks, both in the HAZ and the weld metal (Figure 6c). HAZ cracks ran parallel and vertical to the fusion line. They started in the weld root and propagated along 70–80% of the fusion line length. The worst results were found during observations of test welds in specimen 4 (Figure 6d). Cracks in the HAZ were wide and long (90–100% of the fusion line length). However, the number of cracks in the weld was smaller than in specimen 3. It can be stated that liquid foil and concrete impregnate cannot be used as protective coatings during wet welding of HSLA steels. Microscopic testing of the specimen welded using electrodes coated with paraffin wax showed much different results than for other hydrophobic substances. No cracks were found in the weld metal. In the HAZ, only one short crack running parallel to the fusion line was found (Figure 6e). Microscopic observations proved that cold cracks occurred in wet-welded joints. A number of cold cracks resulted from the presence of brittle structures in the HAZ, characterized by high hardness, with the highest amount of diffusible hydrogen in the deposited metal [39]. It was also proven that HSLA steels are materials in which the high cooling rate leads to creation of the brittle martensitic microstructure [53].
