Article

Effect of Thermal Treatment and Erosion Aggressiveness on Resistance of S235JR Steel to Cavitation and Slurry

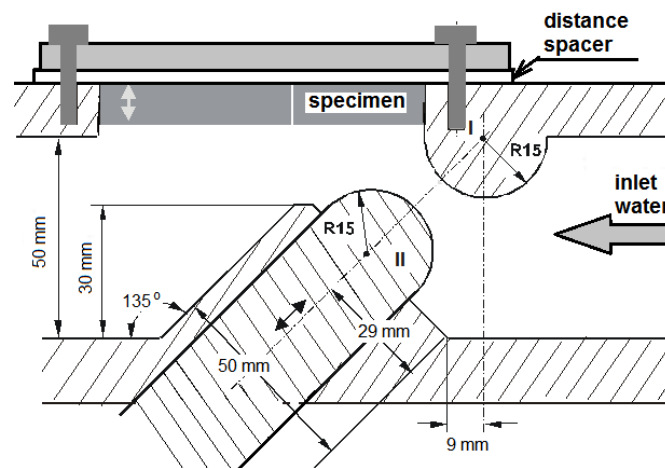
Figure 1. Scheme of the cavitation tunnel.

In order to investigate the effect of cavitation intensity on the erosion process, four tests were carried out using a cavitation tunnel equipped with a system of barricades. The scheme of the cavitation tunnel is shown in Figure 1 and it has been described by Krella et al. [18]. As a working fluid tap water with a temperature of 20 ± 2 °C was used. The intensity of cavitation is governed by the fluid flow rate, which is controlled by the inlet and outlet pressures, which in turn are regulated by the inlet and outlet valves. Flow speed was measured using a portable ultrasonic flowmeter Fluxus® model ADM 6725 (FLEXIM, Edgewood, NY, US) with a measurement accuracy of $\pm 0.5\%$ of the measured value. In the presented investigations, the water flow velocities were 35 m/s, 37.9 m/s, 40.5 m/s, and 43 m/s in the slot between the barricades. The total duration of the test was 600 min.

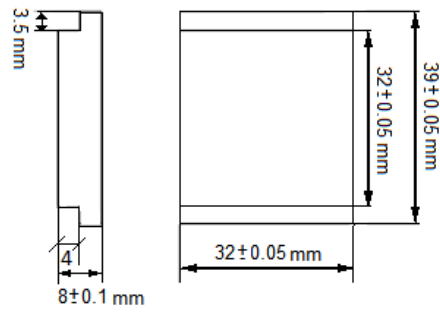
Figure 2. The shape and dimensions of a specimen for cavitation erosion tests.

In order to obtain the cavitation curves and erosion rates, the mass of tested specimens was measured using an analytical balance of 0.1 mg accuracy. Mass measurements were carried out before the tests and after each exposure. Before each mass measurements, the specimens were cleaned and dried. The shape and dimensions of the specimens are shown in Figure 2.

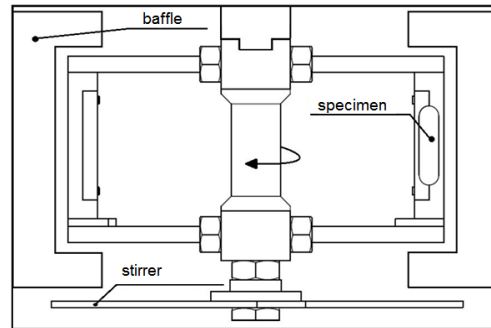
Figure 3. Scheme of a slurry pot tester.

The slurry tests were performed using a slurry pot tester (Figure 3). The pot capacity is 6.4 l. The tester allows simultaneous examination of two specimens. At the inner wall of a slurry pot, four baffles are mounted to minimize centrifuging of the fluid due to the rotation of the specimens. Additionally, a stirrer is mounted to prevent the sedimentation of the solid particles. The rotation speed is adjusted by a power inverter ABB ACS 300 (ABB Asea Brown Boveri Ltd, Zurich, Switzerland). To analyze an effect of erosion intensity on the erosion process, four slurry tests were carried out at rotational speeds of 565 rpm, 786 rpm and 1012 rpm. The duration of the slurry tests was 600 min, similar to cavitation erosion tests. Tap water with a temperature of 18 °C was used as a working liquid. Spherical steel solid particles with a diameter of 520 μm and hardness of 51 HRC were used as erodents. The concentration of erodent was 12.5 wt. %. The impact angle was 90°. The shape and dimensions of the specimens are shown in Figure 4. Before the tests and after each exposure, the specimens were cleaned, dried, and reweighed using an analytical balance of 0.1 mg accuracy.

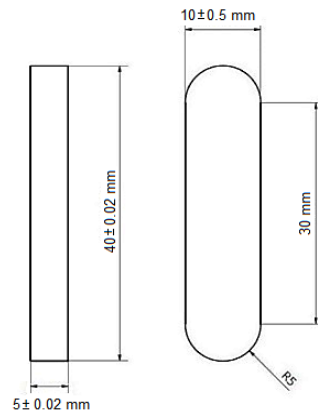
Figure 4. The shape and dimensions of a specimen for slurry erosion tests.

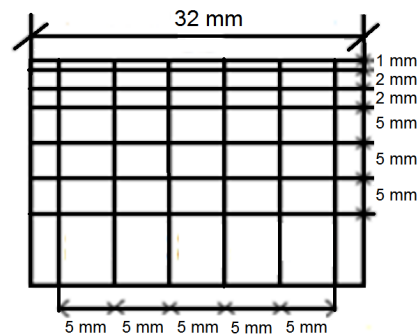
Figure 5. The scheme of the network for surface roughness measurements.

The distributions of surface roughness along the network shown in Figure 5 that developed during the entire cavitation erosion tests are shown in Figures 12 and 13, respectively for S235JR-AR and S235JR-TT steel. In order to show the effect of flow conditions on the roughness, the same maximum Ra value was used in the color bar despite the different maximum Ra values. During the slurry test, the entire surface of the specimens was uniformly eroded, so five measurements of the Ra parameter were taken after each exposure. The development of the Ra surface roughness parameter is shown in Figure 14.

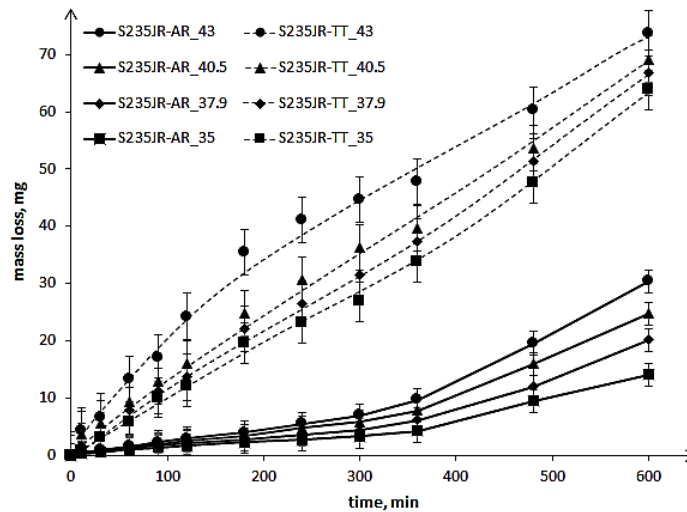
Figure 6. Cavitation erosion curves of S235JR steel in as-received state and after thermal treatment.

The results of cavitation erosion tests are shown in the form of the cavitation erosion curves (Figure 6) and the cavitation erosion rate curves (Figure 7).

These curves show that a decrease in steel hardness and an increase in flow velocity increased the mass losses and erosion rates. These results are consistent with the expectation and investigation obtained by Kahraman et al. [6]. The decrease in steel hardness by 34.2 HV as a result of thermal treatment caused an increase in mass loss after the entire tests by about 43 mg to about 49.7 mg, depending on the test conditions. Thus, the high impact of the hardness of this steel on the erosion resistance was confirmed, although the tests carried out were tests of cavitation erosion, not slurry. However, an

increase in flow velocity did not cause a proportional increase in mass loss of the tested steel, either in the as-received state or after thermal treatment (Figure 6). Moreover, the shape of the cavitation erosion curves indicates the different degradation processes. In the case of the S235JR-AR steel, the cavitation erosion curves indicate two main erosion periods: the first one lasting about 300 min and the second starting from about 360 min. While in the case of the S235JR-TT steel after thermal treatment, the mass losses increased more or less evenly throughout the cavitation erosion tests. This also confirms a high effect of the hardness of this steel on the degradation process.

In the case of the cavitation erosion tests conducted at the highest flow velocity of 43 m/s, the hardness of the S235JR-AR steel increased up to 194 HV at a depth of 35 μm, but the maximum value was 197 HV at a depth of 235 μm (Figure 10a). Such a hardness peak underneath the surface was also obtained in the tests of Fe–Cr–Ni–Mn stainless steels [19,20]. This makes that the maximum strain hardening effect determined from Equation (1) was 10% at a depth of 235 μm (Figure 10b). Moreover, the hardening effect was noted down to a depth of 4 mm. In the case of the S235JR-TT steel tested for resistance to cavitation erosion in these conditions, the maximum increase in hardness was only about 8% (157 HV) at a depth of 235 μm and the hardening effect was noted down to a depth of 2.5 mm. Thus, the initial hardness of the steel prior to the cavitation test had an effect on the hardenability. Steel with lower initial hardness underwent less hardening, and steel with higher initial hardness - stronger. Moreover, as the strengthening of the surface layer increased, the mass loss (Figure 6) and the erosion rate (Figure 7) decreased.

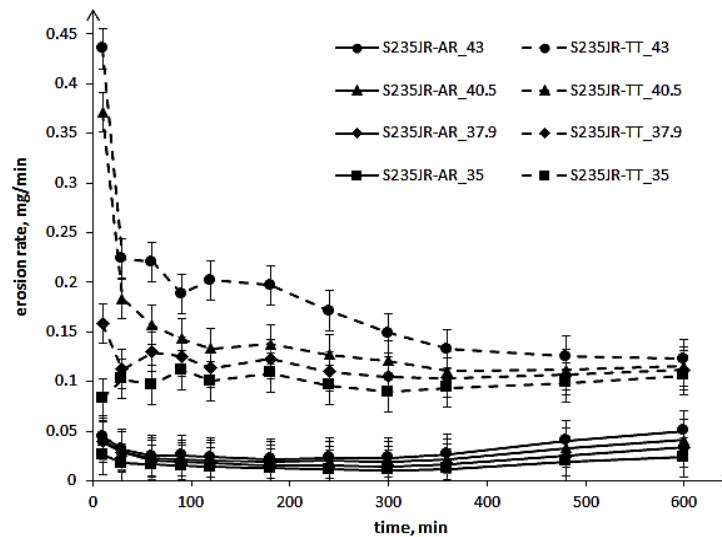
Figure 7. Cavitation erosion rate curves of S235JR steel in as-received state and after thermal treatment.

Figure 7 shows that the mass loss of the tested steel started with a high erosion rate, regardless of the steel hardness. Only the thermal-treated steel tested at 35 m/s failed this rule. After reaching the maximum value, the erosion rate decreased. In the case of the S235JR-AR steel, the erosion rate decreased only until about 180 min of testing. After that, the erosion rate increased. In the case of S235JR-TT steel, the most rapid decrease in erosion rate occurred during the initial 30 min and then the erosion rate decreased more

slowly. The period of erosion rate decrease depended on the flow velocity. In the case of the tests carried out at 35 m/s and 37.9 m/s, this period lasted until about 300 min and then the erosion rate slightly increased. In the case of the tests carried out at 40.5 m/s, the period of the erosion rate decrease lasted until about 360 min. While in the case of the tests carried out at 43 m/s, this period lasted until the end of the test, but after 360 min of testing, this decrease was much slower. Figure 7 also shows that the greatest difference in erosion rate was at the start of the study to approximately 180 min, and as the duration of the study increased, the difference in erosion rate decreased. Thus, the influence of steel hardness on the erosion rate decreased with the duration of the tests. This indicates changes in the structure and properties of the tested steel, i.e., hardness, as a result of impacting the micro-jets formed during the implosion of cavitation bubbles.

In the case of cavitation and slurry erosion, degradation occurs as a result of repeated impacts. The erosion curves (Figures 7 and 9) show changes in the properties of

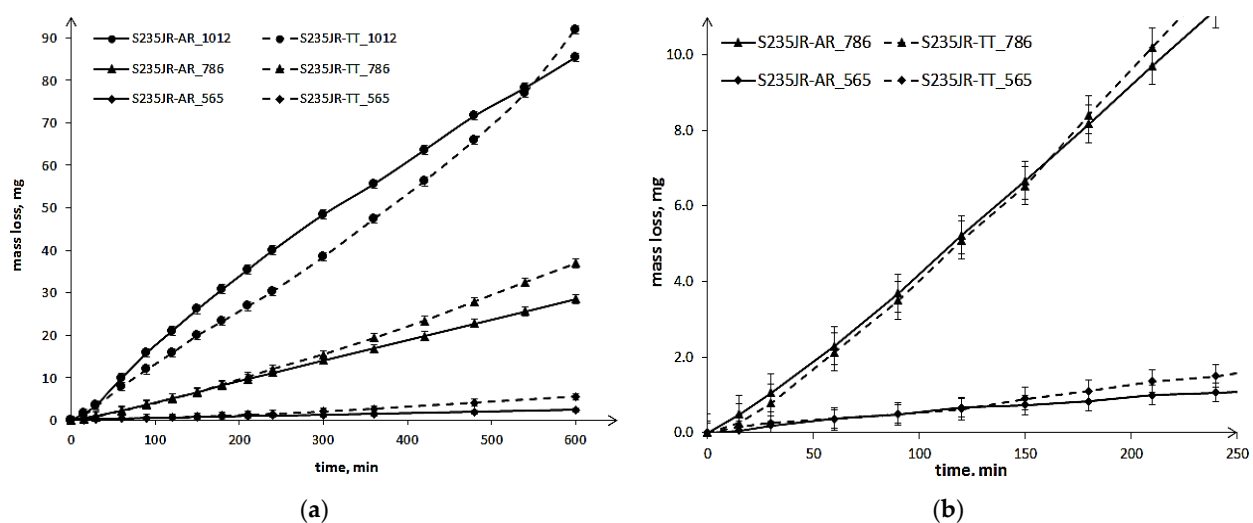
Figure 8. Slurry erosion curves of S235JR-AR and S235JR-TT steels: (a) full test duration, (b) initial 250 min of testing steels at 786 and 565 rpm

The results of slurry erosion tests are shown in the form of the erosion and erosion rate curves (Figures 8 and 9, respectively). The maximum mass losses obtained in the tests carried out with the highest rotational speed of 1012 rpm (Figure 8) are slightly higher than those obtained in cavitation erosion tests, i.e., tests performed at a flow velocity of 43 m/s (Figure 6). This indicates that the maximum rotational speed was chosen correctly. The mass losses increased along with the increase in rotational speed. The increase from 565 rpm to 786 rpm resulted in more than a 12-fold increase in the mass loss of the as-received steel, while a further increase in speed to 1012 rpm only resulted in an almost 3-fold increase. In the case of thermal-treated steel, the increase in rotational speed caused a 6.7-fold and 2.5-fold increase in mass loss, respectively. Thus, the influence of steel hardness on the mass losses is visible. Nevertheless, the slurry erosion curves have a completely different shape than the cavitation erosion curves. Moreover, in the initial periods of tests, a decrease in mass loss was noted for steel after thermal treatment with lower hardness compared to steel in the as-received state with higher hardness. However, after some time of testing, the mass losses of S235JR-TT steel became greater. The duration of the test, in which the mass loss of the S235JR-TT steel became greater than that of the S235JR-AR steel, increased with increasing rotational speed, which was unexpected. The obtained results, especially a decrease in mass loss of the steel with lower hardness, were in opposition to those obtained in cavitation erosion tests and by Kahraman et al. [6], who also tested the resistance of this steel to slurry erosion.

In the case of the tests performed at 565 rpm and 786 rpm, the mass loss difference in the initial period was very slightly, in fact, it was in the measurement error. The increase in mass loss of the S235JR-TT steel in relation to the S235JR-AR steel occurred after 120 min and 160 min, respectively, and then this difference increased. For tests performed at the highest rotational speed (1012 rpm), this difference in mass losses was already significant. The highest (10 mg) occurred between 240 and 300 min of testing. The time when the mass loss of the S235JR-TT steel become bigger than that of the S235JR-AR steel was about 550 min. Thus, the difference in mass losses of S235JR-TT steel and S235JR-AR steel, and the test duration, when the mass loss of the S235JR-TT steel become bigger than for the S235JR-AR, increased with increasing rotational speed.

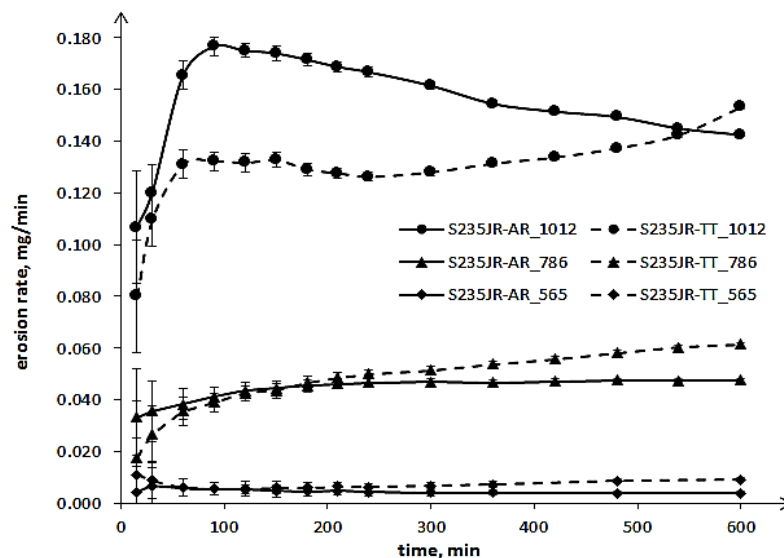
Figure 9. Cavitation erosion rate curves of S235JR steel in as-received state and after thermal treatment.

The influence of thermal treatment on the degradation process is more visible when analysing erosion rates (Figure 9). In the case of tests performed at 565 rpm and 786 rpm, the erosion rate of the S235JR-AR steel increased to the maximum value that remained unchanged until the end of the tests. In the case of the S235JR-TT steel, such a stable erosion rate was not observed. Thus, the lower hardness of the S235JR-TT steel and changes in the structure caused by the action of erodents made it impossible for this steel to achieve a stable erosion rate. The erosion rates increased through the entire tests, but the intensity of this increase was related to rotational speed.

In the case of tests performed at 1012 rpm, the erosion rate of the S235JR-AR steel increased to the maximum value, which was obtained after 90 min of testing, and then decreased. The process of erosion rate decrease lasted until the end of the test. The decrease in erosion rate was likely caused by a surface layer hardness increase. In the case of S235JR-TT steel, the erosion rate increased rapidly during the first 60 min of testing, then it slightly decreased. After 240 min, the erosion rate increased again, but after about 480 min, this increase accelerated. This shape of the erosion rate curve indicates that the surface strain hardening process did not occur or was very small, despite the low hardness of this steel. The high intensity of the dynamic loading probably caused a much faster crack growth than the strain hardening of this mild steel. Thus, the steel hardness and the intensity of loading strongly influenced the degradation mechanism.

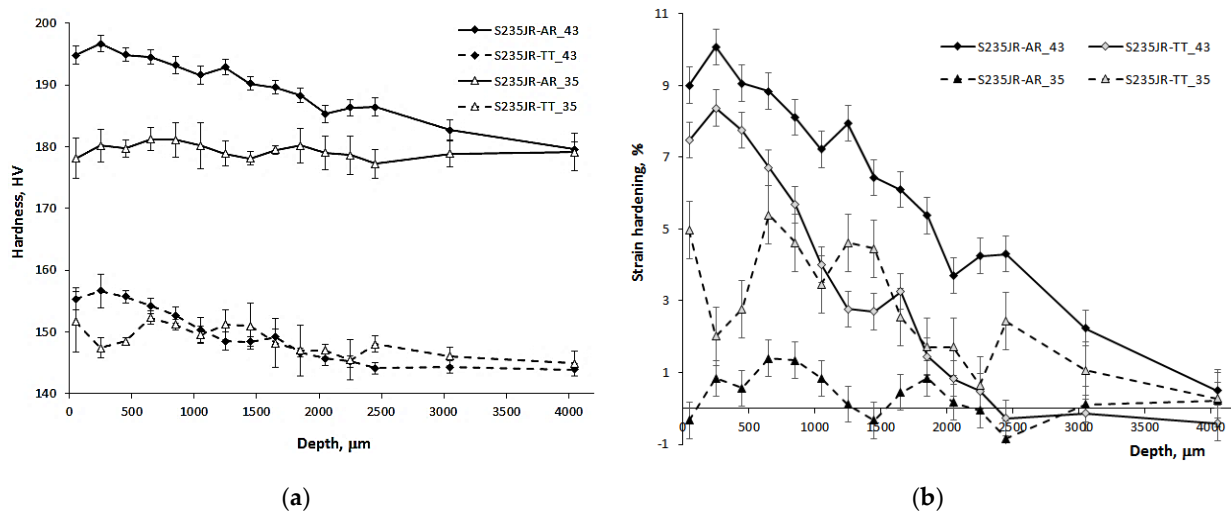
Figure 10. Hardness (a) and strain hardening effect (b) along the specimen depth caused by cavitation

Although mass losses of S235JR-AR steel tested at the highest erosion intensity were comparable, the surface hardness changes and the hardening effect were different (Figures 10 and 11). The effect of cavitation on surface hardness was more pronounced than that of the slurry. This is evidence of the different degradation mechanisms involved in any erosion process.

In the case of the tests carried out at the lowest cavitation erosion intensity, i.e., at a flow velocity of 35 m/s, the hardness changes of the S235JR-AR steel were very slight. The hardening effect was in the range from −0.5% to 1%. This shows that no hardening effect occurred. However, tests of the S235JR-TT steel showed a strain hardening of 5% at a

depth of 35 μm . With increasing depth, hardening ranged from 2% to 5%. The total depth of hardening was 4 mm. Thus, at the flow velocity of 35 m/s, the supplied impact energy resulted in the opposite development of the degradation process to that at the flow velocity of 43 m/s. This is due to a change in the distribution of the cavitation load - the number of high-amplitude pulses and the number of low-amplitude pulses. In the case of harder S235JR-AR steel, only the initiation and growth of cracks leading to mass loss was noted. It was caused by high-amplitude pulses, low-amplitude pulses were not able to cause any effect because of high hardness of the tested steel. Meanwhile, in the S235JR-TT steel with a lower hardness, strain hardening was also noted despite greater mass loss (Figure 6). Strain hardening was likely an effect of large number of low-amplitude pulses and low hardness of the tested steel.

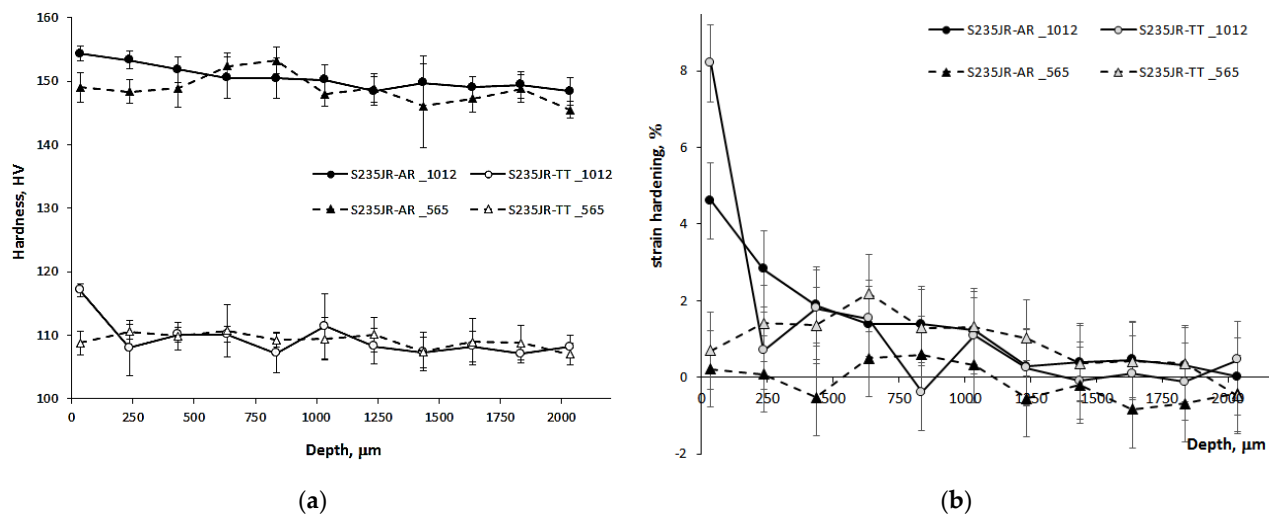
Figure 11. Hardness (a) and strain hardening effect (b) along the specimen depth caused by slurry

In the case of the slurry erosion tests performed at the highest rotational speed of 1012 rpm, the hardness of the as-received steel and the thermally treated steel increased to about 159 HV and 120 HV at a depth of 35 μm (Figure 11a). Thus, the strain hardening effect was about 5% and 8%, respectively (Figure 11b). This indicates that a higher strain hardening effect was obtained for the thermally treated steel, which had lower initial hardness. This effect was in opposition to that obtained during cavitation erosion tests at the flow velocity of 43 m/s. Moreover, the strain hardening of the as-received steel was much lower than that obtained in cavitation erosion tests, while the thermally treated steel was comparable to that obtained in cavitation erosion tests (Figure 10b). The depth of strain hardening was about 1800 μm and 1400 μm , respectively. However, the biggest decrease in strain hardening occurred at a distance of about 200 μm (from 8.2% at 35 μm to 0.7% at 235 μm). These depths are much smaller than those obtained in cavitation tests (about 4 mm). This indicates the different degradation mechanism. In cavitation erosion, cavitation pulses impact the surface with a wide range of amplitudes, from a few kPa to GPa. In slurry erosion, all erodents impact with comparable energy, so the dispersion of impact energy is small. Due to the high rotational speed, which influenced the high impact velocity, the impact energy is used mainly on the initiation and development of cracks, resulting in a significant mass loss and less strain hardening than in the case of cavitation erosion, where low energy impacts also occurred.

In the case of tests carried out at the lowest slurry erosion intensity, i.e., at a rotational speed of 565 rpm, the hardness of the S235JR-AR steel at a depth of 35 μm was about 152 HV. It means that the hardness increase did not occur. All changes in hardness oscillated around the initial value. In the case of S235JR-TT steel, the impacts of solid

particles caused a slight increase in hardness to about 112 HV at a depth of 35 μm . The strain hardening effect was about 1%. The highest hardness (113.4 HV) was obtained at a depth of 635 μm . This makes that strain hardening increased to 2.2%. Then, hardness decreased to an initial value that was reached at a depth of about 1800 μm . Thus, the depth of strain hardening was bigger than in the tests performed at the highest rotational speed. The likely reason for this was the lower impact energy supplied by erodents to the steel surface that caused significant less mass loss and much less removal of the hardened layer.

speed increases, this interaction is likely to increase. A low depth of strain hardening at the highest rotational speeds (Figure 11) is consistent with the assumption that the particles interact with each other.

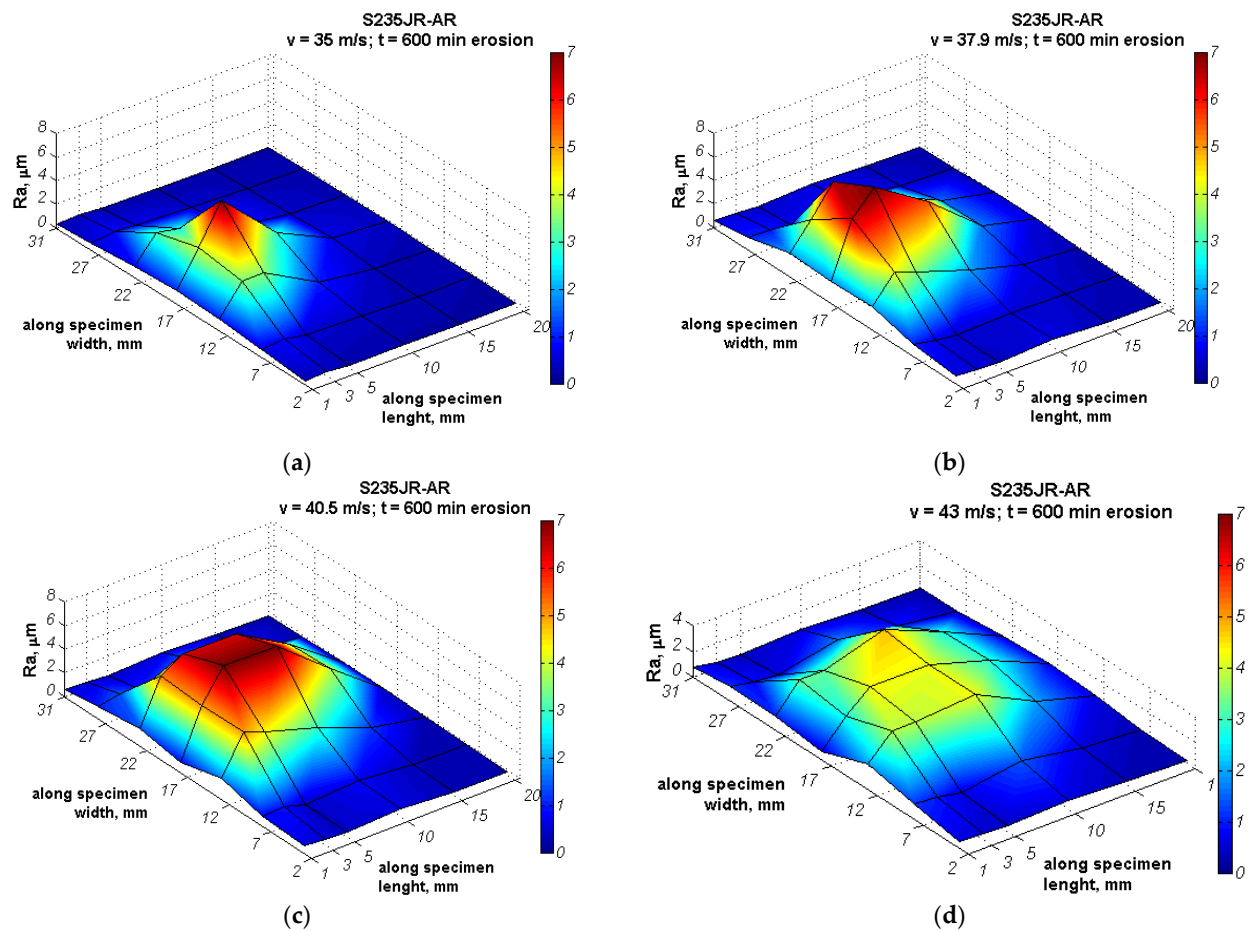
Figure 12. Distribution of the Ra parameter on the surface of the S235JR-AR steel tested for resistance to cavitation erosion at a flow velocity of (a) 35 m/s, (b) 37.9 m/s, (c) 40.5 m/s and (d) 43 m/s.

Roughness measurements of specimens tested in cavitation erosion tests revealed areas of high roughness $Ra > 5 \mu\text{m}$ that are at approximately half the width of the

specimens close to the upper barricade (Figures 12 and 13), regardless of the hardness of the tested steel (steel state) and the flow velocity. With increasing flow velocity, the area with $R_a > 1 \mu\text{m}$ also increases, but it is not followed by the increase in the maximum roughness value. Also, the distribution of R_a parameters changed its character depending on the flow velocity. In the case of tests conducted at a flow velocity of 35 m/s, the maximum R_a value was $7.38 \pm 0.16 \mu\text{m}$ and $8.71 \pm 0.21 \mu\text{m}$, respectively for S235JR-AR and S235JR-TT steel. Thus, higher roughness was obtained on softer steel. The surface roughness increased rapidly to a maximum value, which was reached 5 mm from the specimen edge nearest to the upper barricade, and then decreased, regardless of the steel state. However, the rate of decrease in roughness was related to the hardness of the steel. In the case of softer steel after thermal treatment, this rate was lower. Although the maximum surface roughness had higher values, the roughness (R_a parameter) of less than $1 \mu\text{m}$ was only recorded at a distance of 20 mm from the upper barricade. Nevertheless, in both steel states, the roughness distribution formed a sharp peak.

For the tests carried out at a flow velocity of 37.9 m/s, the maximum R_a value was $8.47 \pm 0.15 \mu\text{m}$ and $11.60 \pm 0.27 \mu\text{m}$, respectively (Figures 12b and 13b). Thus, the maximum R_a value increased $1 \mu\text{m}$ and nearly $3 \mu\text{m}$, respectively. Moreover, the area with $R_a > 2 \mu\text{m}$ increased significantly. The roughness peak was still obtained and located 5 mm from the upper barricade. The roughness peak was sharp in S235JR-TT steel (Figure 13b), while slight in S235JR-AR steel (Figure 12b). Moreover, the eroded surface with $R_a > 6 \mu\text{m}$ formed a large area indicating a zone of high erosion level.

A further increase in a flow velocity to 40.5 m/s caused an increase in the area with $Ra > 2 \mu\text{m}$. However, the roughness values lowered concerning those obtained at a flow velocity of 37.9 m/s. The maximum Ra values of S235JR-AR and S235JR-TT steel were $7.71 \pm 0.19 \mu\text{m}$ and $9.38 \pm 0.28 \mu\text{m}$, respectively. Thus, the maximum Ra value decreased by nearly $0.8 \mu\text{m}$ and over $2 \mu\text{m}$, respectively. Considering that with increasing flow velocity the mass loss also increased (Figure 6), a decrease in surface roughness was caused likely by overlapping damages. However, the surface with $Ra > 6 \mu\text{m}$ increased without any roughness peaks indicating a comparable erosion level.

In the case of tests carried out at a flow velocity of 43 m/s, surface roughness decreased even more (Figures 12d and 13d). The maximum Ra values were $4.31 \pm 0.11 \mu\text{m}$ and $5.48 \pm 0.12 \mu\text{m}$, respectively. Thus, the Ra parameter decreased by nearly $3.5 \mu\text{m}$ and $4 \mu\text{m}$, respectively. Besides, the Ra parameters were lower than those obtained in the tests carried out at the lowest flow velocity. This decrease was caused by the effect of overlapping damages. The surface with the highest surface roughness formed a large, flattened area with a comparable erosion level. The conducted tests showed that the steel of lower hardness was characterized by higher roughness regardless of the flow velocity. This is in agreement with the mass losses and erosion rates.

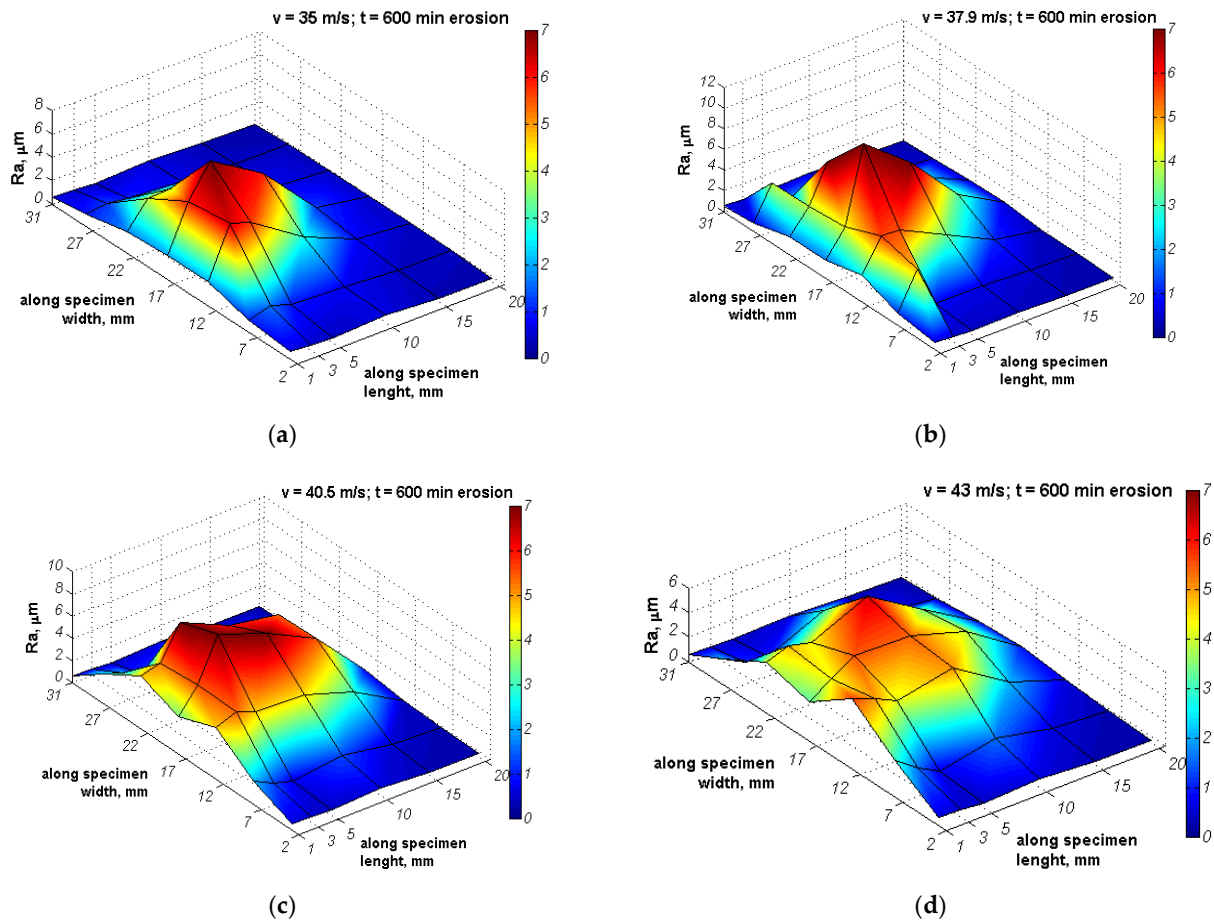
Figure 13. Distribution of the R_a parameter on the surface of the S235JR-TT steel tested for resistance to cavitation erosion at a flow velocity of (a) 35 m/s, (b) 37.9 m/s, (c) 40.5 m/s and (d) 43 m/s.

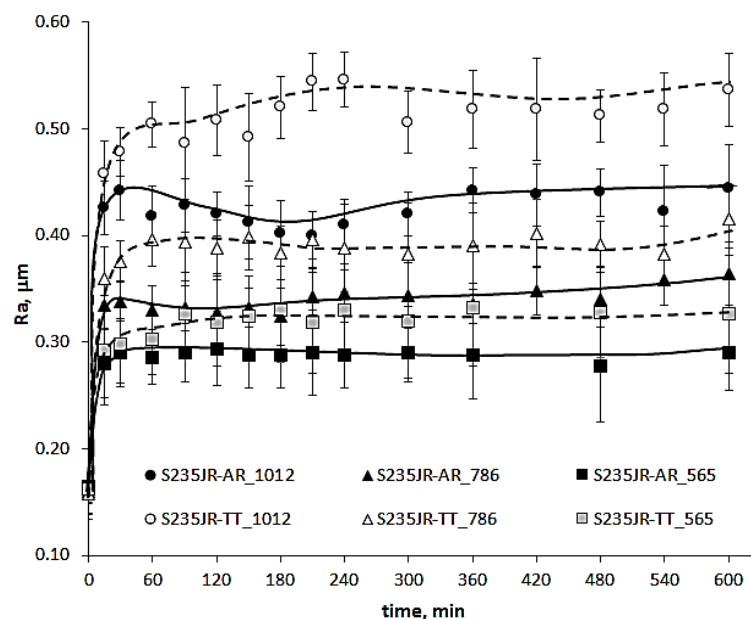
Figure 14. Development of surface roughness (Ra parameter) during slurry tests.

Slurry erosion tests also caused an increase in surface roughness (Figure 14). The highest increase took place during the first 60 min of testing. After reaching the maximum value, the Ra parameter remained stable until the end of the tests. The obtained fluctuations result from the nature of the roughness measurement and should be disregarded in further analysis. The S235JR-TT steel with lower hardness had higher Ra parameters, regardless of the test conditions. This result is comparable to the result obtained in cavitation erosion. Nevertheless, the highest Ra parameters were much lower than those obtained in cavitation erosion tests. In the case of the tests carried out at a rotational speed of 565 rpm, the Ra parameters of S235JR-AR steel and S235JR-TT steel after the entire tests were $0.29 \pm 0.04 \mu\text{m}$ and $0.33 \pm 0.06 \mu\text{m}$, respectively. In the case of the tests performed at a rotational speed of 786 rpm and 1012 rpm, the Ra parameters were $0.36 \pm 0.03 \mu\text{m}$ and $0.42 \pm 0.03 \mu\text{m}$, and $0.44 \pm 0.04 \mu\text{m}$ and $0.54 \pm 0.03 \mu\text{m}$, respectively. Thus, the Ra parameter increased with the increase of the rotational speed, as well as the difference in the surface roughness values. Thus, there was no overlapping damage effect, as was the case with cavitation erosion.

degradation is consistent with the roughness results (Figure 14). As shown in Figure 18c,d, the surface of S235JR-AR steel is slightly undulated, similar to the surface of the thermal-treated steel. However, the undulation of the latter (Figure 18d) seems to be bigger. Yet, the surface looks much smoother. There is no flaking, but pits and short cracks. The number and size of pits depend on the steel state. In the case of the as-received state, pits are much smaller, but their number is much bigger than on the surface of S235JR-TT steel (Figure 18c,d). The pit seen in Figure 18d was likely due to steel removal and not shearing as with cavitation erosion.

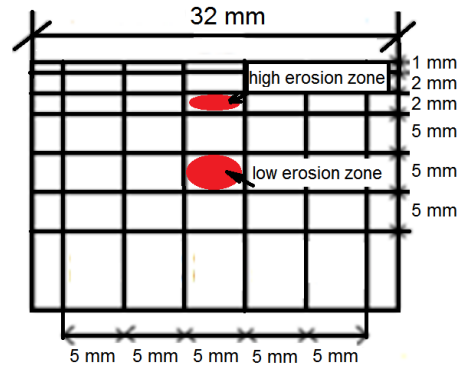
Figure 15. The observation areas of damage developed on the surface of S235JR steel during cavitation erosion tests.

Based on the roughness measurements, the zones of low and high erosion in cavitation tests were determined and showed in Figure 15. The surface damages of the S235JR-AR and S235JR-TT steels developed during tests performed at the lowest (35 m/s) and highest (43 m/s) flow velocity in these zones are shown in Figures 16 and 17, respectively.

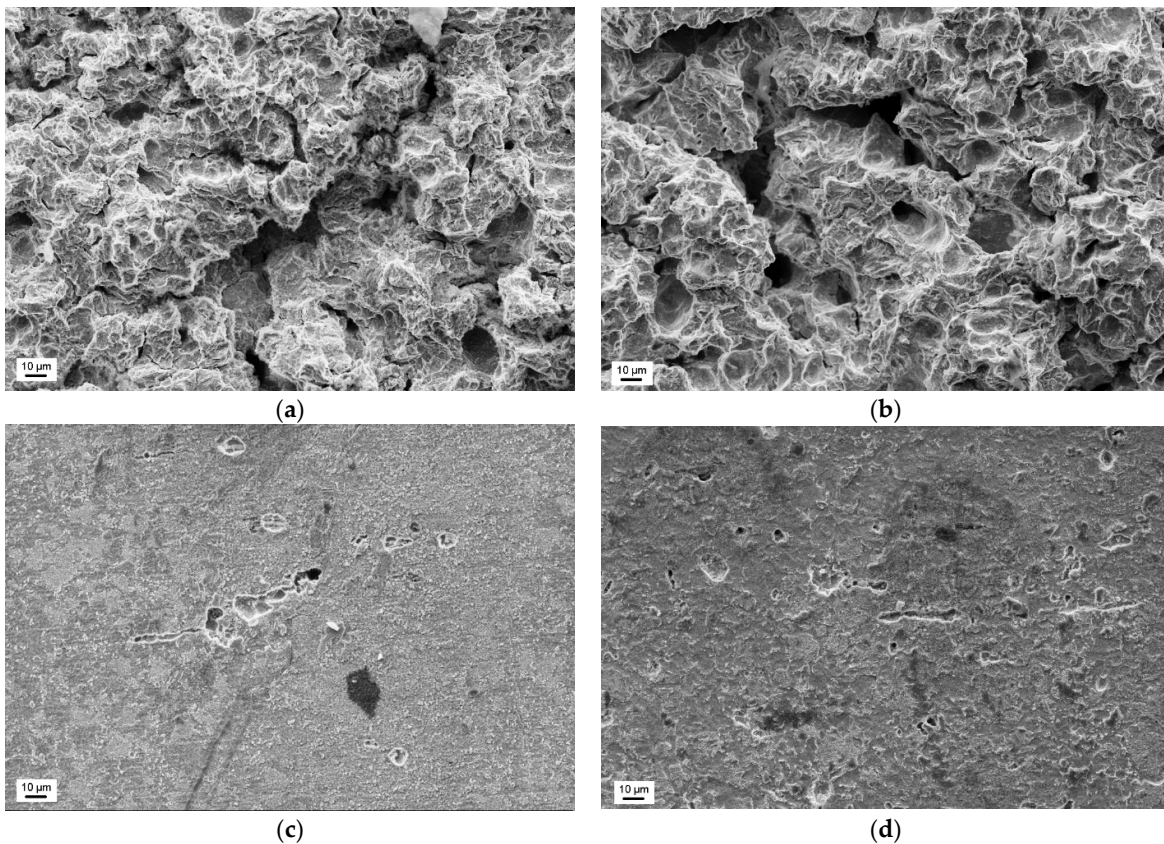
Figure 16. Surface damages developed during cavitation erosion tests carried out at a flow velocity of 35 m/s in the high erosion zone of (a) S235JR-AR steel and (b) S235JR-TT steel, and in the low erosion zone of (c) S235JR-AR steel and (d) S235JR-TT steel.

Damages to the surface of hard S235JR-AR and soft S235JR-TT steels in the strongly eroded zone and tested at a flow velocity of 35 m/s have the form of pits or so-called

cavitation tunnels, voids and cracks developing in a ductile mode (Figure 16a,b). Cracks are a bit wider for soft S235JR-TT steel, indicating the effect of the steel hardness. Although the diameter of some voids or pits can be determined, all damages overlapped. Besides, the damage mentioned above is greater for soft S235JR-TT steel, which complies with the roughness measurements (Figures 12 and 13) and steel hardness. Ductile fracture is in line with the steel grade (low carbon steel) and low hardness (178.7 ± 3.5 HV and 144.5 ± 2.9 HV, respectively) and ferritic-pearlitic structure. In the case of the low erosion zone (Figure 16c,d), the damage is mainly in the form of pitting, but several short cracks are also observed. The damage density is much lower on the surface of the S235JR-AR steel, which had a higher hardness. The pits are well seen and can be divided into two groups: the first with a diameter up to $10 \mu\text{m}$ and the second with a bigger diameter (above $10 \mu\text{m}$). The pits of the first group are much deeper than those of the second. This indicates that the pitting of the first group was the result of shearing by micro-jets impacted at high speed. Such pits do not occur on the surface of hard S235JR-AR steel. Considering that the tests were carried out at the same condition, the S235JR-AR was more resistant to such impacts because of steel hardness.

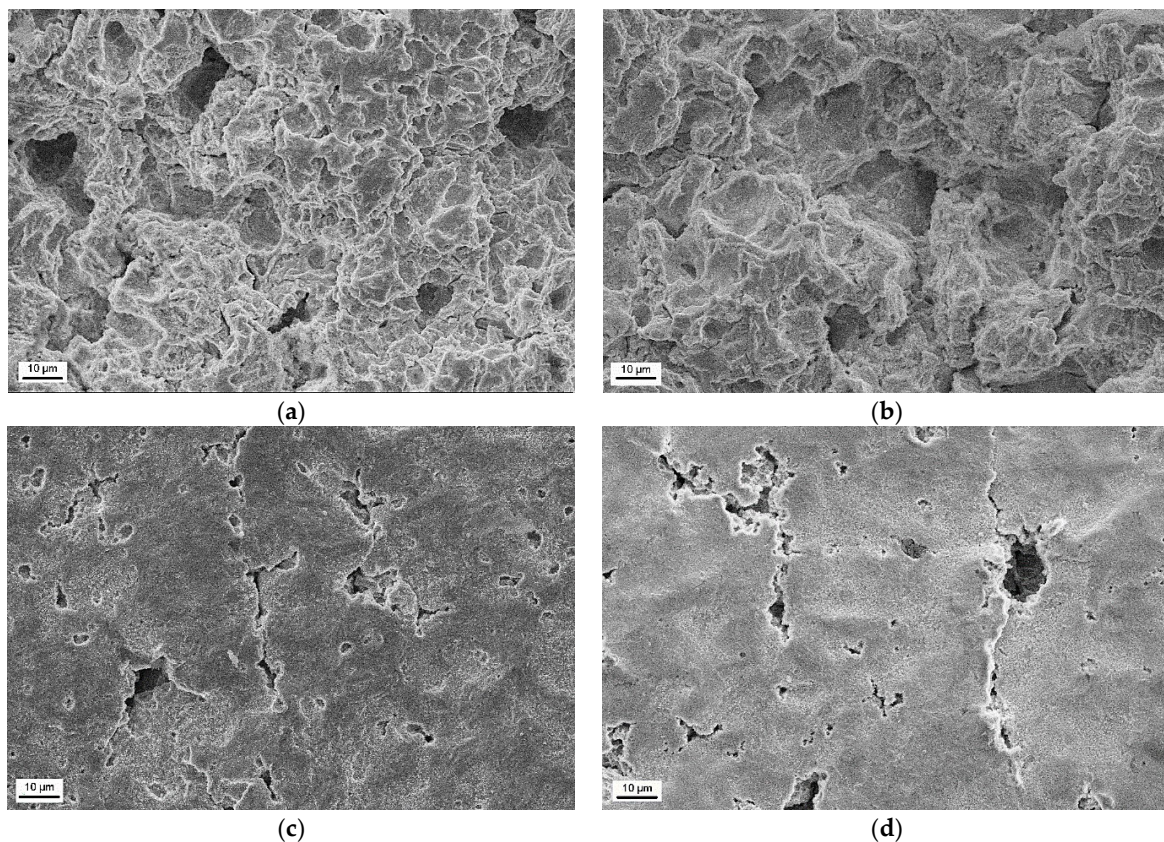
Figure 17. Surface damages developed during cavitation erosion tests carried out at a flow velocity of 43 m/s in the high erosion zone of (a) S235JR-AR steel and (b) S235JR-TT steel, and in the low erosion zone of (c) S235JR-AR steel and (d) S235JR-TT steel.

Damages on the surface of S235JR-AR and S235JR-TT steel in the strongly eroded zone and tested at a flow velocity of 43 m/s also have the form of ductile cracks, cavitation pits/tunnels and voids (Figure 17a,b). Thus, all these failures are typical of this steel and this erosion process. Nevertheless, the intensity of cavitation affected the number and width of the cracks, which are much narrower than those observed at a flow rate of 35 m/s. The diameter of some pits/cavitation tunnels in hard S235JR-AR steel ranges from about $10 \mu\text{m}$ to $20 \mu\text{m}$ (Figure 17a), but such pits are not seen in soft

S235JR-TT steel (Figure 17b). It is related to the hardness of the steel and the mass losses. Taking into account the greater loss of mass on the S235JR-TT steel in the cavitation test, the most likely reason for the lack of such pitting is the removal of such a heavily damaged surface layer. On the other hand, the damage size of the steel as received is smaller than that of thermal-treated steel, which is consistent with the hardness measurements (Figure 10). Also, more severe damage developed during tests with a flow velocity of 35 m/s is consistent with the hardness measurements. Moreover, the observation of the degree of destruction of S235JR steel in both states is consistent with the roughness measurements (Figures 12 and 13).

In the case of the low erosion zone (Figure 17c,d), the damage is mainly in the form of pitting, but several cracks and surface undulation are also observed. The cracks are likely developed along the grain boundaries. The length and width of cracks, as well as the size of pits, are much bigger for the thermal-treated steel. The pits were caused by shearing due to the impacts of high-velocity micro-jets. The bigger size of pits indicates that this steel is more susceptible to such impacts. However, damage density is much bigger for steel in the as-received state. The lower size of pits and cracks length are connected with a higher hardness of this steel.

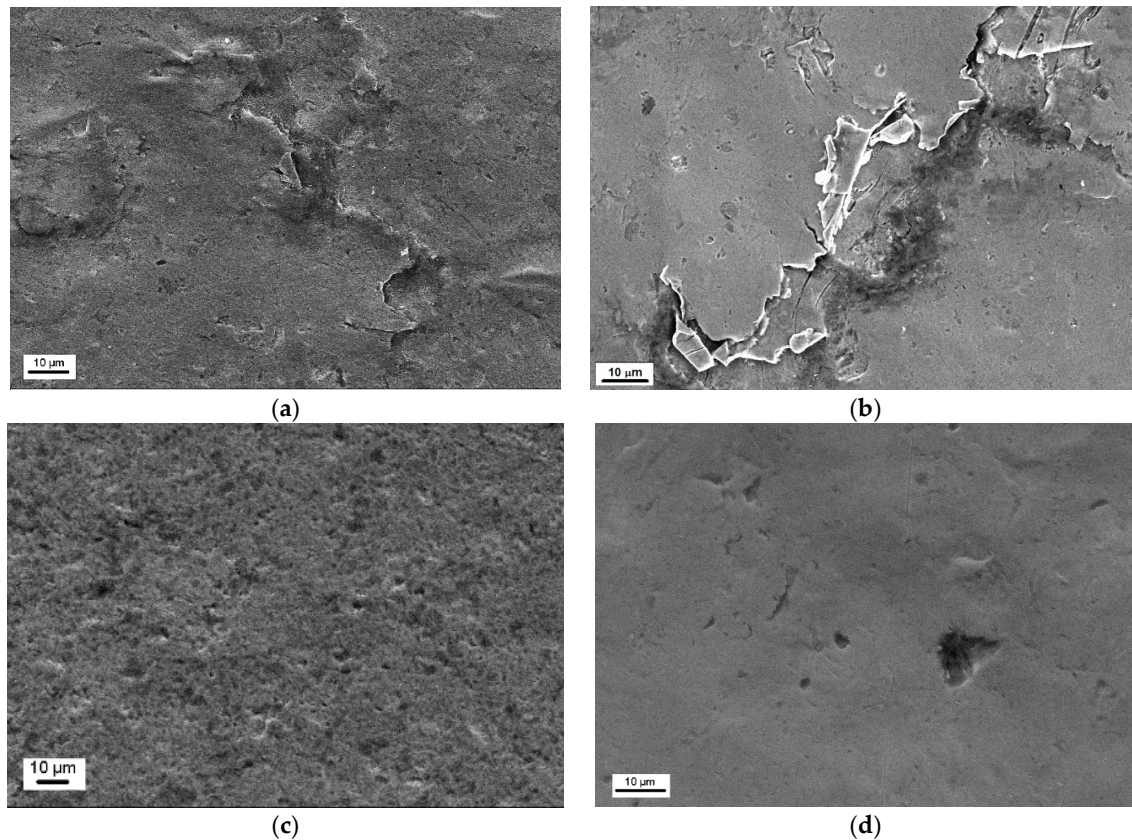
Figure 18. Surface damages developed during slurry erosion tests carried out at a rotational speed of 1012 rpm in (a) S235JR-AR steel and (b) S235JR-TT steel, and at a rotational speed of 565 rpm in (c) S235JR-AR steel and (d) S235JR-TT steel.

The damage from slurry erosion testing is completely different (Figure 18). In the case of tests carried out at a rotational speed of 1012 rpm (Figure 18a,b), flaking and undulation of the surface are visible, regardless of the steel state. There are also some tiny and shallow pits. The surface is much less degraded concerning that developed in cavitation tests (Figures 16 and 17). The level of surface degradation is consistent with the roughness results (Figure 14). Also, damage developed at a rotational speed of 565 rpm

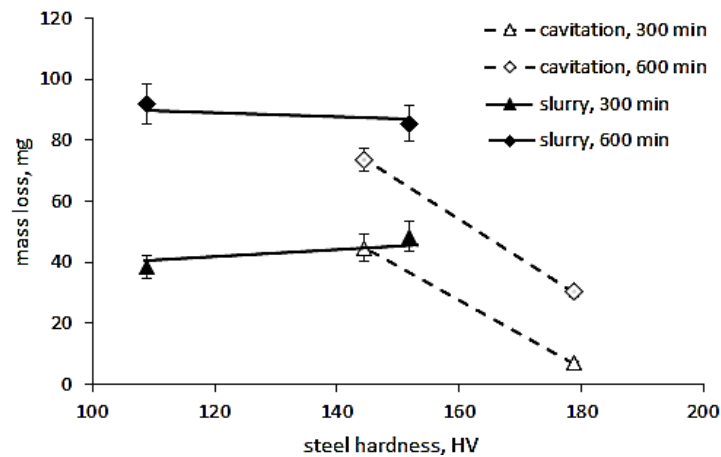
Figure 19. The effect of steel hardness on mass loss.

The performed thermal treatment of the tested steel decreased the hardness by over 30 HV and allowed learning the impact of steel hardness on the resistance of S235JR steel to cavitation and slurry erosion. According to the test results obtained by Hammit [21], Kwok et al. [22] and Rajput et al. [23], resistance to cavitation erosion increases exponentially with increasing hardness. Similar correlation occurs for slurry. Sheldon [24] and Desale et al. [25,26] obtained that resistance to slurry erosion increases exponentially with increasing hardness. Based on the data obtained by Kwok et al. [22] and Rajput et al. [23], this exponent is close to 3. However, when this exponent was determined on the basis of the results obtained by Baghel et al. [27], it was close to 1, while Moore's [28] - to 0.4. Nevertheless, the exponent can range from about 0.5 to over 3 in both types of erosion. On the other hand, investigations of titanium alloys have not confirmed this relationship either in cavitation erosion or in slurry [1], as well as tests of X10CrAlSi18 steel annealed at different temperatures [29]. Slurry tests of aluminum, copper, carbon steels and stainless steels confirmed that material hardness and impact velocity affect the erosion rate [30]. However, no clear single trend of change was achieved. Depending on the tested materials with a given hardness range, the erosion rate may decrease with increasing hardness, but it may also increase, or no effect may be obtained. Kahraman et al. [6], who tested the same steel, have obtained a significant decrease in mass loss in the slurry tests with the increase in steel hardness. The results obtained in these investigations did not confirm such a relationship in the study of slurry erosion (Figure 8a), but showed a big impact of steel hardness on the mass loss in cavitation erosion tests (Figure 6). To better see the effect of steel hardness on the mass loss, a graph was made which takes into account the mass loss obtained at the highest flow velocity (43 m/s) or rotational speed (1012 rpm) after 600 min (the entire tests) and e.g., after 300 min, when the highest difference in mass losses occurred. Figure 19 shows that for S235JR steel, steel hardness strongly influenced the cavitation resistance, i.e., mass loss. The hardness change by 34 HV caused a change in the mass loss by about 40 mg (38 mg after 300 min of testing and 43 mg after the entire tests). Thus, this relationship was slightly dependent on the duration of the test. In the case of slurry tests, the decrease in hardness from 151.7 HV to 109 HV slightly affected mass loss and erosion resistance. Similarly, such a result was independent of the duration of the test. This result was unexpected in the light of the tests carried out by Kahraman et al. [6] and also by Desale et al. [25,26]. However, Oka and Yoshida [30] found that for some materials, some hardness values and specific types of erodent, there may be no change in mass loss caused by a change in the hardness of the steel. Thus, the obtained difference in hardness and mass losses shown in Figure 19 fit in with that observation. Figure 19 shows also that the steel hardness plays a much stronger influence on the mass loss in cavitation erosion resistance tests than in the case of slurry erosion.

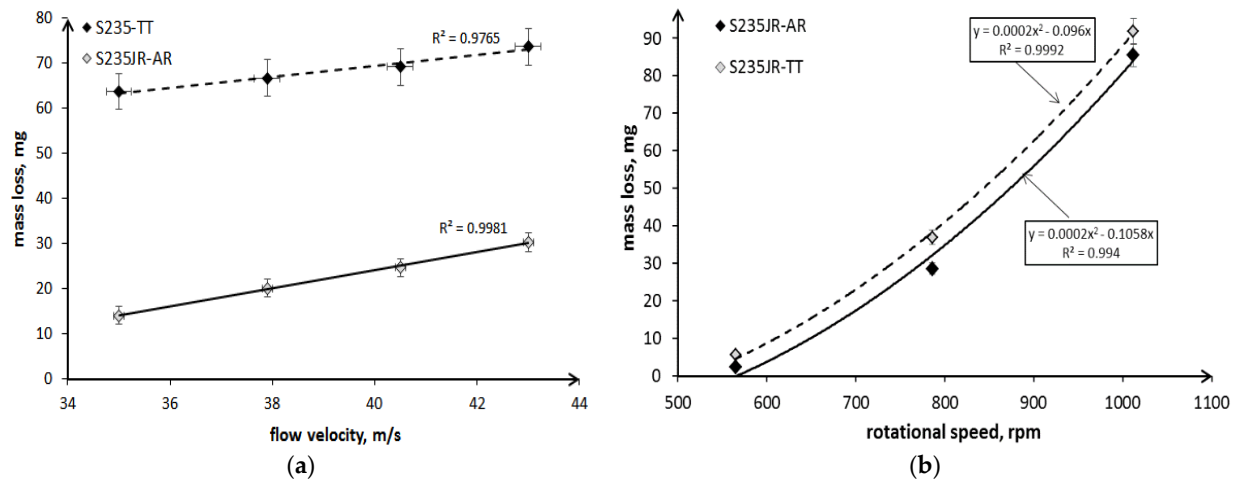
Figure 20. Correlation between the mass loss and (a) a flow velocity in cavitation erosion tests, and (b) a rotational speed in slurry erosion tests.

The other factor influencing the mass loss in cavitation and slurry erosion tests is erosion aggressiveness/intensity. In the case of cavitation erosion, the intensity of the erosion depends on the flow velocity or inlet and outlet pressures in the flow devices, e.g., in a cavitation tunnel or a cavitating jet device, and the frequency and/or amplitude of the vibrations in the vibrating device. Investigations of pure aluminum, copper, bronze, carbon steels and also stainless steels with the use of the cavitating jet apparatus showed an exponential dependence the mass losses with injection and tank pressures [31]. While, in the case of the vibrating apparatus, the relationship between vibrating amplitude and mass losses of pure aluminum and copper was linear [15,32]. In the case of slurry erosion, the impact velocity of erodents is the parameter that affects the erosion intensity and the mass loss the most [26,33–35]. Moreover, erosion rate increases exponentially with the impact velocity and an exponent is usually about 2–3 for metallic alloys, but it can also vary from 0.34 to 4.83 [35]. The correlations between the flow velocity in cavitation erosion tests or rotational speed in slurry tests and the mass loss after the entire erosion tests obtained in these investigations are shown in Figure 20. In the case of cavitation erosion tests, a linear relationship for both steel states was obtained for the tests carried out in the cavitation tunnel and flow velocities ranging from 35 m/s to 43 m/s (Figure 20a). This linear correlation is in accordance with the results obtained by Okada et al. [15] and Hattori et al. [32], although other testing materials and various apparatus were used. However, based on the results obtained by Krella [36], it can be seen that the type of correlation depends on the flow velocity range, and the linear correlation may occur above a certain threshold value of the flow velocity. Figure 20a also shows that the trend line determined for hard S235JR-AR steel is parallel to that determined for the soft steel after thermal treatment. This means that the difference in the mass losses obtained after the entire tests was comparable for all flow velocities and the character of the trend line was independent of the steel state and steel hardness.

In the case of slurry tests, for rotation speed range from 565 rpm to 1012 rpm, the best relationship is a polynomial relationship, not exponential (Figure 20b). In the case of the exponential dependence, the maximum dispersion may reach even 42% for steel in the as-received state or 17% for heat-treated steel. This indicates that the exponential relationship cannot be taken into account. The trend lines of hard S235JR-AR and soft S235JR-TT steels are parallel to each other, so the nature of the correlation does not depend on the state of the steel and steel hardness, as was the case with cavitation erosion, but on the steel grade. The other factors that may affect the relationship are the type of test device, erodent concentration and the range of rotational speed. Also, in the tests of ferritic X10CrAlSi18 steel with the use of a slurry pot, no exponential but rather a linear correlation was obtained by Krella et al. [37]. In a slurry pot, the solid particles can collide with each other, which affects the actual speed and direction of the particles. As

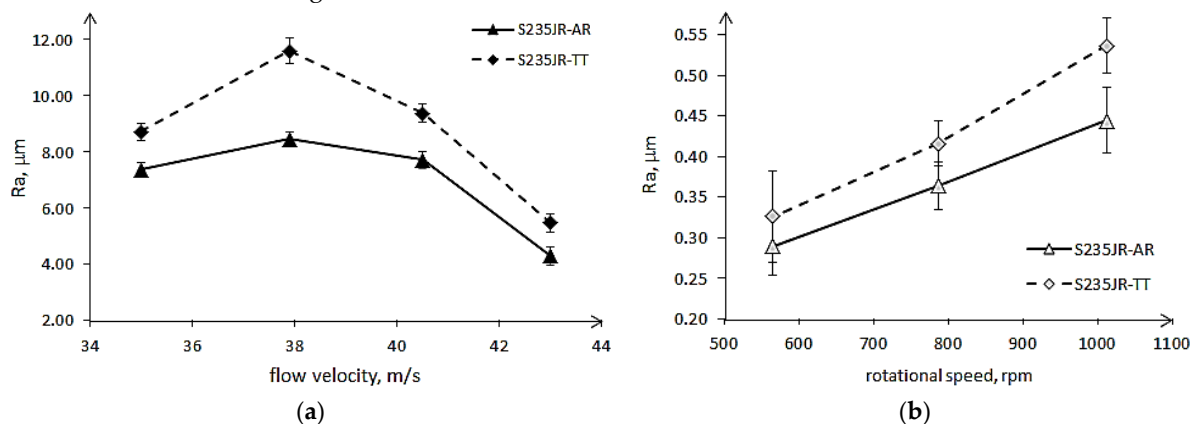
Figure 21. Correlation between (a) the maximum Ra parameter and a flow velocity in cavitation erosion tests, and (b) the mean Ra parameter and a rotational speed in slurry erosion tests.

Although erosion processes concern mainly the degradation of the material surface layer, the investigations of surface roughness development in relation to erosion intensity are not so extensive. According to Chiu et al. [38], in cavitation erosion, surface roughness (Ra parameter) increases up to limit value that is related to the steel grade with increasing testing time and then remains unchanged. However, Dojcinovic et al. [39] showed that the mean surface roughness Ra of ductile cast iron exposed to cavitation increases with testing time, although the rate of roughness change decreases. In the presented results, in cavitation erosion, surface roughness depends also on the cavitation intensity, i.e., flow velocity (Figures 12 and 13). Taking into account the maximum Ra parameter obtained on the exposed surface after 600 min of testing and flow velocity, the correlations shown in Figure 21 a are obtained. As shown in Figure 21a, the Ra parameter increases with increasing flow velocity from 35 m/s to 38 m/s, but for flow velocities greater than 38 m/s, a decrease in surface roughness with increasing flow velocity was obtained. This decrease was probably due to the strain hardening (Figure 10b), the intensive development of surface damage and an increase in overlapping damage (Figures 16 and 17). Regardless of the flow rate, higher roughness values were obtained for thermally treated steel, probably due to its lower hardness. Taking into account the strain hardening, the greater the increase in hardness the lower Ra parameter is observed only for cavitation erosion tests conducted at 43 m/s, but not at 35 m/s. Intense overlapping damage and intensive mass loss may cause a decrease in surface roughness. As a result, the surface roughness obtained at 43 m/s was lower than that obtained at 35 m/s.
