# Non-Destructive Diagnostics of Concrete Beams Strengthened with Steel Plates Using Modal Analysis and Wavelet Transform

**Abstract:** Externally bonded reinforcements are commonly and widely used in civil engineering objects made of concrete to increase the structure load capacity or to minimize the negative effects of long-term operation and possible defects. The quality of adhesive bonding between a strengthened structure and steel or composite elements is essential for effective reinforcement; therefore, there is a need for non-destructive diagnostics of adhesive joints. The aim of this paper is the detection of debonding defects in adhesive joints between concrete beams and steel plates using the modal analysis approach. The inspection was based on modal shapes and their further processing with the use of continuous wavelet transform (CWT) for precise debonding localization and imaging. The influence of the number of wavelet vanishing moments and the mode shape interpolation on damage imaging maps was studied. The results showed that the integrated modal analysis and wavelet transform could be successfully applied to determine the exact shape and position of the debonding in

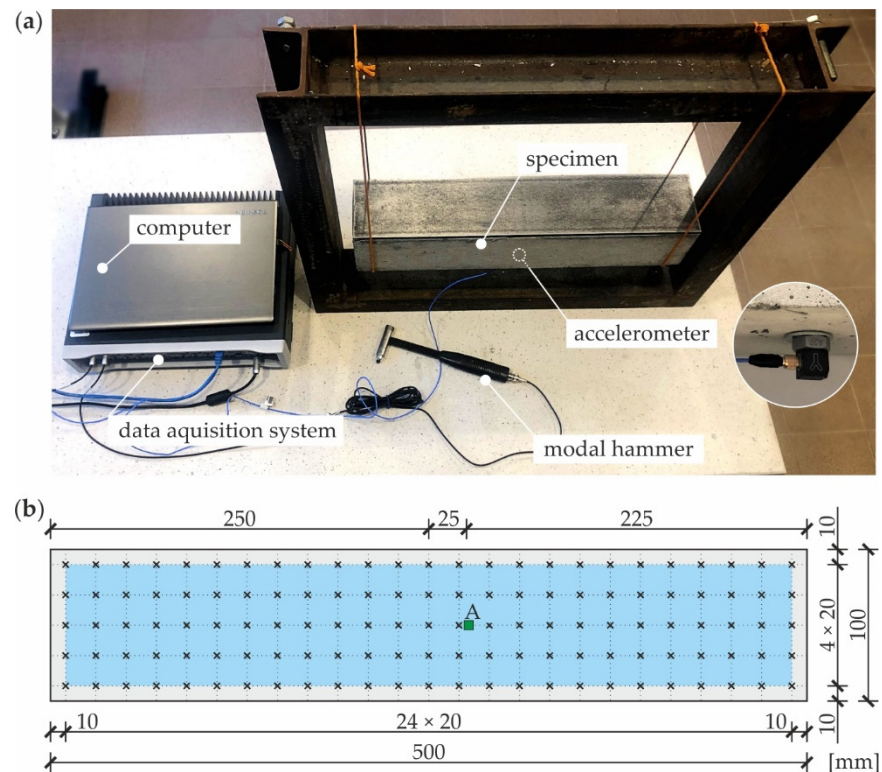
**Figure 2.** Experimental setup (a) and scheme of measurement grid (b).

Dynamic parameters of the tested specimens (i.e., natural frequencies and modal shapes) were determined using the experimental modal analysis (EMA) approach, in which both excitation and response signals were measured. In the study, an impact test was conducted with the use of a modal hammer. The experimental setup for EMA is shown in Figure 2a. The specimen was suspended from both sides on elastic strings to simulate free boundary conditions. Piezoelectric accelerometer 356A15 (PCB Piezotronics, Inc., Depew, NY, USA) was used for the measurement of vibrations. The properties of the sensor used are as follows: sensitivity  $10.2 \text{ mV}/(\text{m}/\text{s}^2)$ , measurement range  $\pm 490 \text{ m}/\text{s}^2$ , resonant frequency  $\geq 25 \text{ kHz}$  and frequency range  $2\text{--}5000 \text{ Hz}$ . The accelerometer was attached to the bottom surface of the beam at point A located 25 mm from the center. The dynamic pulse load was induced by the modal hammer 086C03 (PCB Piezotronics, Inc., Depew, NY, USA) with the following parameters: sensitivity  $2.25 \text{ mV}/\text{N}$ , measurement range  $\pm 2224 \text{ N}$ , resonant frequency  $\geq 22 \text{ kHz}$ . A medium tip was applied with the hammer enabling the excitation of vibrations within the frequency range up to approximately 2800 Hz. A single measurement was performed at each of 125 points. The points of impact, marked in Figure 1b, were distributed on the top surface of the specimen in a regular square grid having 5 rows and 25 columns, resulting with a resolution of 20 mm in both directions. Data acquisition and signal conditioning were performed by LMS SCADAS portable system (Siemens, Leuven, Belgium). Natural frequencies and modal shapes were determined based on the frequency response function (the accelerance in this case) given as the ratio of an output acceleration signal to an input force signal [33,40,41]. The estimation of modal

parameters was performed using a peak picking method. Mode shapes were determined by measuring the peak amplitude of the imaginary part of the frequency response function.
