Agnieszka TUBIS<sup>1</sup>, Mateusz RYDLEWSKI<sup>1</sup>, Marcin BUDZYŃSKI<sup>2</sup>  
<sup>1</sup>Wrocław University of Science and Technology (Politechnika Wrocławska)  
<sup>2</sup>Gdańsk University of Technology (Politechnika Gdańska)

## SAFETY AND FUNCTIONALITY ASSESSMENT OF TRAM LOOPS IN WROCLAW

**Abstract:** *The article presents the implementation of the ISFTL method proposed by the authors consisting in an indicator assessment of the safety and functionality of tram loops. Five tram loops located in Wrocław were analyzed. Each of these loops has different characteristics. The components of each assessment are described in detail and further directions for improving the proposed assessment are indicated.*

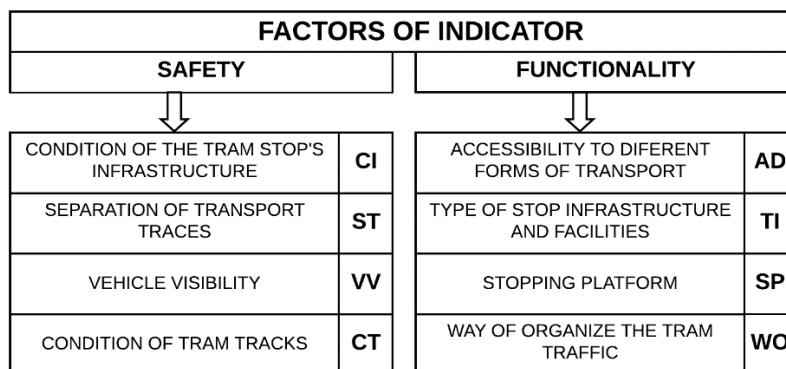
**Fig. 1.** Components of assessment factors for the ISFTL method, based on [14]

The method proposed in [14] involves the determination of two independent indicators relating to the assessment of safety and functionality of tram loops. The idea of the method is to evaluate each of the loops in the area of 4 different criteria, which for both indicators are presented in fig. 1.

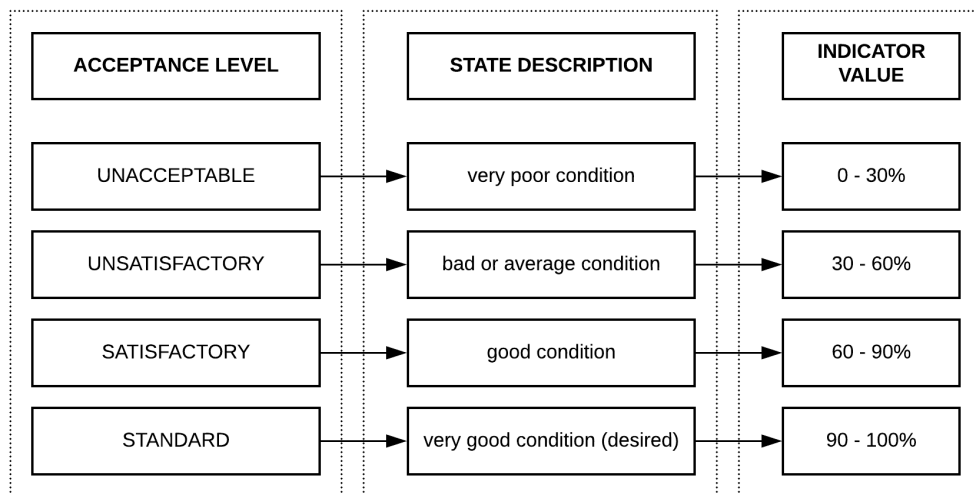
**Fig. 3.** Acceptance levels for the percentage values of safety and functionality indicators of tram loops

For the determined percentage values of the ISTL and IFTL indicators, the levels of acceptance of meeting a given evaluation criterion were determined depending on the percentage value of the indicators of safety or functionality of the tram loop. In fig. 3, a diagram with specific acceptance levels is presented.

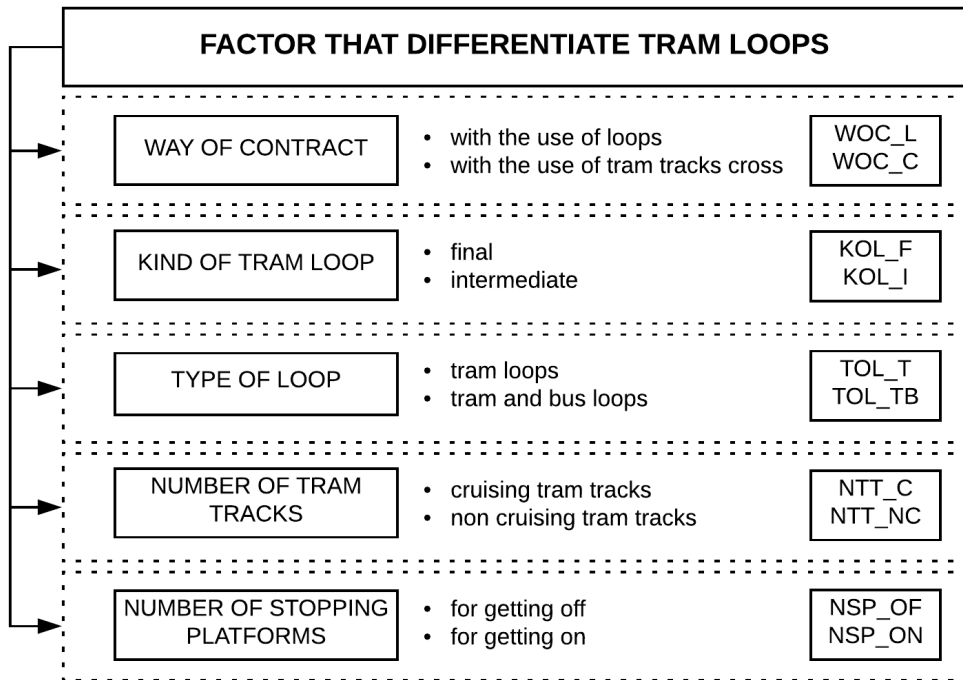
Fig. 4. Factor that differentiates tram loops

The field study was conducted in December 2019. In tab 1. are presenting the most important parameters of the analyzed tram loops taken into account during the analysis and detailed information describing the factors differentiating the tram loops (fig. 4). As an additional parameter - NL - the number of lines served on a given loop as of 31.12.2019 was also given.

No.	Name of tram loop	WOC	KOL	TOL	NTT	NSP	NL
1	KRZYKI	L	I	TB	C-2 NC-0	ON-1* OF-1*	2
2	GAJ	C	F	T	C-0 NC-2	ON-1 OF-1	2
3	OPORÓW	L	F	TB	C-3 NC-0	ON-3 OF-1	3
4	SĘPOLNO	L	F	TB	C-2 NC-0	ON-1 OF-1	3
5	KLECINA	L	F	T	C-2 NC-0	ON-1 OF-1	2

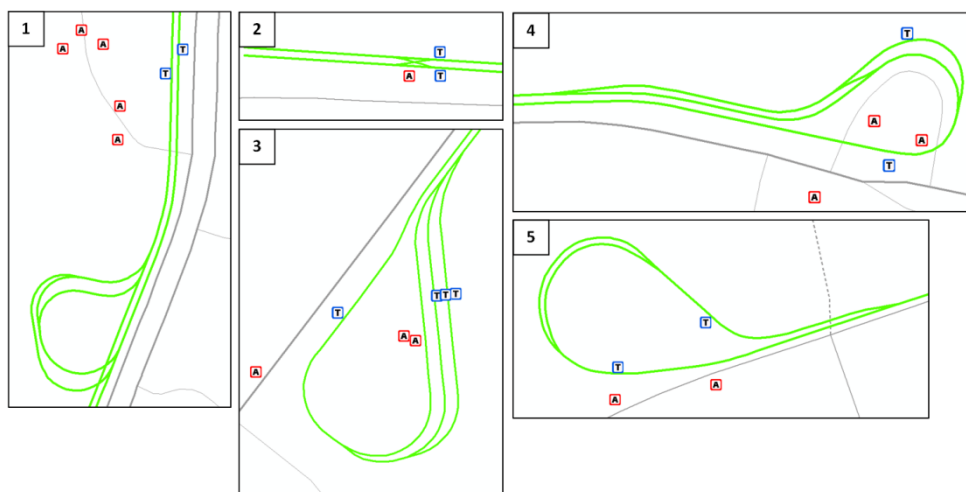
Fig. 5. Diagrams of rated tram loops

Figure 5 presents diagrams of the analyzed tram loops, respectively: 1 – Krzyki, 2 – Gaj, 3 – Oporów, 4 – Sępólno, 5 – Klecina. In the diagrams, the lines correspond to the axes of tram tracks and the markings in the squares with the letters A and T indicate the locations of the stops.

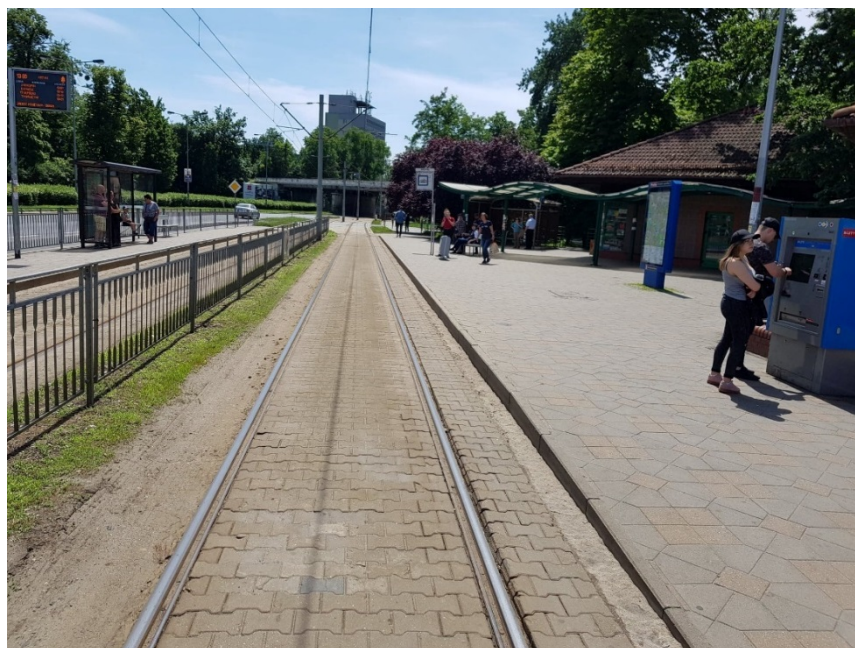
Fig. 6. Tram platform stops located in Krzyki tram loop in Wrocław (Poland)

The measurements carried out allowed for the conclusion that the Krzyki loop (fig. 6) has a low level of safety compliance. The first aspect is the condition of the pavement surface, which is not adequate. There are individual defects and unevenness. In the case of the separation of transport traces (ST), no pedestrian crossing through the tram track was identified and there was a clear problem in separating pedestrian and cyclist streams. The entire length of the stop leads as a road to the bicycle parking lot which can lead to dangerous situations in the cyclist-pedestrian relationship. The technical condition of the track is assessed as satisfactory. In terms of the functionality of the loop, the evaluation result is satisfactory.

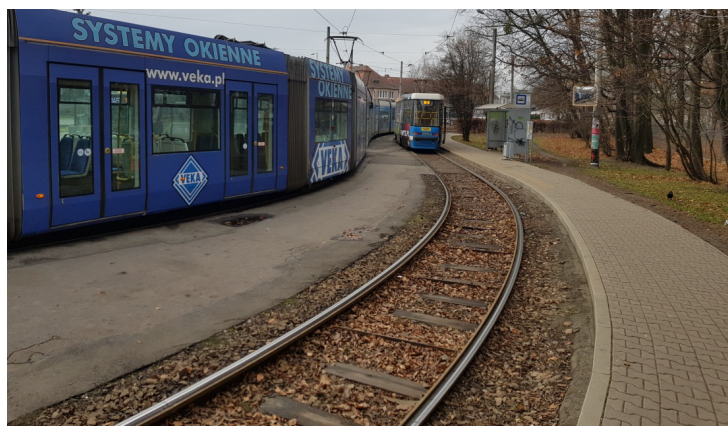
**Fig. 7.** Tram platform stops located in Sępolno tram loop in Wrocław (Poland)

The Sępolno loop (fig. 7) has the lowest values of ISTL and IFTL indicators. Both in the case of the safety and functionality assessment, the conducted tests showed a very bad condition of both parameters, classifying the loops at the unacceptable level in both areas of the assessment. During the audit carried out at the loop it was observed that the condition of the tram track is in poor condition. The surface of pedestrian and bicycle routes is in very poor technical condition, the pavements are uneven and have cavities. In the loop area, there are no pedestrian crossings and pavements separated from the tram track. There is also a lack of bicycle traffic separation. The Sępolno loop meets all requirements only in terms of accessibility to different forms of transport and visibility of tram trains in the area of the loop. In the case of functional indicator parameters, there is a lack of adaptation of bus platforms and infrastructure. There are no shelters, benches and dynamic passenger information boards on the loop. Platforms are not adapted for the disabled. The platform for passengers who getting on is too short. And the number of platforms for passenger who getting on is not adapted to the number of tram lines which serving loops.

The results indicate that the Sępólno loop is an example where it is necessary to carry out repair and modernization works aimed at improving the safety of users and the functionality of the facility. Analyzes indicate a significant risk of adverse events, including those threatening the health and life of users. One loop that has obtained the maximum indicator value (only in terms of security) is the Klecina loop.

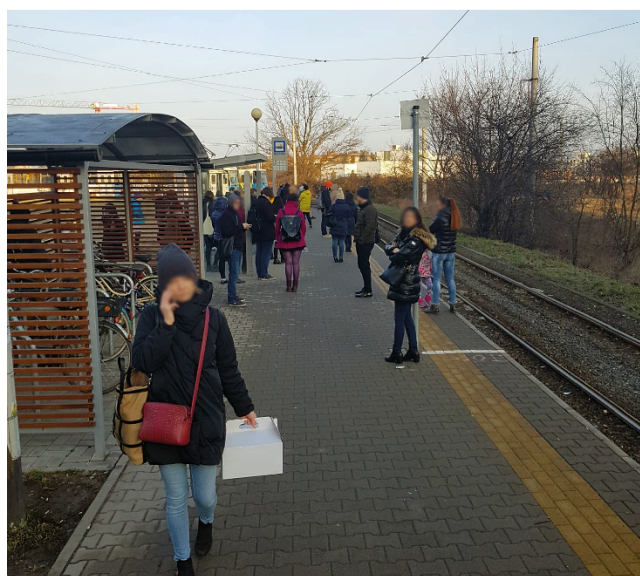
**Fig. 8.** Tram platform stop for getting on located in Klecina tram loop in Wrocław (Poland)

The Klecina loop (fig. 8.) is an example of a tram loop where the direction change takes place differently than on typical loops. As a standard, tramway traffic on the loop runs counter-clockwise and stops are located on the outside of the tram track. In the case of the Klecina loop, the tram traffic is clockwise and the stops are located inside the loop. The awarded point values depend on the selected parameters for: accessibility to different forms of transport (AD) - no P&R parking, the distance from the city bike station is about 80 m, bus stops located at the street adjacent to the loop at a short distance from the stop; type of stop infrastructure and facilities (TI) - no dynamic passenger information boards, service outlets and the ticket machine is located outside the tram loop.

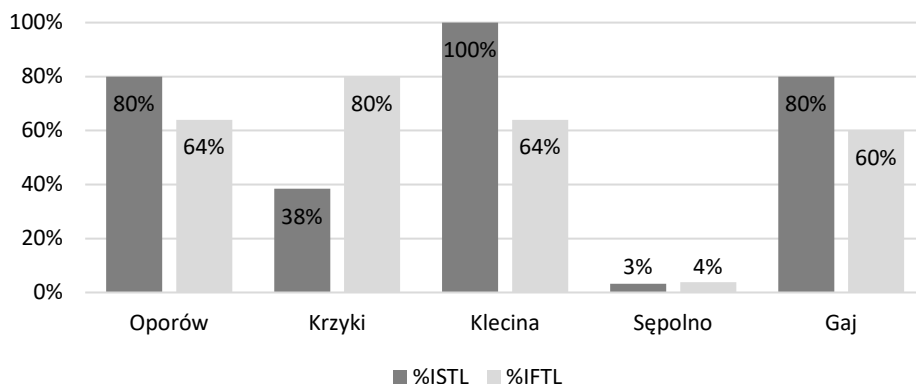
**Fig. 9.** Percentage values of ISTL and IFTL indicators for selected tram loops in Wrocław (Poland)

Based on the results obtained in accordance with formula (3), shows the ranking of individual loops. Figure 9 presents a graph with the percentages of safety and functionality indicator of the analyzed tram loops.
