# Microstructure and Properties of Electroless Ni-P/Si<sub>3</sub>N<sub>4</sub> Nanocomposite Coatings Deposited on the AW-7075 Aluminum Alloy

**Abstract:** The article presents the results of mechanical and tribological tests of Ni-P/Si<sub>3</sub>N<sub>4</sub> nanocomposite coatings deposited on the AW-7075 aluminum alloy using the chemical reduction method. The influence of the chemical composition on the Vickers microhardness determined by the DSI method was examined. The nanocomposite layers were made of Si<sub>3</sub>N<sub>4</sub> silicon nitride in a polydisperse powder with a particle size ranging from 20 to 25 nm. The influence of the content of the dispersion layer material on the adhesion to the substrate was analyzed. The abrasive wear was tested and determined in the reciprocating motion using the “ball-on-flat” method. The surface topography was examined by the contact method with the use of a profilometer. Based on the obtained test results, it was found that the Ni-P/Si<sub>3</sub>N<sub>4</sub> layers produced in the bath with the Si<sub>3</sub>N<sub>4</sub> nanoparticle content in the amount of 2 g/dm<sup>3</sup> are more resistant to wear and show greater adhesio

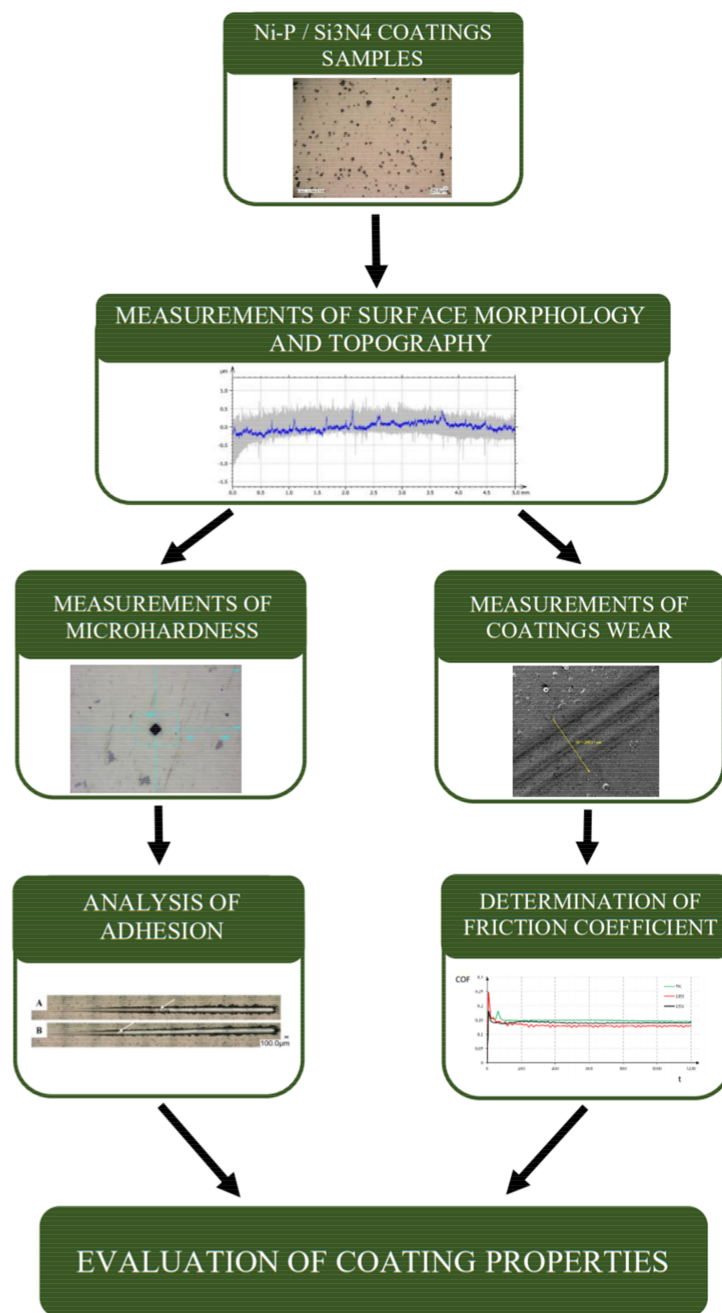
**Figure 1.** The scheme of a conducted experiment.

The basic mechanical parameters of Ni-P/ $\text{Si}_3\text{N}_4$  nanocomposite coatings were evaluated as part of this study. Measurements of coating wear and evaluation of surface texture were performed during the experiments. Therefore, the microhardness and adhesion measurements have been applied. The tests were supplemented by the performance of complete tribological tests, including wear analysis and determination of the friction coefficient. Figure 1 presents the overall scheme of the conducted experiments.

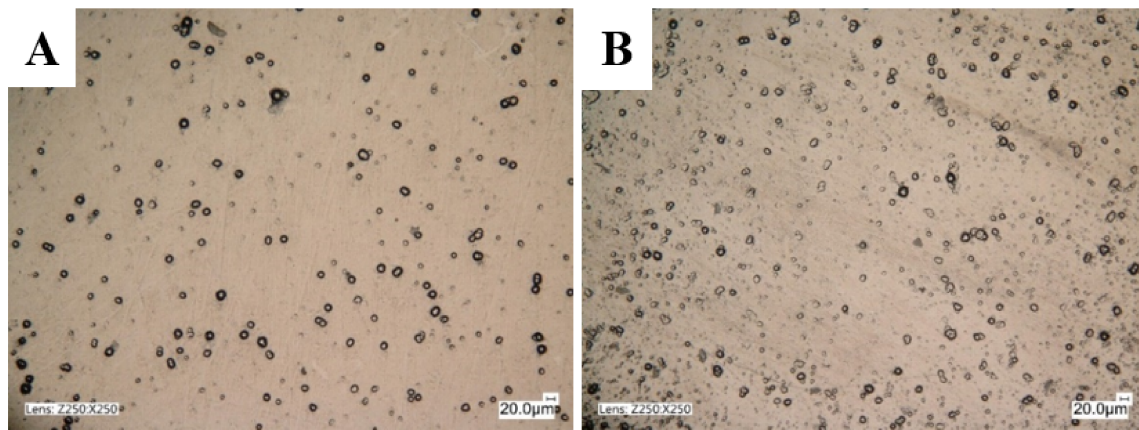
**Figure 2.** The morphology of the layers: Ni-P/Si<sub>3</sub>N<sub>4</sub>; (A) Ni-P/Si<sub>3</sub>N<sub>4</sub> (2 g/dm<sup>3</sup>); (B) Ni-P/Si<sub>3</sub>N<sub>4</sub> (5 g/dm<sup>3</sup>).

The results of the morphological tests are shown in Figure 2. The matrix of the composite of layers produced was a solid solution of phosphorus in nickel Ni–P containing 6% P mass by the chemical reduction method. According to [5,13,23], the coating structure depends on the type of layer and composition. In a composite material, the structure is determined by constructing the matrix material, the type of dispersion ceramic phase, the degree of fragmentation and the material's content. The content of the dispersion ceramic phase in the nanocomposite coating depends on the concentration of nanoparticles in the electroplating bath. As the Si<sub>3</sub>N<sub>4</sub> content in the bath grows, the number of particles integrated into the deposited coating material increases, contributing to the formation of highly concentrated places.

The morphology results confirm that homogeneous and compact structures characterize all tested coatings. In the content of the dispersion phase, the nanocomposite layers are different from each other. The results of qualitative tests of the surface of Ni–P/Si<sub>3</sub>N<sub>4</sub> layers deposited in the bath with 5 g/dm<sup>3</sup> Si<sub>3</sub>N<sub>4</sub> content showed an increased porosity and roughness compared to the layers deposited in the bath with 2 g/dm<sup>3</sup> Si<sub>3</sub>N<sub>4</sub> content. The reason is due to the more significant number of peaks, which was confirmed in later profilometric tests. The “dots” visible in Figure 2 are the peaks of the coating irregularities, the topography of which is shown in Figure 3. Increasing the concentration of Si<sub>3</sub>N<sub>4</sub> causes an increase in the number of peaks.

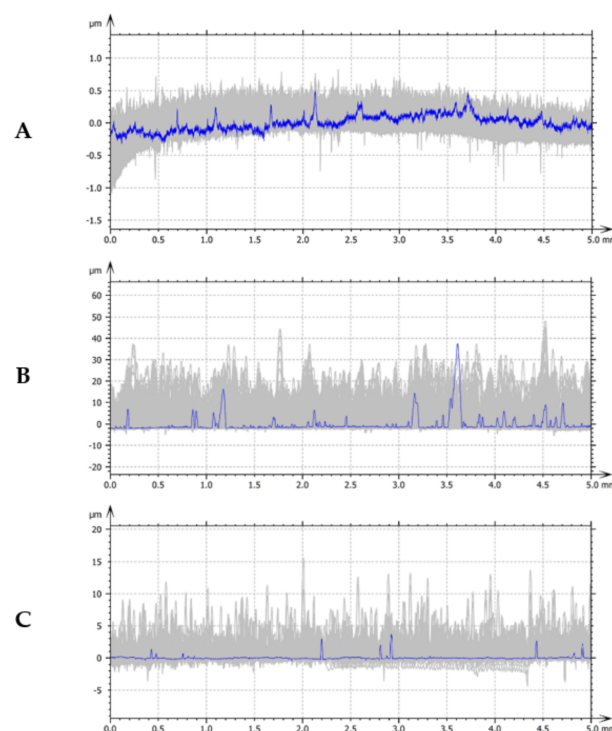
**Figure 3.** Topography of AW-7075 and Ni-P/Si<sub>3</sub>N<sub>4</sub> coating surface: (A) AW-7075; (B) Ni-P/Si<sub>3</sub>N<sub>4</sub> (2 g/dm<sup>3</sup>); (C) Ni-P/Si<sub>3</sub>N<sub>4</sub> (5 g/dm<sup>3</sup>).

The surface morphology studies were carried out using the Keyence VHX 5000 optical microscope (Keyence Corporation of America, Itasca, IL, USA), while the surface topography was examined by scanning electron microscope Tescan Vega 5135 (Tescan Analytics, Fuveau, France) and profilometer Hommel ETAMIC T8000 (Jenoptik Industrial Metrology Germany GmbH, VS-Schwenningen, Germany) with the AltiMap Premium 7.1.7037 software (Jenoptik Industrial Metrology Germany GmbH, VS-Schwenningen, Germany). The topography tests were performed using the contact method in the middle parts of the samples. The measuring principle was to move the diamond measuring tip with a constant speed of 90° and a rounding radius from 2 μm over a precisely defined measuring section. The study of the surface topography revealed the parameters of the height of the peaks and roughness and the areas of depressions, elevations and bulges. Surface roughness tests were carried out individually, on each sample separately, and included a square of 5 mm × 5 mm surfaces in the central part of the sample. In turn, the morphology of each sample was repeatedly tested in several places. Figure 2 shows sample images, while the roughness test results are shown in Figure 3 and Table 2.

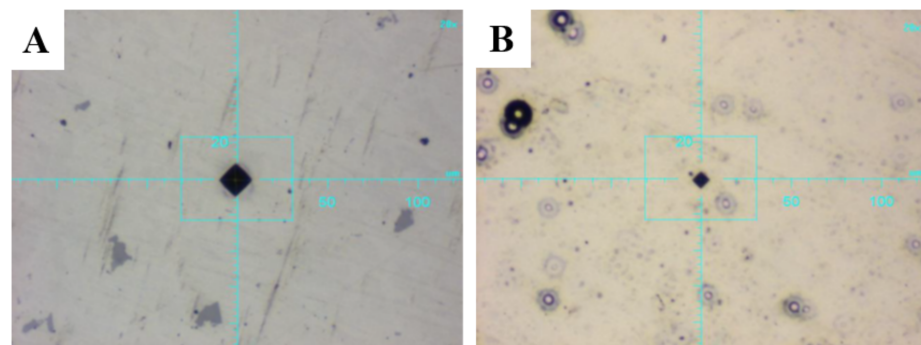
**Figure 4.** Images of traces on sample surfaces (magnification  $20\times$ ; (A) AW-7075; (B) Ni-P/ $\text{Si}_3\text{N}_4$ ).

The results presented in Table 5 and Figure 4 show two-dimensional images of the examined surfaces. In both cases, the surfaces are dull and devoid of gloss, and the peaks of the unevenness are even. Material defects, such as discontinuities, cavities or microcracks, were not observed.

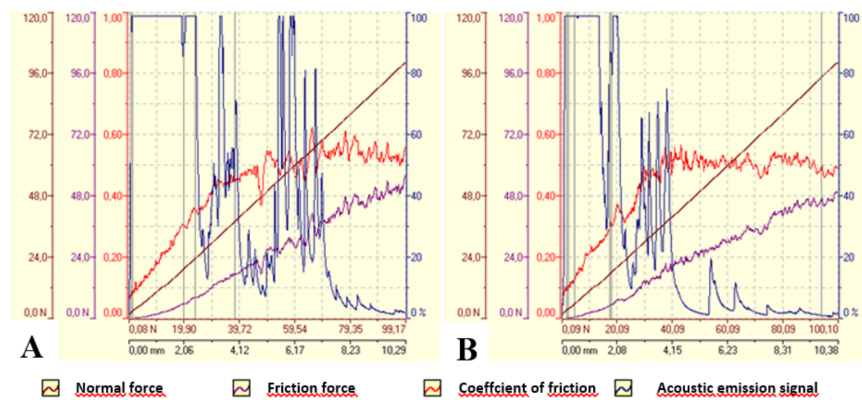
**Figure 5.** Scratch tests results for Ni-P/Si<sub>3</sub>N<sub>4</sub> coatings: (A) Ni-P/Si<sub>3</sub>N<sub>4</sub> (2 g/dm<sup>3</sup>); (B) Ni-P/Si<sub>3</sub>N<sub>4</sub> (5 g/dm<sup>3</sup>).

A scratch test was used to analyze the strength of the bond between the coating and the substrate. The diamond indenter moved along the surface of the test layer at a constant speed with a constantly increasing loading force. Changes in individual parameters recorded during the test, i.e., normal pressure, friction force, friction coefficient and acoustic emission along the crack, are shown in Figure 5. The images of the cracks are shown in Figure 6.

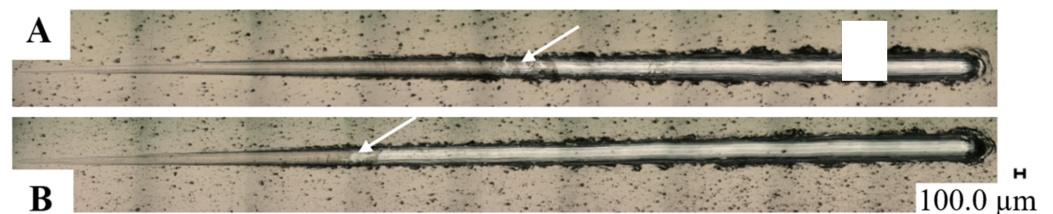
**Figure 6.** Images of scratches on the surfaces of layers: Ni-P/Si<sub>3</sub>N<sub>4</sub>; (A) Ni-P/Si<sub>3</sub>N<sub>4</sub> (2 g/dm<sup>3</sup>); (B) Ni-P/Si<sub>3</sub>N<sub>4</sub> (5 g/dm<sup>3</sup>). The white arrows indicate the coating destruction point.

In Tables 7 and 8, the damages of a cohesive and adhesive character are marked with colors. It was difficult to determine at what load the first cracks began. The focus was on cracks that were not single and random, as well as damage to the coatings that began to appear and grow and had a clear and indisputable cohesive or adhesive character. Detailed values of the critical loads are presented in Table 9. For both coatings, the lower limit loads are in a similar range of 19.73N and 17.91N. An evident change is noticeable in the critical load, during which the coating breaks; the values differ significantly. The moment of coating decohesion is marked with a white arrow in Figure 6.

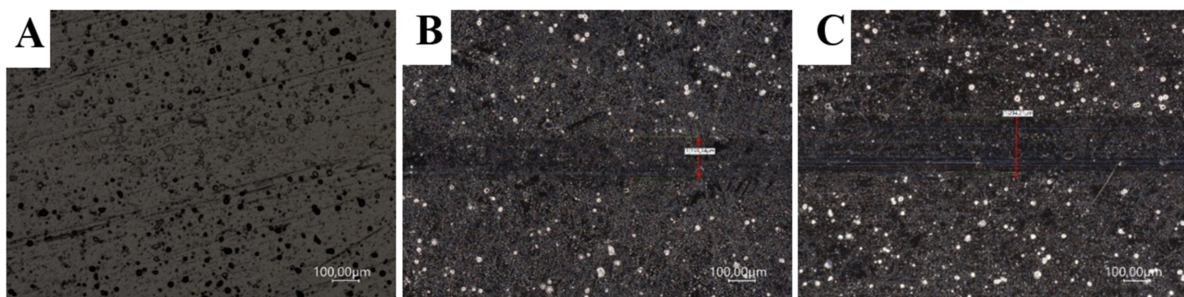
**Figure 7.** Images of scratches for samples with NiP/Si<sub>3</sub>N<sub>4</sub> coatings deposited in a bath with 2 g/dm<sup>3</sup> Si<sub>3</sub>N<sub>4</sub> (load: (A) 5 N; (B) 10 N; (C) 15 N; magnification: 500×).

The microscopic images of the resulting cracks, shown in Figures 7 and 8, clearly differ from each other. The crack widths characterizing the degree of surface wear depended on the pressure force of the counter-sample and the type of the tested surface, the use of lubricant and the duration of the tests at a given speed. Crack widths are not the only determinant of surface wear and its behavior under given operating conditions. The sample with the applied layer of Ni-P/Si<sub>3</sub>N<sub>4</sub> (2 g) nanocomposite showed the highest resistance to any signs of wear because, during microscopic observations, it is difficult to see traces of the counter-sample for the 5 N force. In Figure 7a, no signs of wear have been noticed. The Ni-P/Si<sub>3</sub>N<sub>4</sub> (5 g) layer showed higher wear than the previous sample because the scratches were distinct and larger than the Ni-P/Si<sub>3</sub>N<sub>4</sub> (2 g) layer and its width was within the range of 114.0 ÷ 118.5 μm. It was noticed that these layers are characterized by a very high resistance to abrasion and puncturing of the coating.

Increasing the pressure of the counter-sample from 5 to 10 N, and then to 15 N, resulted in more expansive and distinct cracks; the edges and abrasion marks of the counter-sample passage are more visible. The SEM photos and the measurements of the width of the paths show that the 15 N force caused the most visible deformation of the surface of the samples (see Figure 9). The analysis of the cross-section profiles of the tracks using SEM did not show any significant differences between the samples. Similarly, no damage to the surface of the coatings in the form of cracks, delamination and material defects or nicks was found. In addition, the influence of the content of the disperse phase on the tribological properties is more noticeable at lower loads. The research confirmed that nanocomposite layers deposited on the AW-7075 alloy can be subjected to loads of various values and can be successfully operated in multiple environments using lubricants. It was confirmed that the tested layers contributed to the increase in the surface resistance to tribological wear to a different extent. Table 10 summarizes the crack widths for the individual samples in order to more accurately illustrate the degree of wear.

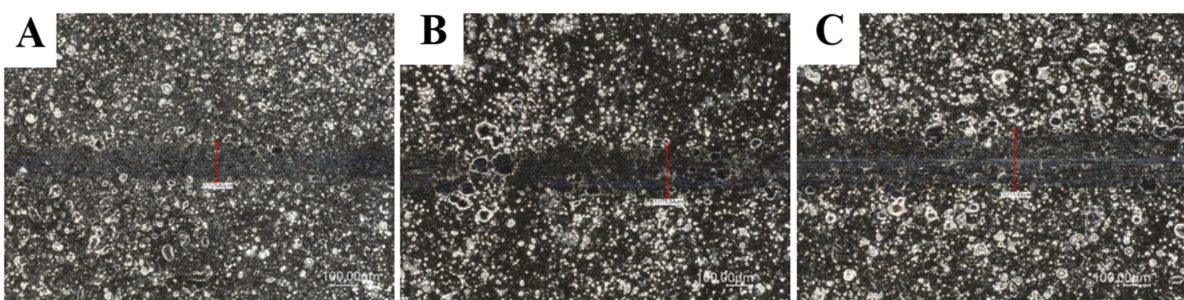
**Figure 8.** Images of cracks for samples with NiP/Si<sub>3</sub>N<sub>4</sub> coatings deposited in a bath with 5 g/dm<sup>3</sup> Si<sub>3</sub>N<sub>4</sub> (load: (A) 5 N; (B) 10 N; (C) 15 N; magnification: 500×).

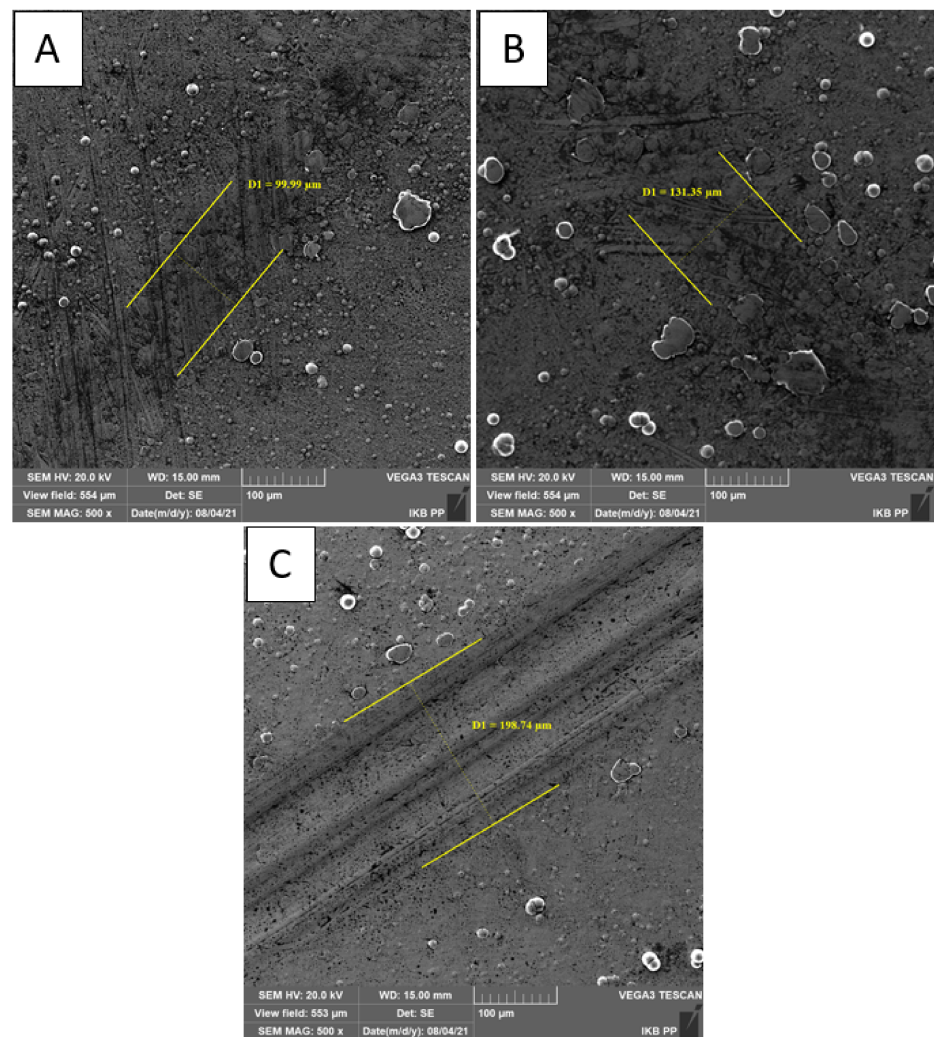
**Figure 9.** SEM Images of cracks for samples with NiP/Si<sub>3</sub>N<sub>4</sub> coatings deposited in a bath with 5 g/dm<sup>3</sup> Si<sub>3</sub>N<sub>4</sub> (load: (A) 5 N; (B) 10 N; (C) 15 N; magnification: 500×).

Figures 7–9 show the results of tribological tests performed with the ball-on-flat method, which were carried out during 1200 s using GL-4 75W/90 semi-synthetic gear oil. All other parameters and wear diameters remained unchanged. Specialized computer software was used again, which is an integral part of the light microscope. The drawings show high-resolution microscopic images showing the width of the carved grooves to an accuracy of 0.1 μm.

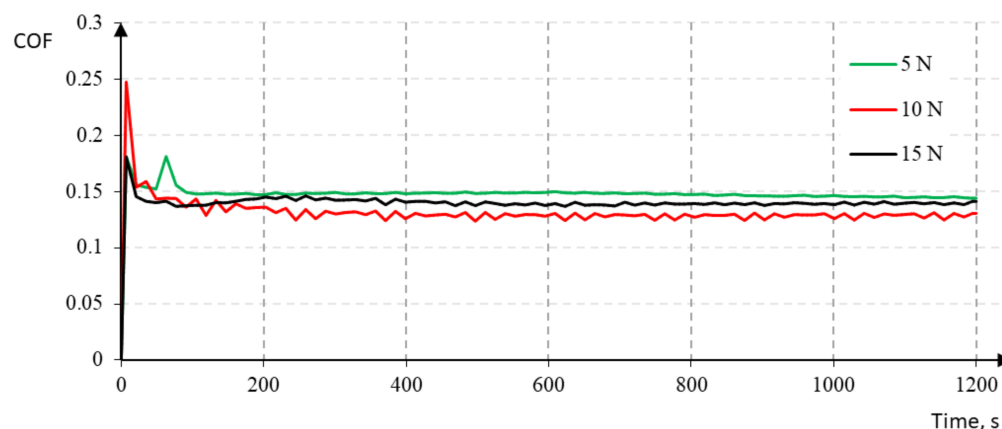
**Figure 10.** The friction coefficient measurements for Ni-P/Si<sub>3</sub>N<sub>4</sub> (2 g) sample with different basic loads.

The example values of the measured friction coefficients were shown in Figure 10. The charts of changes in the friction coefficient were obtained automatically from tribological tests using the computer software attached to the BRUKER UMT TriboLab device. For all samples, the value of the friction coefficient was stabilized.

The obtained diagrams show that the friction coefficients for the Ni-P/Si<sub>3</sub>N<sub>4</sub> (2 g) layers with a thickness of 10 μm stabilize after 40 s at one level in the range of 0.12–0.16 (see Figure 10). On the other hand, nanocomposite Ni-P/Si<sub>3</sub>N<sub>4</sub> (5 g) layers with an increased content of the dispersion phase are characterized by a similar, slightly higher coefficient, which oscillated in the range of 0.14–0.15, which is reflected in the results of profilometric tests that confirmed a greater roughness. Moreover, the surfaces of the Ni-P/Si<sub>3</sub>N<sub>4</sub> (2 g) nanocomposite layers showed significantly higher abrasive wear resistance—for the 5 N load, the crack was imperceptible, while for the 10 N and 15 N loads, the crack widths are much smaller compared to the Ni-P/Si<sub>3</sub>N<sub>4</sub> layer (5 g), where the scratches are clearer and appear regardless of the load.
