# Microstructure and Properties of Electroless Ni-P/Si<sub>3</sub>N<sub>4</sub> Nanocomposite Coatings Deposited on the AW-7075 Aluminum Alloy

**Abstract:** The article presents the results of mechanical and tribological tests of Ni-P/Si<sub>3</sub>N<sub>4</sub> nanocomposite coatings deposited on the AW-7075 aluminum alloy using the chemical reduction method. The influence of the chemical composition on the Vickers microhardness determined by the DSI method was examined. The nanocomposite layers were made of Si<sub>3</sub>N<sub>4</sub> silicon nitride in a polydisperse powder with a particle size ranging from 20 to 25 nm. The influence of the content of the dispersion layer material on the adhesion to the substrate was analyzed. The abrasive wear was tested and determined in the reciprocating motion using the “ball-on-flat” method. The surface topography was examined by the contact method with the use of a profilometer. Based on the obtained test results, it was found that the Ni-P/Si<sub>3</sub>N<sub>4</sub> layers produced in the bath with the Si<sub>3</sub>N<sub>4</sub> nanoparticle content in the amount of 2 g/dm<sup>3</sup> are more resistant to wear and show greater adhesio

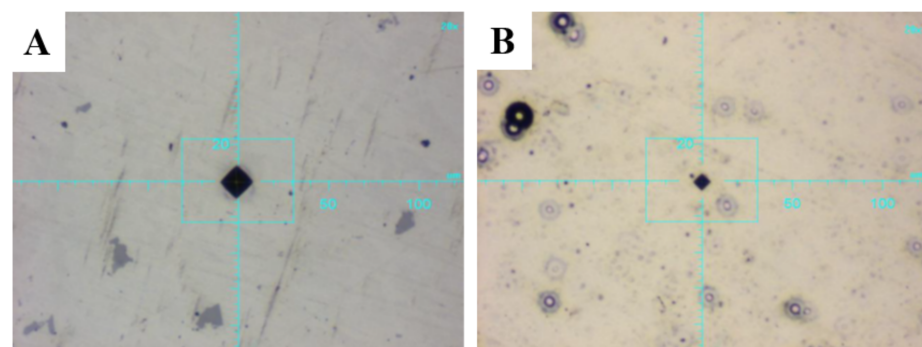
**Figure 4.** Images of traces on sample surfaces (magnification  $20\times$ ; (A) AW-7075; (B) Ni-P/ $\text{Si}_3\text{N}_4$ ).

The results presented in Table 5 and Figure 4 show two-dimensional images of the examined surfaces. In both cases, the surfaces are dull and devoid of gloss, and the peaks of the unevenness are even. Material defects, such as discontinuities, cavities or microcracks, were not observed.

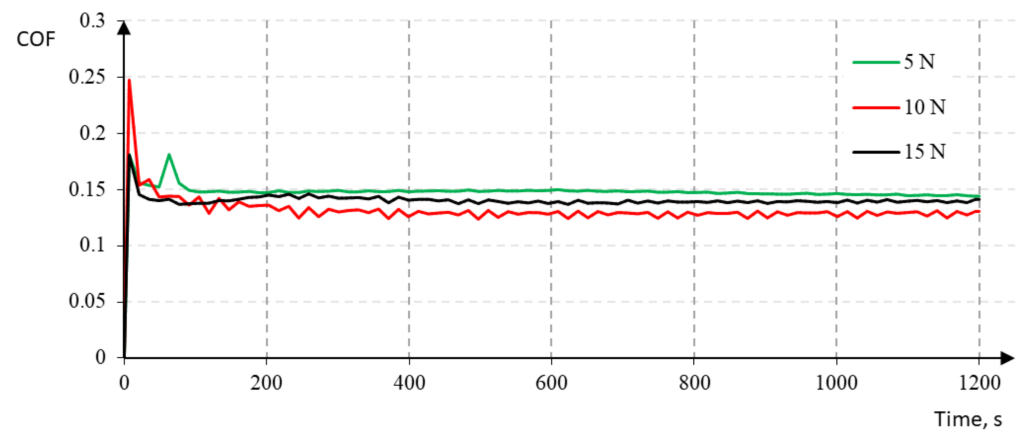
**Figure 10.** The friction coefficient measurements for Ni-P/Si<sub>3</sub>N<sub>4</sub> (2 g) sample with different basic loads.

The example values of the measured friction coefficients were shown in Figure 10. The charts of changes in the friction coefficient were obtained automatically from tribological tests using the computer software attached to the BRUKER UMT TriboLab device. For all samples, the value of the friction coefficient was stabilized.

The obtained diagrams show that the friction coefficients for the Ni-P/Si<sub>3</sub>N<sub>4</sub> (2 g) layers with a thickness of 10 μm stabilize after 40 s at one level in the range of 0.12–0.16 (see Figure 10). On the other hand, nanocomposite Ni-P/Si<sub>3</sub>N<sub>4</sub> (5 g) layers with an increased content of the dispersion phase are characterized by a similar, slightly higher coefficient, which oscillated in the range of 0.14–0.15, which is reflected in the results of profilometric tests that confirmed a greater roughness. Moreover, the surfaces of the Ni-P/Si<sub>3</sub>N<sub>4</sub> (2 g) nanocomposite layers showed significantly higher abrasive wear resistance—for the 5 N load, the crack was imperceptible, while for the 10 N and 15 N loads, the crack widths are much smaller compared to the Ni-P/Si<sub>3</sub>N<sub>4</sub> layer (5 g), where the scratches are clearer and appear regardless of the load.
