# Microstructure and Properties of Electroless Ni-P/Si<sub>3</sub>N<sub>4</sub> Nanocomposite Coatings Deposited on the AW-7075 Aluminum Alloy

**Abstract:** The article presents the results of mechanical and tribological tests of Ni-P/Si<sub>3</sub>N<sub>4</sub> nanocomposite coatings deposited on the AW-7075 aluminum alloy using the chemical reduction method. The influence of the chemical composition on the Vickers microhardness determined by the DSI method was examined. The nanocomposite layers were made of Si<sub>3</sub>N<sub>4</sub> silicon nitride in a polydisperse powder with a particle size ranging from 20 to 25 nm. The influence of the content of the dispersion layer material on the adhesion to the substrate was analyzed. The abrasive wear was tested and determined in the reciprocating motion using the “ball-on-flat” method. The surface topography was examined by the contact method with the use of a profilometer. Based on the obtained test results, it was found that the Ni-P/Si<sub>3</sub>N<sub>4</sub> layers produced in the bath with the Si<sub>3</sub>N<sub>4</sub> nanoparticle content in the amount of 2 g/dm<sup>3</sup> are more resistant to wear and show greater adhesio

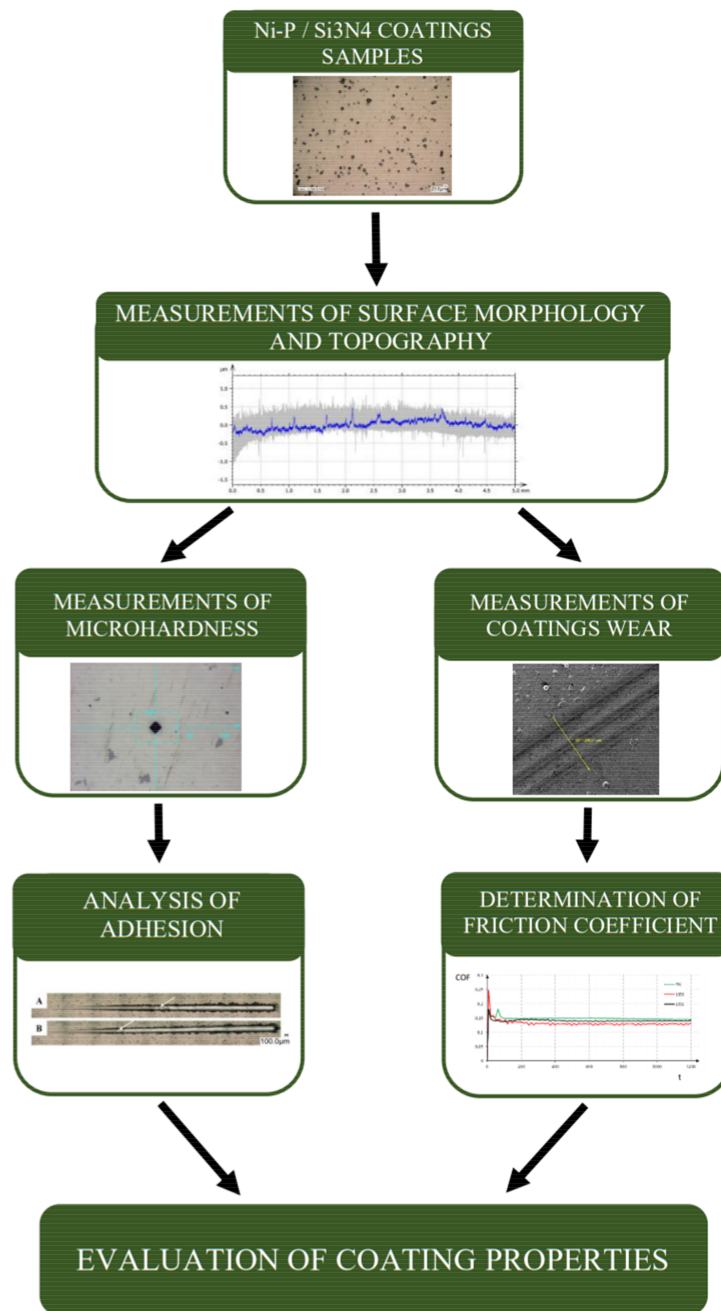
**Figure 1.** The scheme of a conducted experiment.

The basic mechanical parameters of Ni-P/ $\text{Si}_3\text{N}_4$  nanocomposite coatings were evaluated as part of this study. Measurements of coating wear and evaluation of surface texture were performed during the experiments. Therefore, the microhardness and adhesion measurements have been applied. The tests were supplemented by the performance of complete tribological tests, including wear analysis and determination of the friction coefficient. Figure 1 presents the overall scheme of the conducted experiments.

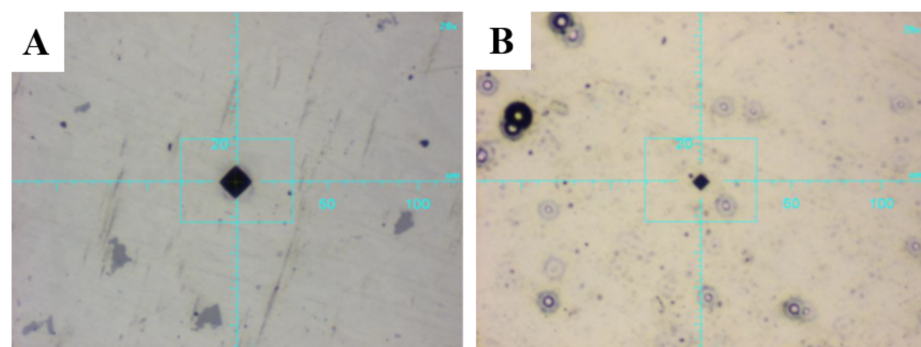
**Figure 4.** Images of traces on sample surfaces (magnification 20 $\times$ ; (A) AW-7075; (B) Ni-P/ $\text{Si}_3\text{N}_4$ ).

The results presented in Table 5 and Figure 4 show two-dimensional images of the examined surfaces. In both cases, the surfaces are dull and devoid of gloss, and the peaks of the unevenness are even. Material defects, such as discontinuities, cavities or microcracks, were not observed.

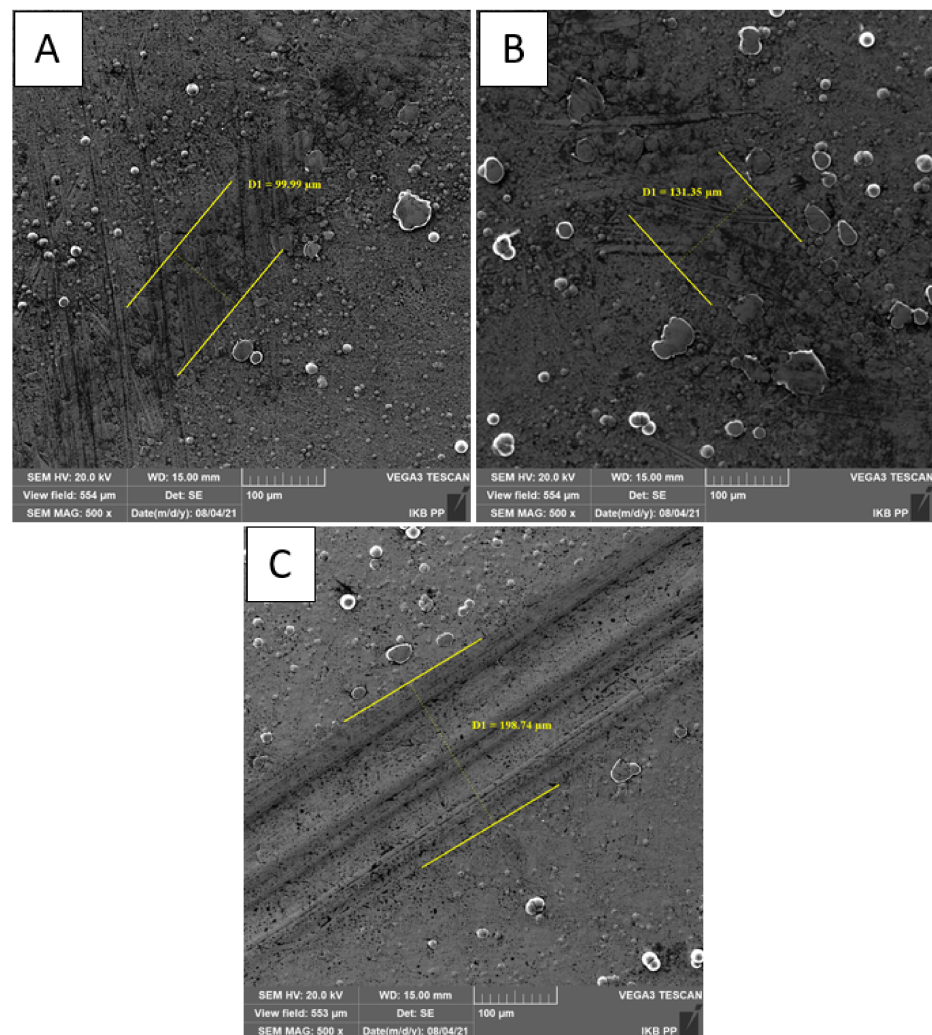
**Figure 9.** SEM Images of cracks for samples with NiP/Si<sub>3</sub>N<sub>4</sub> coatings deposited in a bath with 5 g/dm<sup>3</sup> Si<sub>3</sub>N<sub>4</sub> (load: (A) 5 N; (B) 10 N; (C) 15 N; magnification: 500×).

Figures 7–9 show the results of tribological tests performed with the ball-on-flat method, which were carried out during 1200 s using GL-4 75W/90 semi-synthetic gear oil. All other parameters and wear diameters remained unchanged. Specialized computer software was used again, which is an integral part of the light microscope. The drawings show high-resolution microscopic images showing the width of the carved grooves to an accuracy of 0.1 μm.

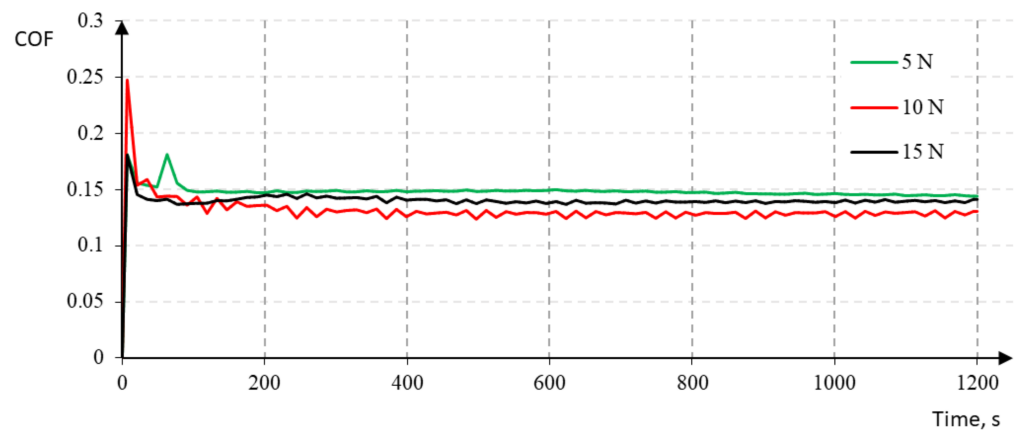
**Figure 10.** The friction coefficient measurements for Ni-P/Si<sub>3</sub>N<sub>4</sub> (2 g) sample with different basic loads.

The example values of the measured friction coefficients were shown in Figure 10. The charts of changes in the friction coefficient were obtained automatically from tribological tests using the computer software attached to the BRUKER UMT TriboLab device. For all samples, the value of the friction coefficient was stabilized.

The obtained diagrams show that the friction coefficients for the Ni-P/Si<sub>3</sub>N<sub>4</sub> (2 g) layers with a thickness of 10 μm stabilize after 40 s at one level in the range of 0.12–0.16 (see Figure 10). On the other hand, nanocomposite Ni-P/Si<sub>3</sub>N<sub>4</sub> (5 g) layers with an increased content of the dispersion phase are characterized by a similar, slightly higher coefficient, which oscillated in the range of 0.14–0.15, which is reflected in the results of profilometric tests that confirmed a greater roughness. Moreover, the surfaces of the Ni-P/Si<sub>3</sub>N<sub>4</sub> (2 g) nanocomposite layers showed significantly higher abrasive wear resistance—for the 5 N load, the crack was imperceptible, while for the 10 N and 15 N loads, the crack widths are much smaller compared to the Ni-P/Si<sub>3</sub>N<sub>4</sub> layer (5 g), where the scratches are clearer and appear regardless of the load.
