Portico farmhouses of the Vistula Delta: architecture, current state and finite element modelling of timber roof truss under material and cross-section uncertainty

Abstract: The article focuses on the oldest surviving I-type portico houses located in the Vistula Delta, which were built in the 17th and 18th centuries. The study describes the houses' origins, structure, details of roof structures and technical condition, and it also includes numerical modelling of a roof truss and its mechanical analysis. Numerical models of the roof trusses are defined and analysed by means of the finite element method. Global sensitivity analysis with the use of the polynomial chaos expansion method is used to study the influence of uncertainties in material properties of wood, such as Young's modulus and the friction coefficient, and also the beam cross-sectional height in the output of the numerical model of the structure. The outcomes show that uncertainty of beam height exerts the dominating influence on the maximum deflection of the roof truss hence accurate measurements of geometry are of great importance in the planning of conservation and renovation of such historic structures.

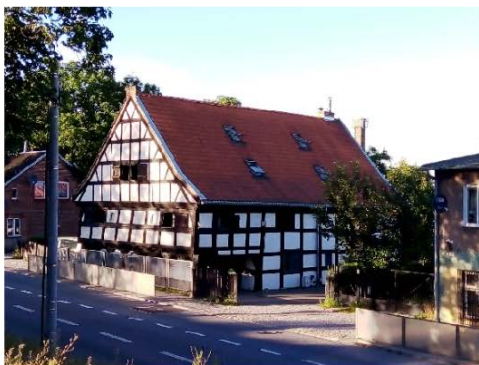
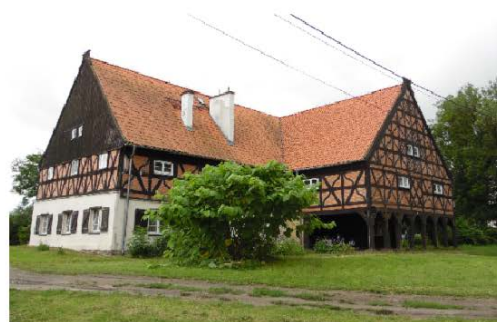
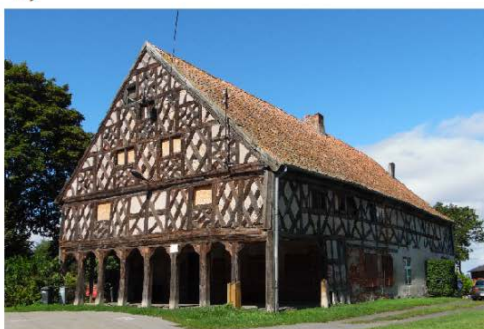
Figure 1. Three types of houses; a) 1, 2 – “I-type” house, 3; The portico houses in: b) Gdańsk Lipce c) Klecie d) Trutnowy e) Miłocin f) Nowa Kościelnica

Kloeppel (1924) differentiated three basic types of houses, (Figure 1a). It should be noted that the term *portico* should be treated somewhat conventionally here, and in some cases, the term *arcade* might be substantiated. In the building of the first and second type, the portico constituted the facade of the house, so we can call them I-type houses. The second type was in fact a result of the development of the I-type plan by adding a wing to the body of the house. Therefore, for this study they can also be classified as

The oldest preserved house in Lipce by Gdańsk (Germ. Guteherberge) was built ca 1600 (Kloepfel 1924 ; Bertram, Kloepfel, and La Baume 1924), (Figure 1b). The newest houses, retaining traditional style and proportions, come from the 1840 (Woede 1980).

by Gdańsk (Germ. Guteherberge) (Figure 1b), Klecie (Germ. Klettendorf) (Figure 1c), Trutnowy (Germ. Trutenau) (Figure 1d), Miłocin (Germ. Herzberg) (Figure 1e), Nowa Kościelnica (Germ. Neumünsterberg) (Figure 1f).
