Portico farmhouses of the Vistula Delta: architecture, current state and finite element modelling of timber roof truss under material and cross-section uncertainty

Abstract: The article focuses on the oldest surviving I-type portico houses located in the Vistula Delta, which were built in the 17th and 18th centuries. The study describes the houses' origins, structure, details of roof structures and technical condition, and it also includes numerical modelling of a roof truss and its mechanical analysis. Numerical models of the roof trusses are defined and analysed by means of the finite element method. Global sensitivity analysis with the use of the polynomial chaos expansion method is used to study the influence of uncertainties in material properties of wood, such as Young's modulus and the friction coefficient, and also the beam cross-sectional height in the output of the numerical model of the structure. The outcomes show that uncertainty of beam height exerts the dominating influence on the maximum deflection of the roof truss hence accurate measurements of geometry are of great importance in the planning of conservation and renovation of such historic structures.

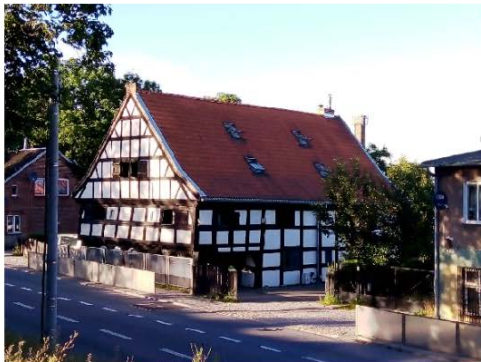
Figure 1. Three types of houses; a) 1, 2 – “I-type” house, 3; The portico houses in: b) Gdańsk Lipce c) Klecie d) Trutnowy e) Miłocin f) Nowa Kościelnica

Kloeppel (1924) differentiated three basic types of houses, (Figure 1a). It should be noted that the term *portico* should be treated somewhat conventionally here, and in some cases, the term *arcade* might be substantiated. In the building of the first and second type, the portico constituted the facade of the house, so we can call them I-type houses. The second type was in fact a result of the development of the I-type plan by adding a wing to the body of the house. Therefore, for this study they can also be classified as

The oldest preserved house in Lipce by Gdańsk (Germ. Guteherberge) was built ca 1600 (Kloepfel 1924 ; Bertram, Kloepfel, and La Baume 1924), (Figure 1b). The newest houses, retaining traditional style and proportions, come from the 1840 (Woede 1980).

by Gdańsk (Germ. Guteherberge) (Figure 1b), Klecie (Germ. Klettendorf) (Figure 1c), Trutnowy (Germ. Trutenau) (Figure 1d), Miłocin (Germ. Herzberg) (Figure 1e), Nowa Kościelnica (Germ. Neumünsterberg) (Figure 1f).

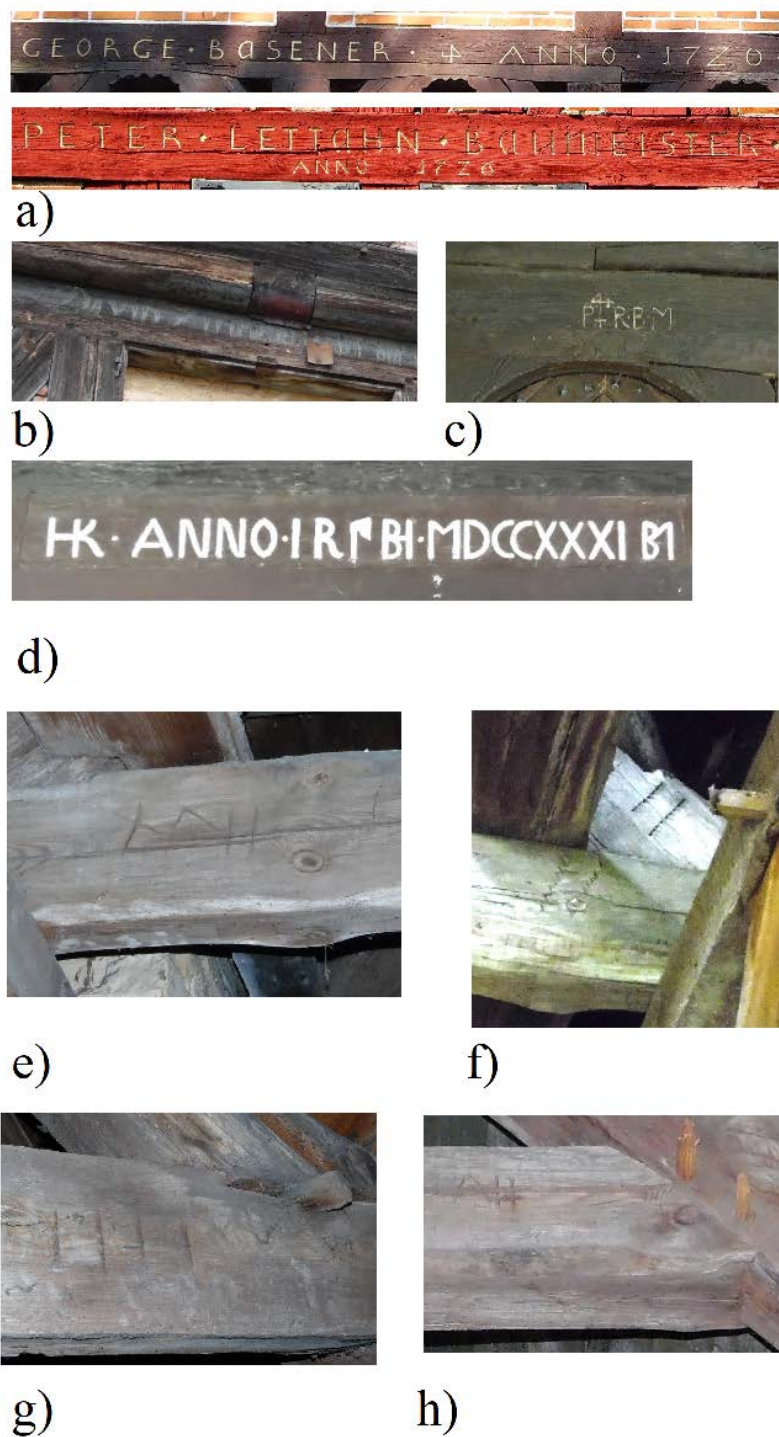
Figure 4. Inscriptions on houses: a) Trutnowy b) Klecie c) Nowa Kościelnica d) Miłocin
 Carpenters' marks on roof truss elements: e) Trutnowy f) Trutnowy g) Klecie h) Nowa
 Kościelnica.

During visual inspections in the years 2017-2020 the construction of houses was examined (foundations, walls, ceilings, roofs), decorative inscriptions and carpenters' marks (Figure 4). Results of field research are shown in Table 1 and Table 2. The cross-sections of the construction elements, the span of the roof structure, the number of particular elements, the angle of inclination were measured (Figure 5), see e.g. (Sousa et al. 2016). The types of carpentry joints were determined (Figure 6), photographic documentation showing the current condition of roof construction was made (Figure 7). To compare different types of roof structures the amount of timber used for their construction was calculated (Bláha, Kloiber, and Serafini 2018). To compare the amount

Structural elements have carpenters' marks, mainly with Roman numerals, designating to be attached rafters and collar beams. They show that these elements are
