Article

Imaging of Increasing Damage in Steel Plates Using Lamb Waves and Ultrasound Computed Tomography

Monika Zielińska ^{1,*}

and Magdalena Rucka ²

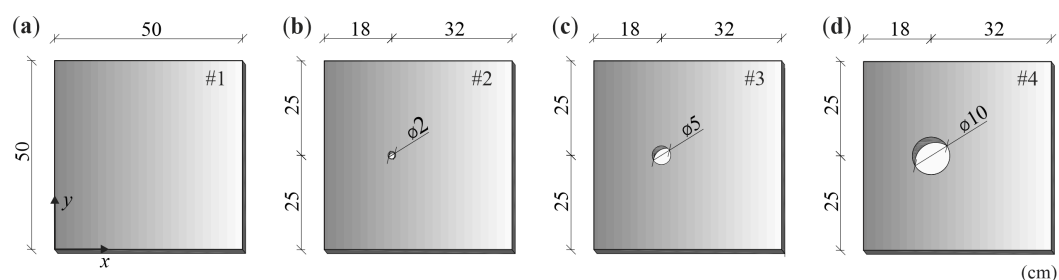
Figure 2. The geometry of the tested plates: (a) plate without damage (#1); (b–d) plates with surface damage (#2–#4).

The tests were carried out on four steel plates with dimensions of 50 cm \times 50 cm and 3 mm thickness. A reference model was the first element without damage (plate #1). The other three plates contained a circular hole of variable diameter: 2 cm (plate #2), 5 cm (plate #3) and 10 cm (plate #4), which represented damage of a surface type. Holes were made through the entire thickness of the plate. The centres of all holes were placed symmetrically in the y -axis direction and at a distance of 18 cm from the outer edge of the plate in the x -axis direction. The geometry of the test models is shown in Figure 2. Photographs of the plates used for the experimental tests are presented in Figure 3.

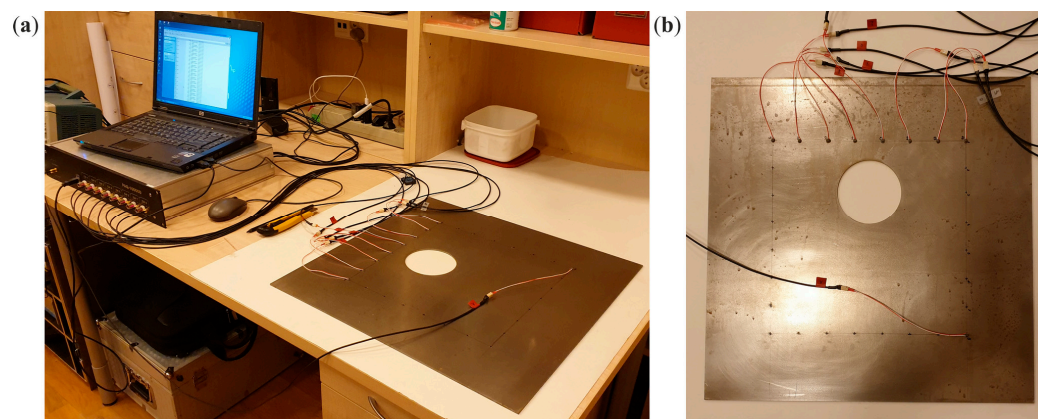
Figure 4. Experimental setup (a) and view on the steel plate with piezoelectric transducers (b).

Experimental tests of the propagation of Lamb waves in the steel plates were performed using a system for generation and registration of ultrasonic waves, the PAQ-16000D system (EC Electronics, Krakow, Poland). The experimental setup is shown in Figure 4. For both transmitting and receiving Lamb wave signals, plate piezoelectric transducers, NAC2024 (Noliac, Kvistgaard, Denmark), were applied. The excitation was a wave packet with a central frequency of 150 kHz, consisting of five sinusoid cycles modulated with the Hann window.

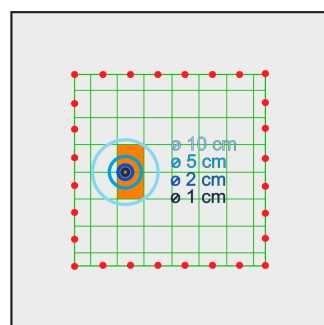
Figure 12. Location of damage with respect to the division of the element into pixels.

The existence and position of the surface growing damage in steel plates were determined based on the time of flight and UT reconstruction for both experimental and numerical data (see Figures 9, 11, 13 and 14). However, the damage size assessment using the indicated methods did not reflect the actual dimensions of the hole. This was due to the size of the pixels into which the tested structure was divided. Such a division resulted from the number of transmitters and receivers used in the study. On two perpendicular edges, eight transmitters and eight receivers on opposite edges were used, which determined the division of the element into 64 pixels. The number of pixels affected the resolution of the obtained tomography image (cf. Figure 12).
