# Imaging of Increasing Damage in Steel Plates Using Lamb Waves and Ultrasound Computed Tomography

**Abstract:** This paper concerns the inspection of steel plates, with particular emphasis on the assessment of increasing damage. Non-destructive tests were performed on four plates, one of which was undamaged, while the remaining three had defects in the form of circular holes with diameters of 2, 5 and 10 cm. Guided Lamb waves were used in the research, and the image reconstruction was performed using ultrasound computed tomography. The damage size was estimated by tracking the real course of rays and densifying the pixel grid into which the object was divided. The results showed the great potential of ultrasound tomography in detecting defects in steel elements, together with the possibility of estimating damage size.

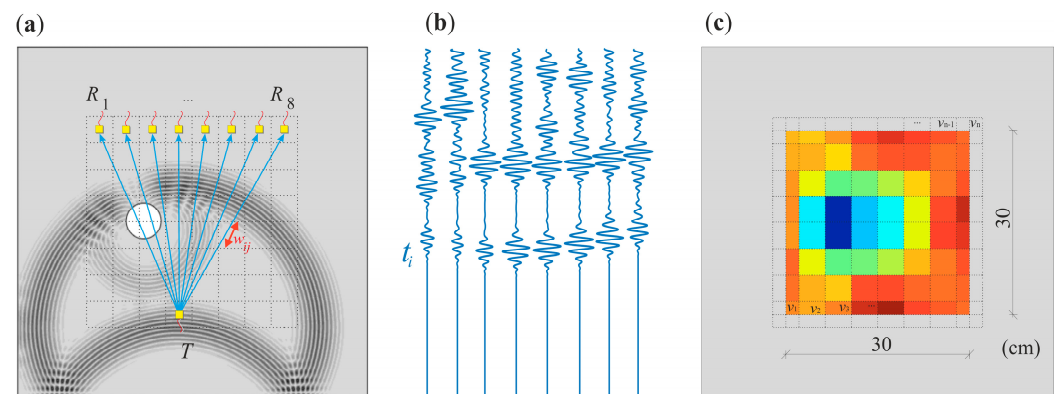
**Figure 1.** Schematic diagram of velocity reconstruction using ultrasound tomography: (a) plate with indicated receivers ( $R$ ), transmission ( $T$ ) points and simulated wave field; (b) guided wave propagation time signals; (c) ultrasound tomography map.

Ultrasound tomography imaging allows recreating the internal structure of an examined object using the properties of elastic waves. A schematic process of performing ultrasound tomography is shown in Figure 1. The first step is to divide the test sample into cells called pixels. Each one of them constitutes a discrete area in the tested element. Such a division is shown with a dashed line in Figure 1a. Then, after applying appropriate algorithms, each pixel takes a value representing the speed of the ultrasonic wave propagated through this area.

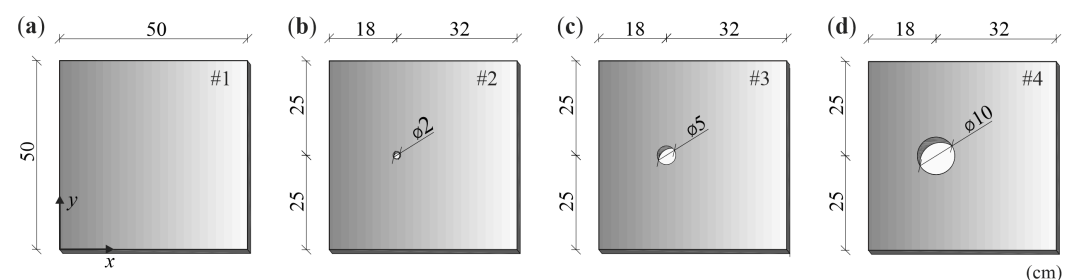
**Figure 2.** The geometry of the tested plates: (a) plate without damage (#1); (b–d) plates with surface damage (#2–#4).

The tests were carried out on four steel plates with dimensions of 50 cm  $\times$  50 cm and 3 mm thickness. A reference model was the first element without damage (plate #1). The other three plates contained a circular hole of variable diameter: 2 cm (plate #2), 5 cm (plate #3) and 10 cm (plate #4), which represented damage of a surface type. Holes were made through the entire thickness of the plate. The centres of all holes were placed symmetrically in the  $y$ -axis direction and at a distance of 18 cm from the outer edge of the plate in the  $x$ -axis direction. The geometry of the test models is shown in Figure 2. Photographs of the plates used for the experimental tests are presented in Figure 3.
