Article

Imaging of Increasing Damage in Steel Plates Using Lamb Waves and Ultrasound Computed Tomography

Abstract: This paper concerns the inspection of steel plates, with particular emphasis on the assessment of increasing damage. Non-destructive tests were performed on four plates, one of which was undamaged, while the remaining three had defects in the form of circular holes with diameters of 2, 5 and 10 cm. Guided Lamb waves were used in the research, and the image reconstruction was performed using ultrasound computed tomography. The damage size was estimated by tracking the real course of rays and densifying the pixel grid into which the object was divided. The results showed the great potential of ultrasound tomography in detecting defects in steel elements, together with the possibility of estimating damage size.

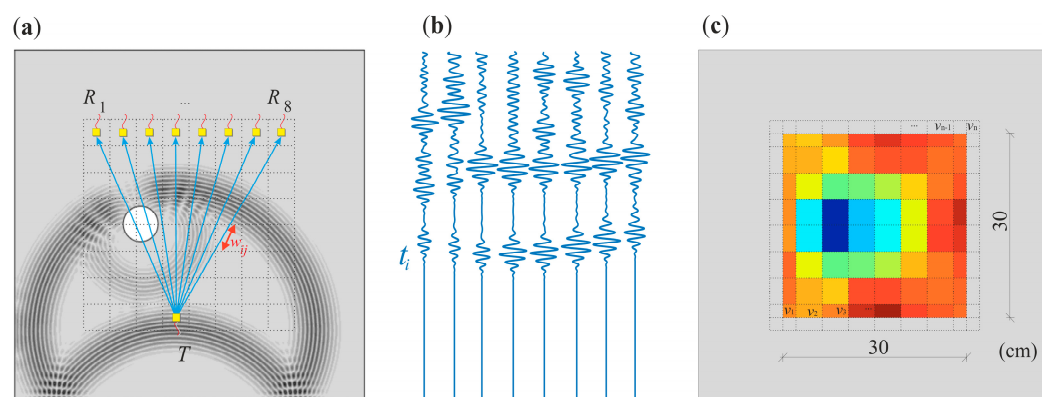
Figure 1. Schematic diagram of velocity reconstruction using ultrasound tomography: (a) plate with indicated receivers (R), transmission (T) points and simulated wave field; (b) guided wave propagation time signals; (c) ultrasound tomography map.

Ultrasound tomography imaging allows recreating the internal structure of an examined object using the properties of elastic waves. A schematic process of performing ultrasound tomography is shown in Figure 1. The first step is to divide the test sample into cells called pixels. Each one of them constitutes a discrete area in the tested element. Such a division is shown with a dashed line in Figure 1a. Then, after applying appropriate algorithms, each pixel takes a value representing the speed of the ultrasonic wave propagated through this area.

Image reconstruction is based on information from ultrasound wave signals propagating from transmitting points (T) to receiving points (R). This information may be, for example, the time of flight (TOF), measured along with the multiple ray paths, determined after appropriate signal processing [34–36]. Each obstacle in the path of the travelling wave changes the propagation time. Among them, we can distinguish defects that delay the wave reaching the receiver, such as air voids or cracks, and those that decreased total velocity along all rays passing through these inclusions. The latter include inclusions made of materials whose propagation velocity is higher than in the surrounding medium. Based on the time of flight of the wave, with the known geometry of the tested object, it is possible to determine wave propagation speed, correlated with the mass density, modulus of elasticity, and Poisson's ratio characteristic for a given material.

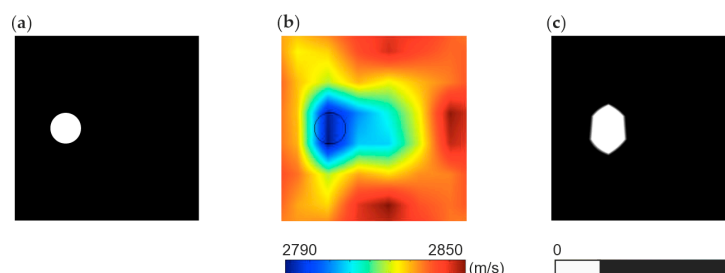
Figure 17. Error coefficient values for maps with reduced spectrum based on direct travel time measurement method: (a) reference model with a reduced spectrum, (b) topographic map with a full spectrum, (c) tomographic map with a reduced spectrum.

The accuracy of the tomographic reconstruction was quantified by using an error coefficient comparing the reference image with the obtained tomographic maps. Each of the prepared tomographic maps was replaced by a simplified model with a reduced spectrum, indicating high and low velocities as well as large and small differences. In the case of direct measurement, pixels with velocities below the 25th percentile of the maximum scale value are considered to be low-velocity indications and are assigned a value of 0, while others are assigned a value of 1. An example of spectrum reduction for direct measurement is shown in Figure 17. In the case of maps based on signal differences for an undamaged structure and a damaged structure, pixels with a difference above the 75th percentile of differences in a scale are assigned a value of 0, and the remaining pixels are assigned a value of 1.
