# Analysis of the state of preservation the historic arcaded houses in Vistula Delta listed in the National Inventory of Historical Monuments

**Abstract:** Historic arcaded houses are part of the material heritage of the Vistula Delta. Unfortunately, their number is decreasing year by year. The article is the result of a query of available sources and field research carried out by the author in 2015-2020. The paper presents the current state of preservation the historic arcaded houses in Vistula Delta listed in the National Inventory of Historical Monuments. Criteria for the selection of test objects are described. The author has prepared a tabular list of arcaded houses with information about their location, type according to Kloepfel statistics, date of construction, technical condition and functions. The summary of the analysis are pie charts with a statistical presentation of the data collected by the author during the research.

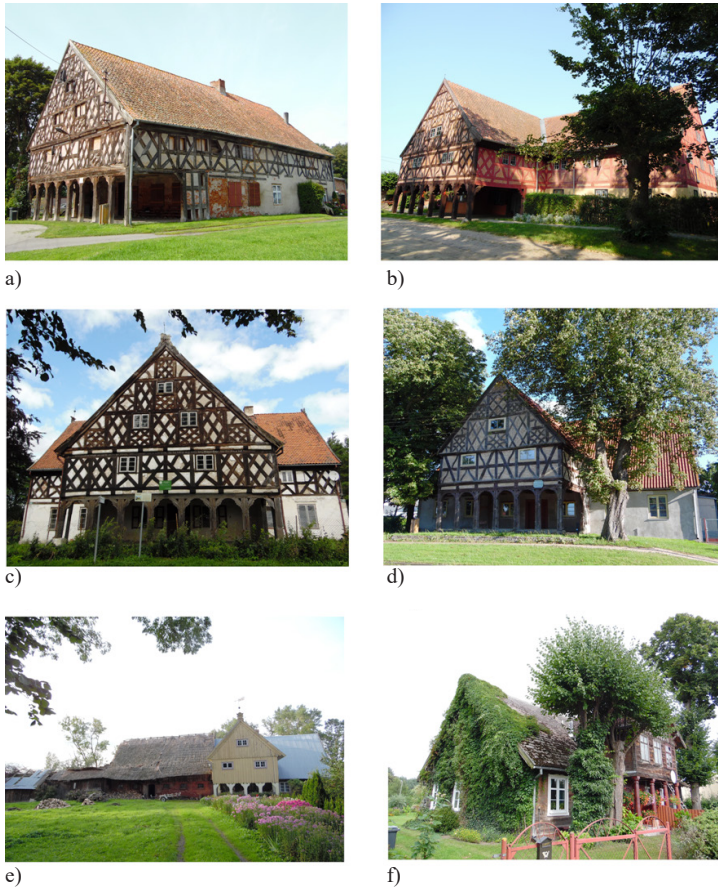
Fig. 1. Types of arcaded houses: a) type I house in Klecie, b) type II house in Trutnowy, c) type II-III house in Stalewo no.14, d) type III house in Koszwały, e) type III house in Markusy, f) type III house in Mikoszewo no. 68 (photo by the author)

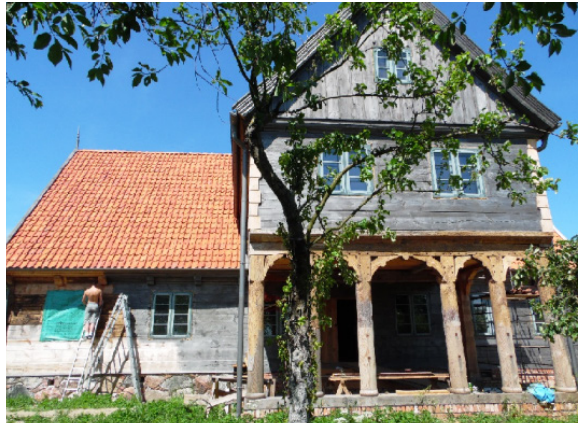
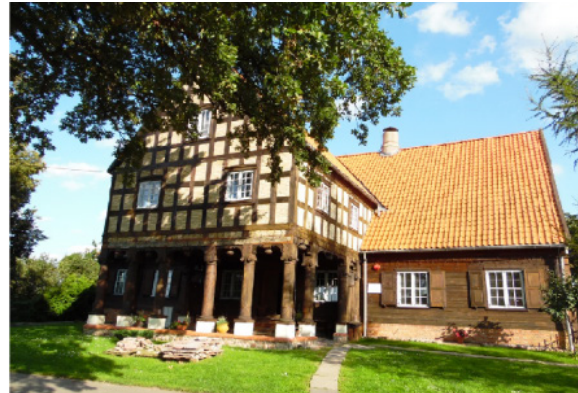
Fig. 5. Arcaded houses in: a) Orłowo no. 66, during construction and conservation works in 2015, b) Miko-szewo no. 55, during construction and conservation works in 2017, c) Przemysław no. 4, d) Marynowy no. 19 / 19a (photo by the author)
