## Failure analysis of a high-speed induction machine driven by a SiC-inverter and operating on a common shaft with a high-speed generator

Due to ongoing research work, a prototype test rig for testing high speed motors/generators has been developed. Its design is quite unique as the two high speed machines share a single shaft with no support bearings between them. A very high maximum operating speed, up to 80,000 rpm, was required. Because of the need to minimise vibration during operation at very high rotational speeds, rolling bearings were used. To eliminate the influence of higher harmonics of supply voltage and current on the formation of torque oscillations on the shaft and excessive losses in the form of heat, a voltage source inverter with high switching silicon carbide (SiC) power transistors characterizing high precision of the output voltage generation with a fundamental harmonic frequency of several kilohertz has been used. During the first start-ups, it turned out that the system was not stable, and a failure occurred. The paper presents the consequences that may arise when a machine operating at a speed of about 70,000 rpm fails. The article contains pictures of a

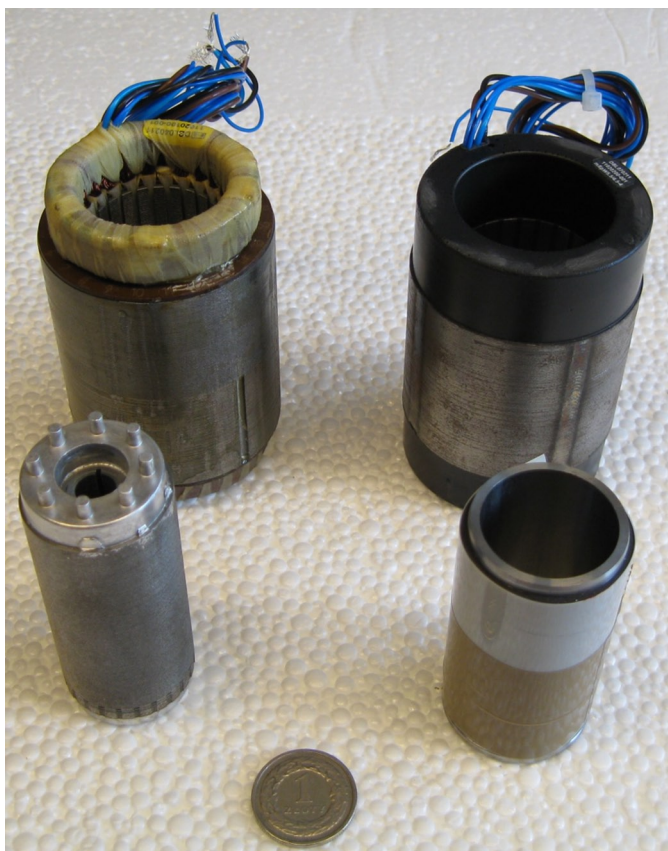
Fig. 1. Stator and rotor of a 3.4 kW induction motor/generator (left) and a 6-kW permanent magnet synchronous motor/generator (right) designed to operate at speeds above 80,000 rpm and voltage frequency above 1.3 kHz.

trol algorithms at high rotational speeds [12, 33]. The development of these technologies affects both high-speed induction motors/generators that are valued in the industry for their reliability, simple rotor design, low inertia, and ability to operate in high temperatures, as well high-speed permanent magnet motors/generators with high torque density and power density. The stator and rotor of a 3.4 kW generator and a 6-kW generator, which were used on the test rig analysed, are shown in Fig. 1.

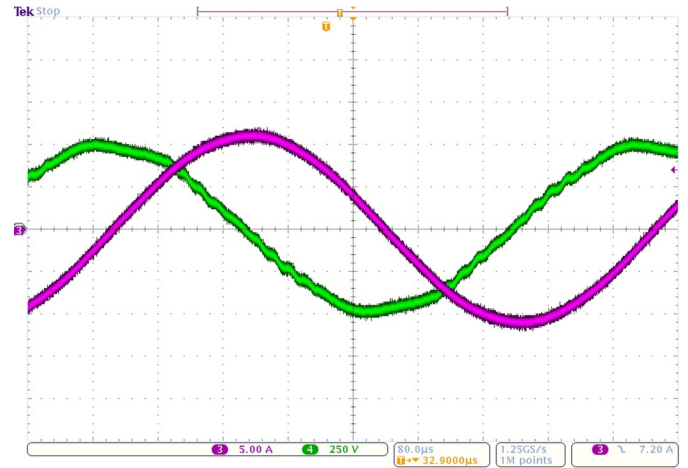
Fig. 7. Voltage and current waveforms of the stator of a 3.4 kW induction motor installed in the tested system with a silicon carbide inverter measured after the sinusoidal filter at a voltage frequency of 1.5 kHz

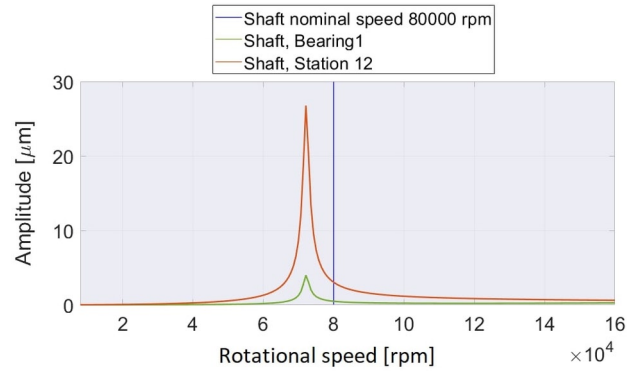
The forced vibration analysis shows (Fig. 19) that the maximum displacement of the bearing journal (node 5 – green line) and of the part of the rotor which is most exposed to stator rubbing (node 12 – red line) was respectively 3.97  $\mu\text{m}$  and 26.76  $\mu\text{m}$  at a speed of 72,130 rpm. Compared to the reference case, the vibration amplitude has hardly changed. What has changed is the speed at which the resonant vibration occurred; it changed by 4,853 rpm. This indicates an increase in the maximum permissible speed of almost 5,000 rpm. However, for safety reasons, a speed of 6,000 rpm should not be exceeded.

Fig. 19. Forced vibration analysis
