Fatigue life improvement using low transformation temperature weld material with measurement of residual stress

To appear in: *International Journal of Fatigue*

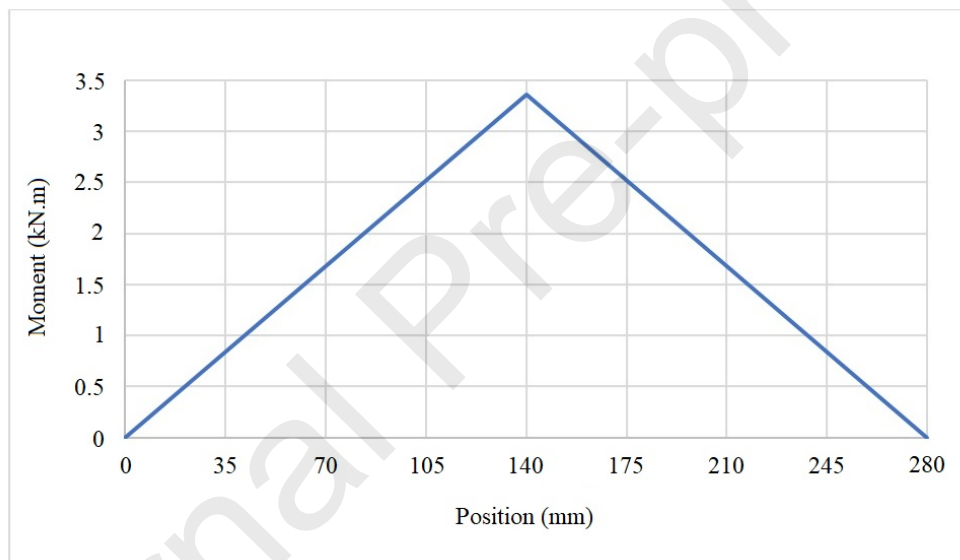
Figure 5. The testing apparatus: (a) load pattern; (b) normal force diagram; and (c) bending moment diagram.

experimental test setup shown in Figure 4. The frame is firmly mounted into the testing machine with the specimen bolted on top, then connected to the hydraulic ram. The fatigue tests were conducted under pulsating loading conditions with a cycle frequency of 5 Hz and a maximum load of 24 kN. Several safety elements were programmed to eliminate the likelihood of the parts projecting off, such as the maximum allowable force and the maximum displacement, with an automatic shutdown. Using the testing machine with a precise programmed loading pattern, it was eliminated any human error from the fatigue testing phase. Each specimen was run until complete failure, with a maximum displacement of 10 mm. Details about the load pattern as well as about the normal force and the bending moment diagrams, are exhibited in Figure 5.

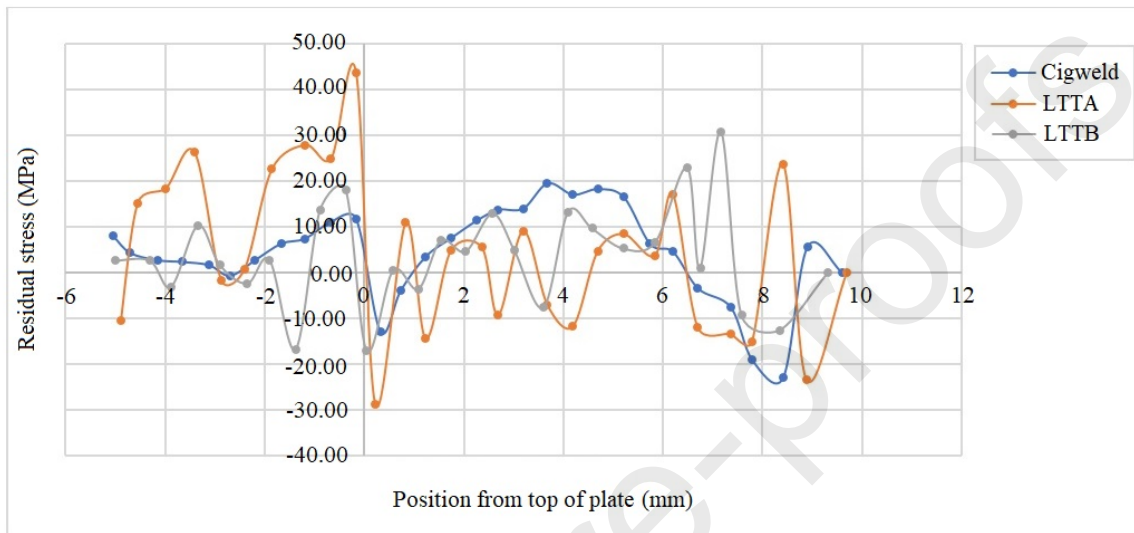
Figure 7. Residual stress field against position from top of plate for: (a) Mild steel fillers; and (b) LTTB and stainless fillers.

Figure 7 shows residual stress field against position from top of plate for mild steel fillers, LTTB and stainless fillers. The calculated residual stress is also presented in Table 4. Overall, both LTT weld fillers showed reduced residual stresses when compared to all other weld wires. The Cigweld wire began in compression for the initial 4 mm, it then transferred to residual tensile forces, with a maximum occurring at approximately 3 mm. LTTA had mainly residual compressive stress with only slight tensile stresses applied. LTTA experienced mostly compressive forces until the weld was almost completely

milled away. LTTB was similar to LTTB with he applied stresses until the weld was completely milled away. The BOC weld filler had the highest tensile forces. Initially it had compressive forces lasting until a position of 5mm where the tensile forces began increasing as the weld was milled away. The BOC weld filler experienced tensile forces almost 10 times more than the LTT weld fillers. The Tetra weld filler experienced phenomenal amounts of compressive stresses, consistent compressive stress until approximately 1 mm from the base.

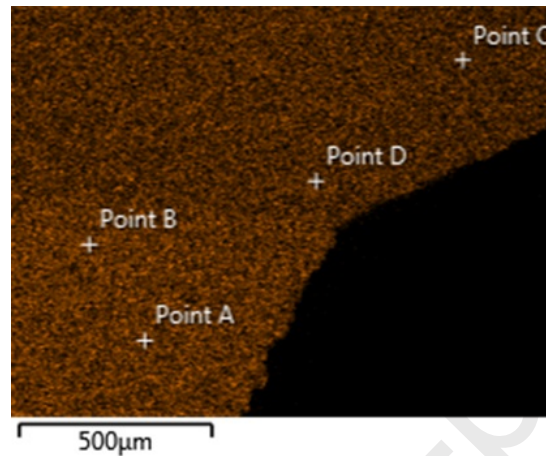
Figure 10. The definitive increase in manganese percentage: (a) manganese scan sample LTTB; and (b) scanning electron microscopy image.

manganese, silicone, and aluminium. Point A was positioned on the weld, this was important to analyse the difference between the untouched base metal and the pure weld. Looking at the trends for point A, it shows that the manganese percentage was higher in all welds. Figure 10 shows the definitive increase in manganese percentage. This figure displays the manganese measurements as a scanned image, where the weld is shown by the lighter orange containing points A and B, whereas the parent metal is shown by the darker orange containing points D and C.
