# Influence of PWHT Parameters on the Mechanical Properties and Microstructural Behavior of Multi-Pass GTAW Joints of P92 Steel

**Keywords:** P92 steel; GTAW; heat treatment; impact toughness; hardness; tensile properties

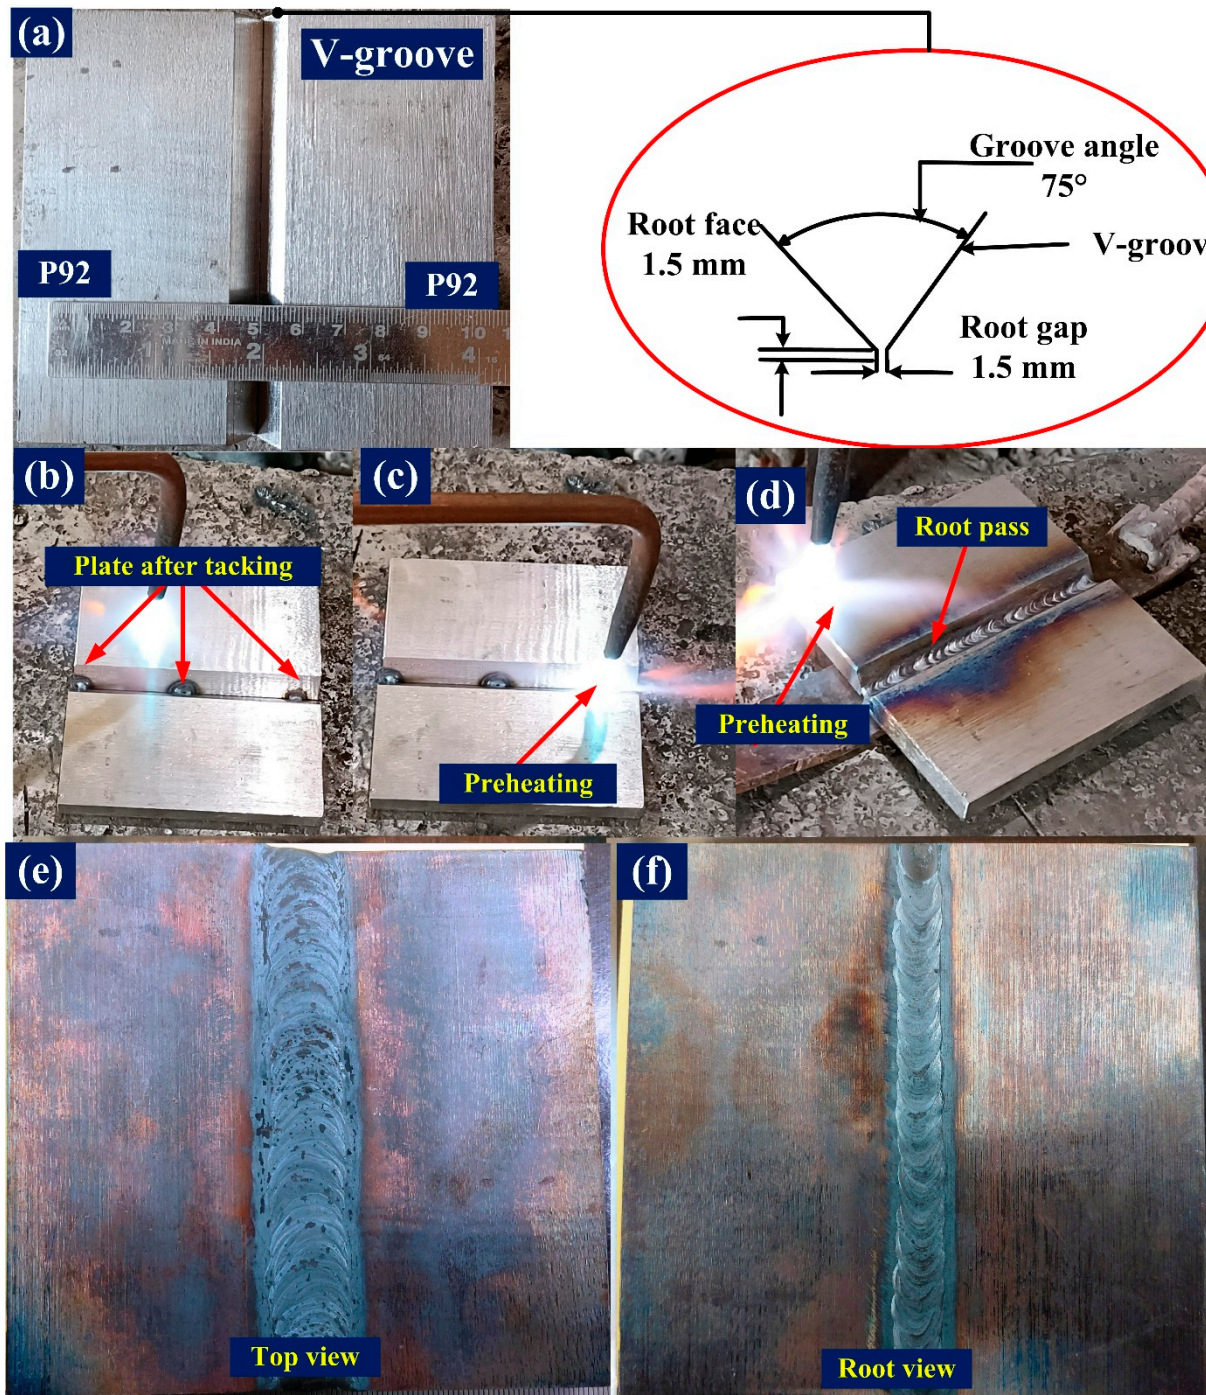
**Figure 1.** (a) Grooved plate and detail of groove geometry, (b) plate after tacking, (c) preheating, (d) root pass, (e) top view of plate, (f) root view of the plate.

The plate after the root pass is depicted in Figure 1d. The top and root views of the welded plate are shown in Figure 1e,f. After each pass, the weld area was cleaned using a wire brush. The inter-pass temperature was maintained at 280–300 °C. Commercially pure argon (99.9%) was used to shield the arc column and weld area and was supplied at a

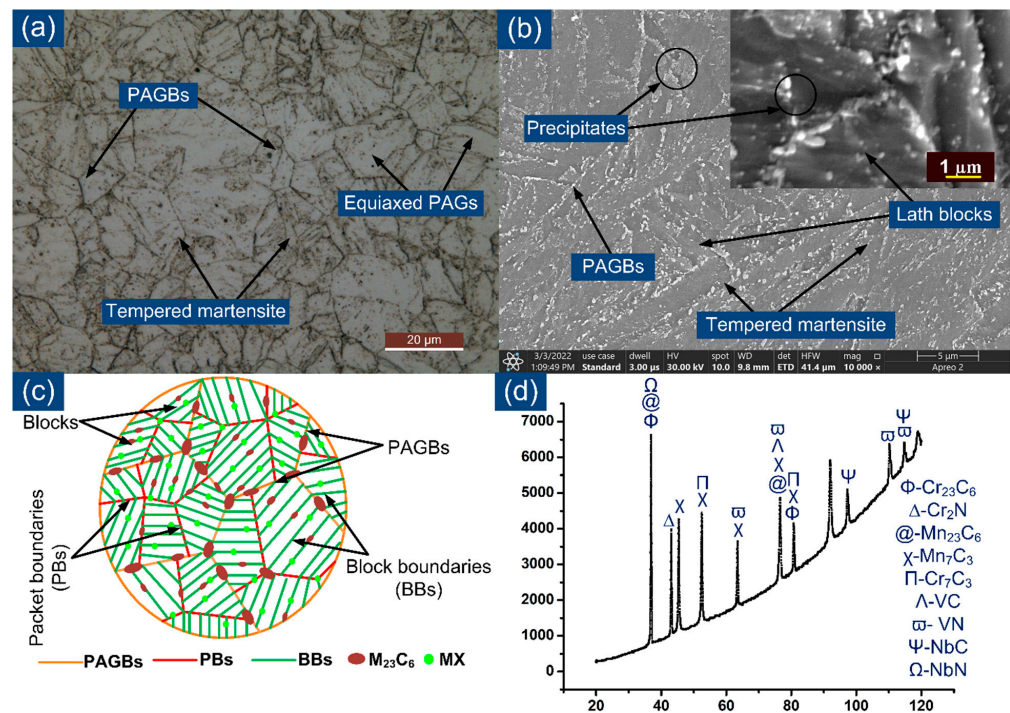
**Figure 3.** (a) Optical image showing tempered martensitic microstructure and boundaries, (b) SEM image showing lath blocks, boundaries and precipitate decoration along boundaries and inside the matrix, (c) schematic showing precipitate decoration along boundaries and blocks, and (d) XRD profile showing the phases present in P92 steel.

The micrograph of the P92 steel exhibited a tempered martensitic microstructure, as depicted in Figure 3a. Figure 3a shows equiaxed prior austenite grains (PAGs) with an average size of  $12 \pm 5 \mu\text{m}$ , lath blocks and boundaries. The SEM image, captured at a magnification of  $10,000\times$ , reveals the lath blocks, boundaries (block boundaries (BBs), packet boundaries (PBs) and prior austenite grain boundaries (PAGBs)) and decoration of the precipitates (Figure 3b). The precipitates located along the PBs and PAGBs are coarse in size and were confirmed to be Fe-, Mn- and Cr-rich  $\text{M}_{23}\text{C}_6$  precipitates [56]. The size of the coarse precipitates was in the range of 100–200 nm. Other fine precipitates, with sizes lower than 50 nm, were also observed within the lath blocks and confirmed to be Nb- and V-rich carbonitrides (VC, VN, NbC and NbN) [56]. The evolution of the microstructure in N&T P92 steel is also represented by a schematic image, given in Figure 3c. The other precipitates, except  $\text{M}_{23}\text{C}_6$  and MX, were  $\text{M}_7\text{C}_3$  and  $\text{Cr}_2\text{N}$  as confirmed via X-ray diffraction (XRD) analysis (Figure 3d). Hurtado-Noreña et al. [57] also reported the presence of  $\text{M}_{23}\text{C}_6$ ,  $\text{M}_3\text{C}$  and MX precipitates in 9% Cr steels. The tensile strength and yield strength of P92 after N&T treatment were  $758 \pm 6 \text{ MPa}$  and  $520 \pm 8 \text{ MPa}$ , respectively.

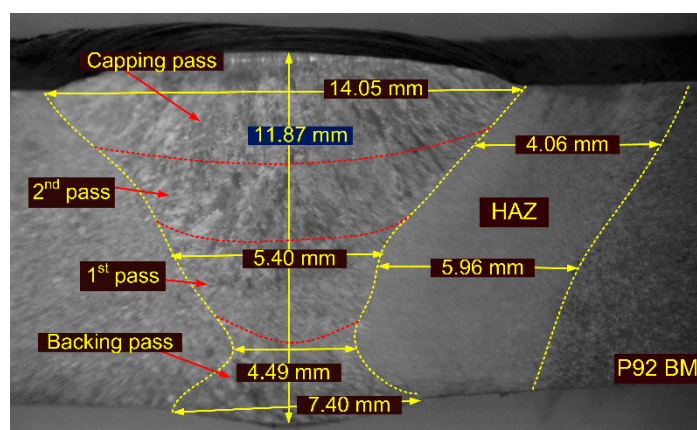
**Figure 4.** Macrograph of the welded joint.

The welding was completed in four passes and each pass is marked in the macrograph of the welded joint shown in Figure 4. The weld widths at the capping and backing passes were 14.05 mm and 7.40 mm, respectively. The widths of the HAZ corresponding to the capping pass and filling pass (second pass) were 4.06 mm and 5.96 mm, respectively.

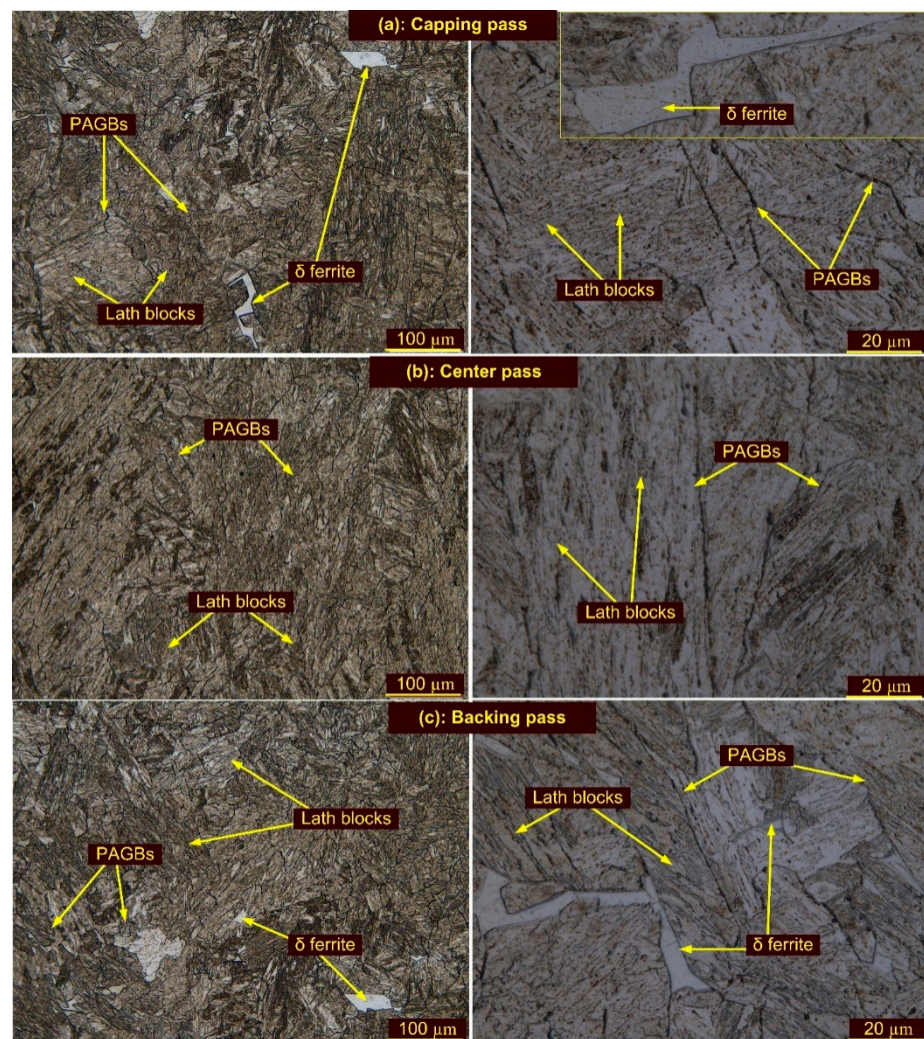
**Figure 7.** Optical image of WFZ corresponding to passes: (a) capping pass, (b) center pass, (c) backing pass.

A micrograph showing the effect of the welding passes on the WFZ is given in Figure 7. The WFZ corresponding to the capping and backing passes showed a microstructure type with elongated grains and typical lath blocks (Figure 7a–c). For both passes, WFZ showed the presence of  $\delta$  ferrite patches of different shapes and morphology. The WFZ corresponding to the backing and capping passes was directly exposed to the surroundings and achieved a higher cooling rate. Ferrite stabilizers such as W and Cr, present in the filler metal, also accelerated the formation of the ferrite patches in the WFZ. Previous studies also reported the role of ferrite stabilizer content on the formation of ferrite patches [62].

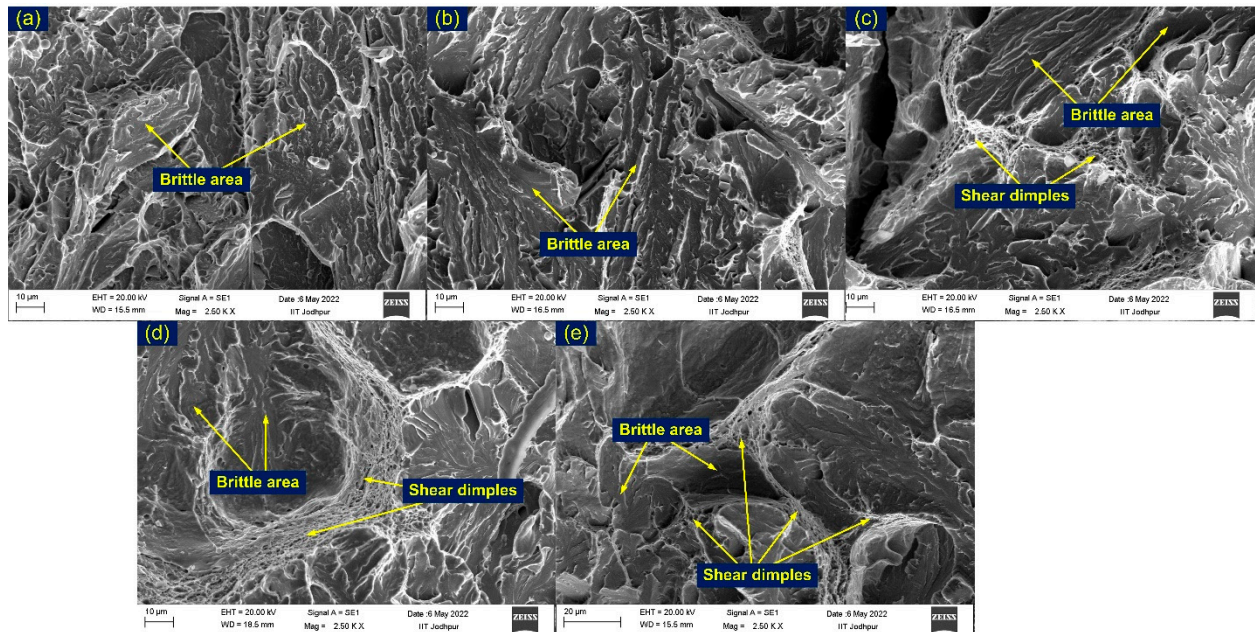
**Figure 19.** SEM image of fractured impact tested specimens: (a) AW, (b) T1, (c) T2, (d) HT1, (e) HT2.

SEM micrographs of the impact-tested fractured specimens are presented in Figure 19. The appearance of the fracture surface for AW and T1 specimens supports the impact test

results, as in both cases the fracture was dominated by a brittle area (Figure 19a,b). The fracture surface shows the typical characteristics of a cleavage area and river patterns. In T2, both dimples and a cleavage area appeared at the fracture surface; however, the fracture mode was dominated by the brittle area (Figure 19c). In HT1 (Figure 19d) and HT2 (Figure 19e), both cleavage and shear dimples are seen; however, the major portion was represented by the brittle area.
