APPLICATION OF THE CORROSION TESTER IN CORROSION TESTS USING THE ACOUSTIC EMISSION METHOD

Gdansk University of Technology, Poland

ABSTRACT

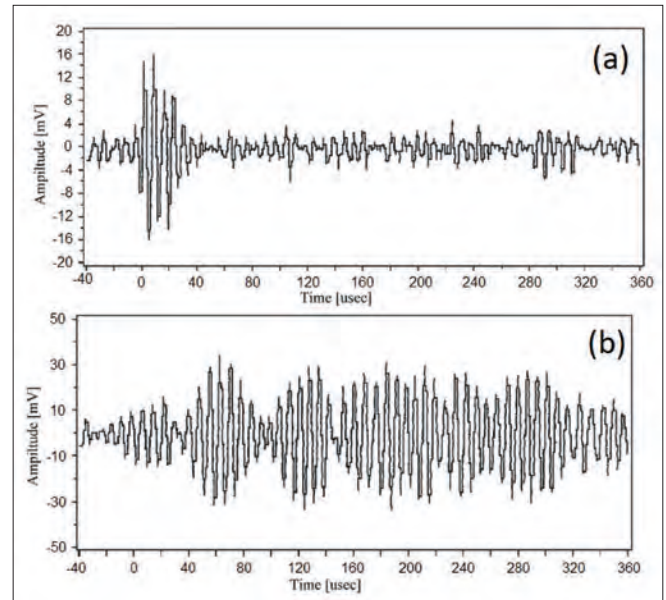
Fig. 1. Run of (a) short wave, (b) reflected wave [26].

of the released internal energy. A wave formed in this way (Fig. 1(a) and Fig. 1(b)) is registered by the acoustic sensor. In the case of pitting corrosion monitoring, events arise from cracks in the passive layer that form on the surface of the corrosive metal. The events that become the source of wave emissions may be low-energy or high-energy events and determine the progress of pitting formation.

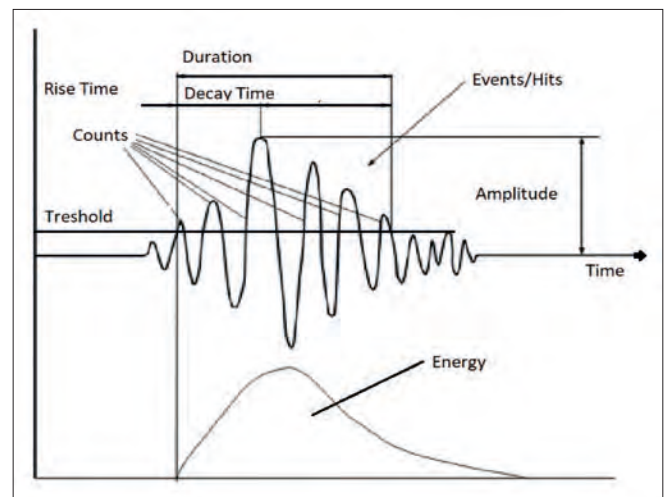
Fig. 2. A single acoustic emission signal [17].

The acoustic emission signal is characterised by such parameters as: energy, amplitude, number of crossings of the discrimination threshold, rise time and duration of the acoustic signal (Fig. 2).

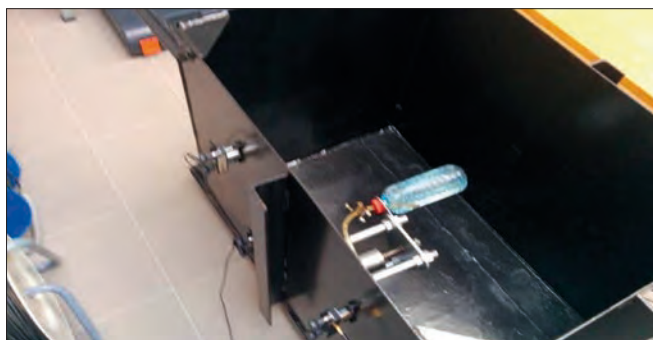
Fig. 4. Corrosion test tank with the KE-2 corrosion tester attached and the VS75-V and VS150 RIC acoustic sensors installed.

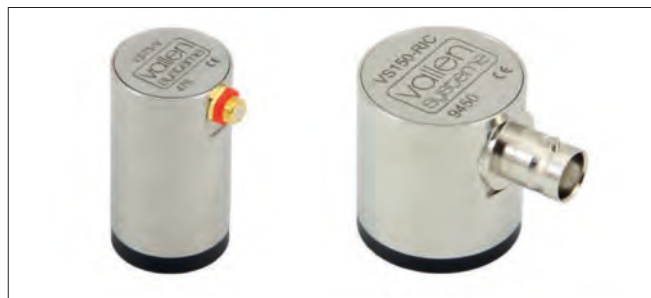
Fig. 5. Acoustic sensors, type VS-75V i VS-150 RIC, used during the tests.

For corrosion tests using the acoustic emission method, AMSY-5 measuring equipment from Vallen GmBH was used, together with a set of acoustic sensors (Fig. 5), the KE-2 (given name for corrosion tester according to patent no. P.431331) corrosion tester (shown in Fig. 5), a corrosion test tank made of hull steel of category A, and corrosive solution (Table 1). All elements of the measurement set are summarised in Table 2.

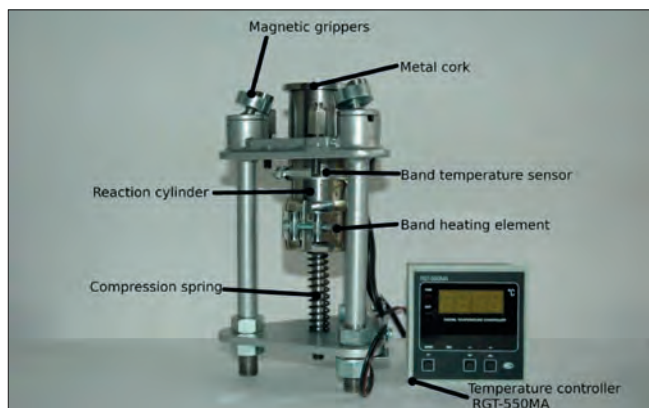
Fig. 6. The KE-2 corrosion tester with some of its elements.

The above criteria are met by the KE-2 corrosion tester (Fig. 6.), which is used during corrosion measurements and accompanying acoustic events monitored by the VALEN system. It can be used to study both corrosion phenomena, occurring at a constant ambient temperature, and phenomena occurring at elevated temperatures, including in gases. It aims to collect the necessary data, which may help to build a better classifier in the future, and this will translate into better detectability of the corrosion process itself in real conditions.

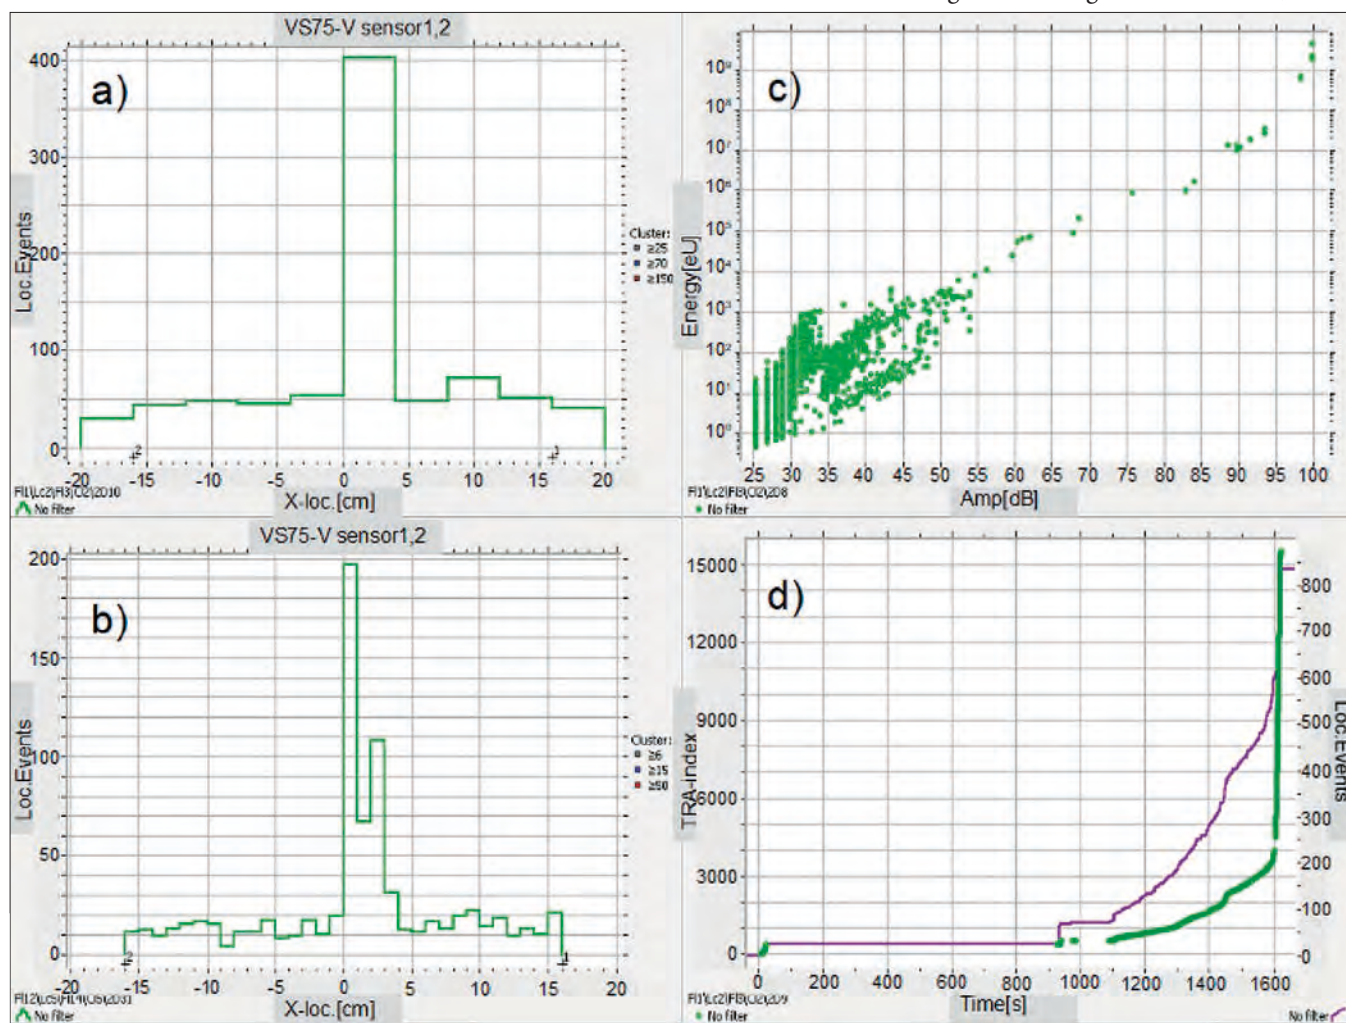
Fig. 7 The KE-2 corrosion tester and its background detectability for VS 75-V sensors, a), b) - the relationship between the location of the tester in relation to the sensors and the number of events recorded by the system, c) the dependence of the signal amplitude given in decibels (dB) to the released energy, d) graph of the measurement time and the number of events.

Before the acoustic test itself, all components of the corrosion tester were well cleaned. After removing all impurities, the reaction cylinder and stopper were degreased with ethyl alcohol. Then, the corrosion processes in the tester were initiated, commencing with flooding the tester reaction tank with the corrosive solution (Table 1) to 1/3 of its volume. After placing and mounting the tester in the tank (Fig. 4) and connecting the VS150 RIC and VS75 sensors with preamplifiers, the AMSY-5 acoustic emission system was activated and the recording of the acoustic signal was started. The signal recording from the moment of flooding to its completion was about 30 minutes. The results of this measurement are presented in Fig. 7 and Fig. 8.

The presented test results prove the possibility of continuous detection of acoustic signals from the corrosion tester. It gives a stable and clear 50 dB signal that stands out clearly from the rest of the acoustic background during the measurement, which

fluctuates around 20-30 dB, as shown in the graphs (Fig. 7c and 8c). This is a similar result to that found by [25], which is characteristic for the amplitude of the signal originating from corrosion occurring in steels in seawater. The corrosion signal obtained in the laboratory during corrosion tests also corresponds to the amplitude of the signal obtained during further tests carried out on real objects [26]. It can be observed that the tester is visible against the background noise coming from the laboratory. A clearly visible increase in energy in the places where the acoustic sensors of both VS75-V and VS150-RIC are attached, can also be observed. This proves not only the possibility of detecting the signal coming from the corrosion tester, but also the possibility of its partial localisation, which is very well illustrated in the graphs in Fig. 7a, 7b, 8a and 8b.

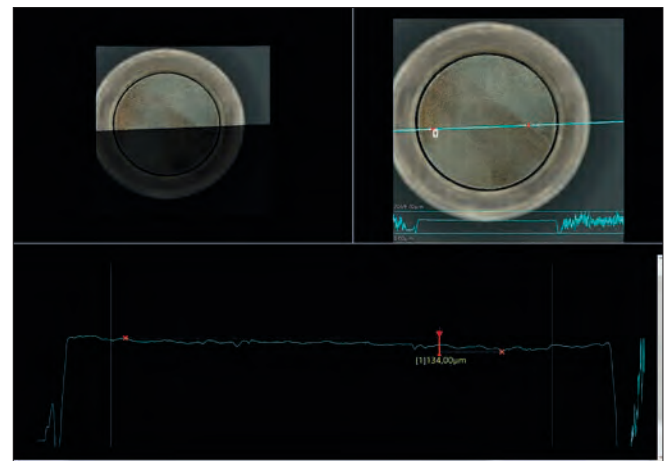
Fig. 9. The profile of the cylinder plug surface after the corrosion test.

Figures 9 and 10 present the results of metallographic testing of the plug covering the tester's reaction cylinder. The profile of the plug's surface shows extensive corrosion damage along the cross-section up to a certain point. Once that is exceeded,

the damage that occurs is very small. This is due to the way the corrosion tester is attached to the tank during the test. After careful examination of the photographs, a distinct line can be seen between the corrosive solution and the air trapped in the rest of the tester's reaction cylinder (Fig. 10).

It can be seen that, in part of the contact between the solution and the corrosive gas, the corrosion losses are interconnected pits, extending along the line of immersion of the cork of the reaction cylinder in the corrosive solution. Their depth, as shown in Fig. 10, is different. The greatest value of the depth, about 107-134 μm , is achieved in the chambers of the phase contact. The largest and most extensive complex of corrosion pits can be observed in Fig. 10. The photographs make up the cork profile and were built on the basis of the conceptual image stitching method implemented in the KEYENS optical microscope software. The magnification of a single photo was about 20 times (Fig. 9). Points 1 to 6 (Fig. 10) show a fragment of the plug surface corresponding to the measurement points of the profile cross-section and show the depths of the corrosion cavities collected in various places of the resulting corrosion pitting complex. The deepest pit in the complex has a depth of 110 μm , while the smallest has a depth of 0.32 μm . It should be mentioned that both pits presented in Fig. 9 and Fig. 10 were only selected as examples and do not show the full scope of the observed corrosion degradation of the material on the measured plug.

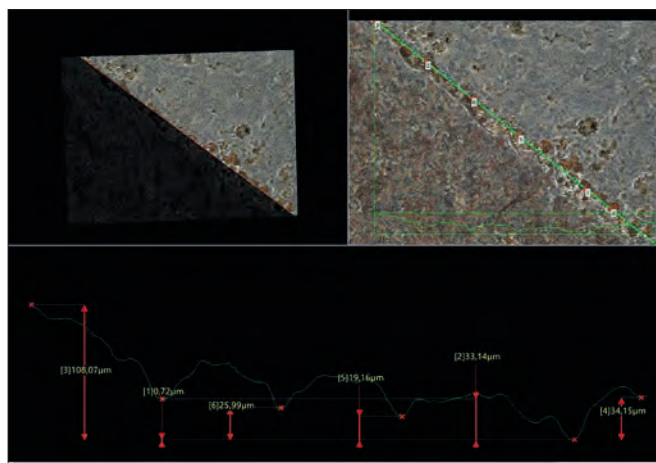
Fig. 10. The surface profile of the greatest corrosion damage observed on the surface of the plug from the reaction cylinder. As you can see in the photograph, the shape of this damage is extensive and consists of many pits connected with both. The deepest corrosion cavity is about 110 μm deep and the smallest is about 0.32 μm .
