## RESEARCH ARTICLE

# Quality Assessment of Low Voltage Surge Arresters

**ABSTRACT** Users expect reliable operation of the surge arrester during overvoltages, which may originate from a switching process or a lightning discharge. The necessary conditions to guarantee these expectations are: appropriate construction of the surge arrester, its production being maintained in accordance with technical standards, and a positive results of the type test (as well routine and acceptance tests). The recipient, especially when purchasing large quantities of the product, can check the final quality of the product through selective testing of samples from the market in order to find the best supplier. This manuscript specifies the basic parameters of low-voltage (LV) surge arresters of four manufacturers. Basic electrical parameters, i.e. leakage current and varistor voltage ( $U_{1mA}$ ) before and after the nominal discharge current ( $I_n$ ) of  $8 \mu s/20 \mu s$ , were determined for 10 randomly selected surge arresters of each manufacturer. Moreover one sample of each varistor batches was aged by fifty  $8 \mu s/20 \mu s$  current impulses with  $I_n$ . The obtained results of structu

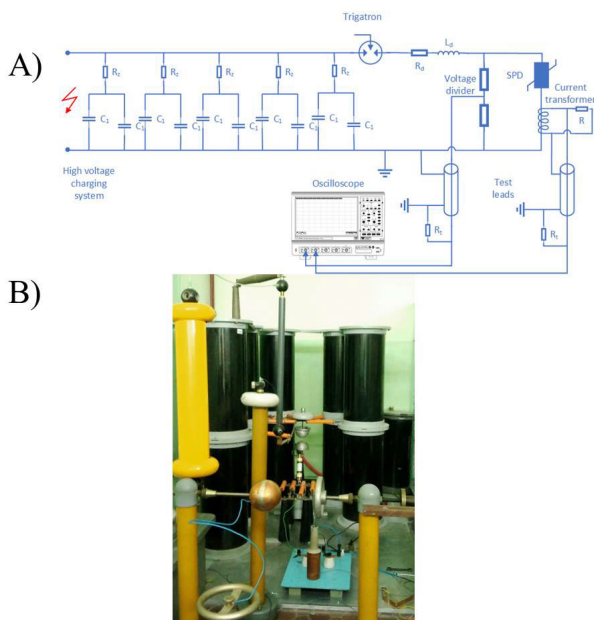
**FIGURE 1.** Measurement of the residual voltage of varistors with the nominal discharge current flow of  $8 \mu\text{s}/20 \mu\text{s}$  with an amplitude of 5 kA, (a) layout scheme, (b) test stand.

- varistor voltage  $U_{1mA}$  of the LV limiter, the methodology according to the IEC 61643-331 standard was used, measuring the voltage  $U_{1mA}$  at the varistor terminals with a direct current flow of 1 mA - measurement before and after the applied surge,
- limiting voltage  $U_{res}$  (IEC 61643-11 standard) at rated discharge current (surge 8/20  $\mu$ s/ $\mu$ s) measured as it shown in Fig.1,

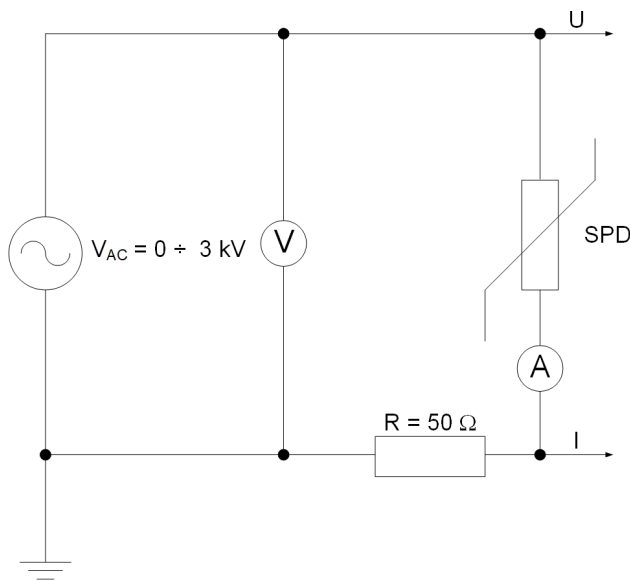
**FIGURE 2.** A scheme of test stand for leakage current measurements.

- total leakage current  $I_{LCT}$  and its resistive component ( $I_{LCR}$ ) at the highest continuous operating voltage  $U_C$  according to Table 1 measured at test stand from Fig.2.

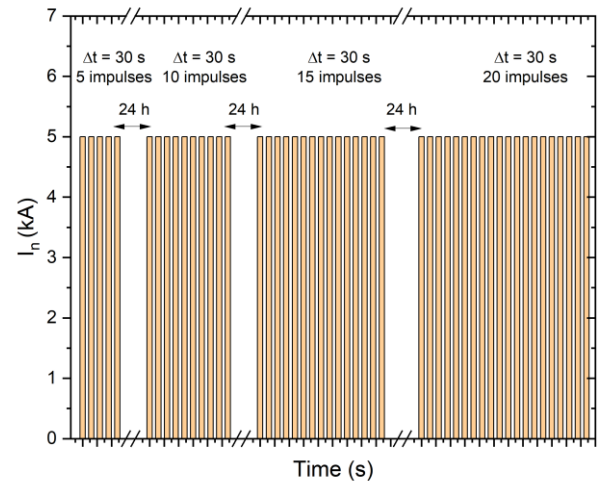
**FIGURE 3.** A procedure of aging of surge arresters.

Additionally, an aging process of the arresters was performed for a random samples of each manufacturer (1 out of 10 items). We deliberately applied a series of current surges up to 50 (5 strokes, 10 strokes, 15 strokes, 20 strokes, surge  $8/20 \mu\text{s}/\mu\text{s}$ ) following the procedure shown in Fig.3. The duration between impulses was  $\Delta t = 30 \text{ s}$  and its maximum current was equal  $I_n = 5 \text{ kA}$ . The 24 hour interval between each series of impulses was applied to avoid damage to the

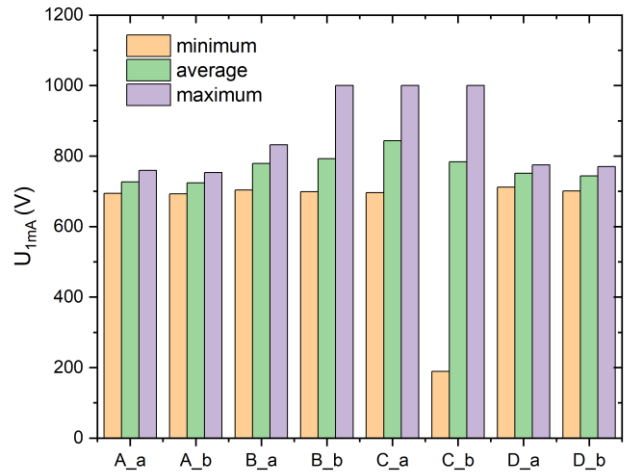
**FIGURE 4.** Statistical values of the varistor voltage  $U_{1mA}$  (minimum, average and maximum values) for a different samples of LV surge arresters (A, B, C, D) before (a) and after (b) an aging process.

Figure 4 shows the statistical parameters of the varistor voltage  $U_{1mA}$  of the population of investigated surge arresters. It can be observed that the A and D surge arresters are characterized by high repeatability, which remains even after an ageing process. An increase of  $U_{1mA}$  was observed for one sample of manufacturer B and a drastic decrease in this parameter for one of the varistors C, which means its complete damage. Moreover, the C-surge arresters are characterized by the greatest spread of the  $U_{1mA}$  for the investigated population.

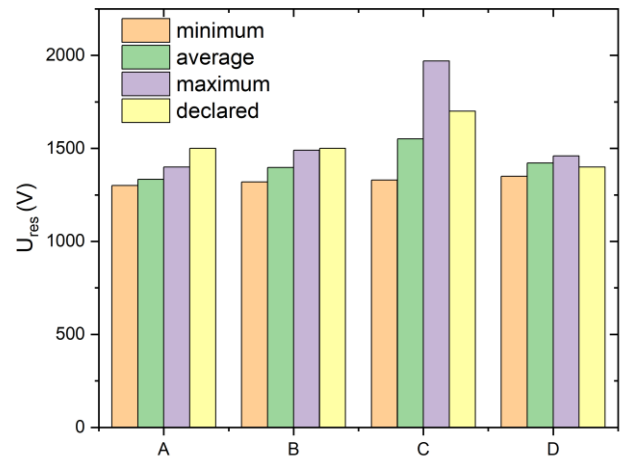
**FIGURE 5.** Statistical values of the threshold voltage (minimum, average and maximum values) for a different samples of LV surge arresters.

Figure 5 shows the results of  $U_{res}$  measurements. The largest dispersion of the maximum voltage values accompanying the discharge current flow can be observed again for the C- surge arresters. The remaining companies achieve similar spreads, however it is worth noting that the values obtained for C and D exceed the limits declared by the manufacturers. In this experiment, it can be concluded that manufacturer A obtained the reproducible and lowest residual voltage values. For the products of this manufacturer, the highest of the measured values of the limiting voltage is definitely below the voltage declared by the manufacturer. On the basis of

the above-mentioned test and analysis of other parameters, it can be assumed that in the case of LV surge arresters, the residual voltage test may be the basic method of checking the quality and durability of the surge arresters when performing, for example, a series of repeated current surges with specific parameters.

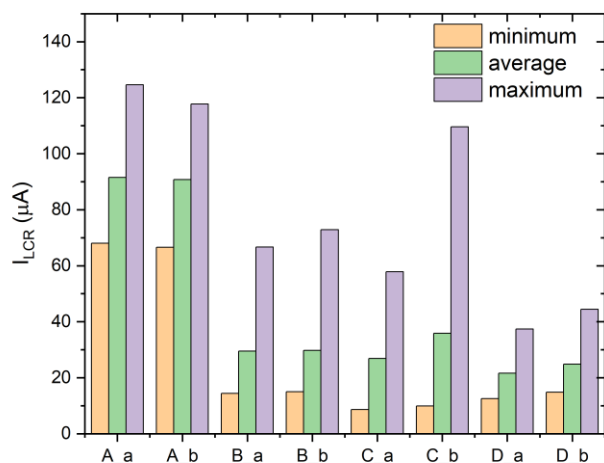
**FIGURE 6.** Statistical values of the active component of the leakage current (minimum, average and maximum values) for a different samples of LV surge arresters before (a) and after (b) an aging process.

The analysis of the resistive component of the leakage current, which is presented in Fig. 6 clearly indicates the highest values in the case of product A, which may cause greater heating of this limiter in the steady state and indirectly affect its current-voltage characteristics. The divergence between A samples and others manufacturers products may be a result of a different insulation method of these surge arresters. The analysis of the  $I_{LCR}$  value before and after the application of the current surge shows the greatest stability of the B population, where there was a slight increase in the statistical parameters of the resistance component compared to C and D (greater value change). A reverse trend was observed

for product A, as the values of the resistance component slightly decreased, which may be due to the stabilization of the parameters of samples with a significant leakage current.

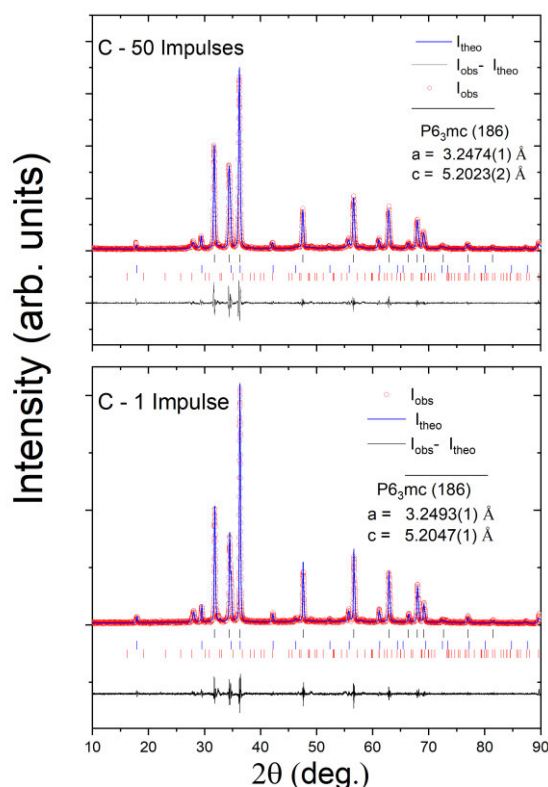
**FIGURE 7.** Le Bail refinement of powder XRD data for ETI varistors. Observed data and calculated intensity are represented by red circles and blue lines respectively. Black vertical ticks correspond to Bragg peaks for space group  $P6_3\text{mc}$  (no. 186); blue to  $Fd\text{-}3m$  (no. 227) and red to  $P\text{-}42_1c$  (no. 114).

Fig. 7 shows the room temperature XRD patterns for C varistors after 1 and 50 impulses (plots for other varistors are presented in Fig S2 of the ESI). It is clear that multiple crystalline phases are present in each varistor sample. In each case the main phase ( $> 85 \text{ mol } \%$ ) was identified as ZnO, which crystallizes in a hexagonal structure with space group  $P6_3\text{mc}$  (no. 186). Another similarity between these materials is occurrence of  $\delta\text{-Bi}_2\text{O}_3$  (cubic structure; space group

$Fd\text{-}3m$  – no. 227) and  $\text{Sb}_2\text{O}_3$  (tetragonal structure; space group  $P\text{-}42_1c$  – no. 114). Both of them have a crucial meaning for grain growth process, which was earlier discussed in the literature [1], [2]. Results of the Le Bail refinement are gathered in Table S1 of the ESI. Calculated values of lattice parameters are in a good agreement with reported data. Moreover all of studied varistors contain trace amounts of additional phases, which could not be identified using pXRD method.

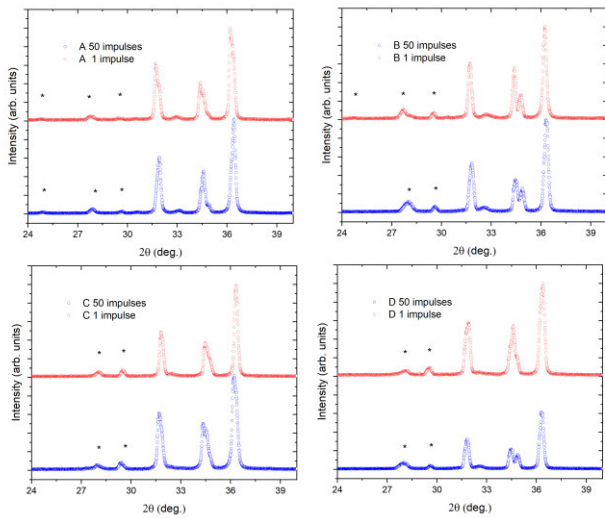
FIGURE 8. pXRD patterns for selected samples in the 2θ region 24° - 40°.

Fig. 8 shows results of pXRD measurements expanded in the  $2\theta$  region  $24^\circ - 40^\circ$ . It is worth noting that for both samples of A varistors around  $2\theta \approx 25^\circ$  one can observe a small reflection, which was not indexed. Similar behavior was not noticed for samples C and D. Furthermore this low angle reflection is present for B varistor treated with 1 impulse but disappears for sample treated with 50 impulses. It is an evidence for differences of composition of tested materials which may be a reason for dissimilarities between their electrical properties. What is more for a chemically pure ZnO intensity of a peak  $002$  is about 25% smaller than for a peak  $001$  [16], whilst in studied varistors these reflections are comparable. This phenomenon can be explained by the contribution of additional phases to the peak intensity around  $2\theta \approx 34^\circ$ . The shape of this reflection is strongly affected by the ageing process, which is especially visible in the case of

sample C. After multiple lightning strikes the crystallinity of the samples is improved, which is probably due to the influence of Joule's heating on structural properties. There are two plausible explanations of this phenomenon. First, exposure to heat may cause phase transition of  $Sb_2O_3$  to a pyrochlore or spinel structure type, during states is partially oxidized from  $Sb^{3+}$  to  $Sb^{5+}$  [8]. Moreover that the  $Bi_2O_3$  phase is polymorphic, with 4 phases existing in different temperature ranges. Another possibility is a substitution Zn atoms in Bi positions of bismuth oxide. In order to answer this question it is necessary to carry out further investigations e.g. neutron diffraction measurements. The pXRD method was also used to determine microstructural properties of surge arresters employing the line broadening analysis. The methodology of this process was described in [17] and the instrumental profile was approximated by  $LaB_6$  standard measurements results. Obtained values of coherently scattering domain (CSD) for ZnO,  $Bi_2O_3$  and  $Sb_2O_3$  are presented in Fig. 9. It is important to stress out that the CSD size is not directly connected to the grain and crystallite size and is used here only to highlight the evolution of XRD peak shape driven by microstructural changes.

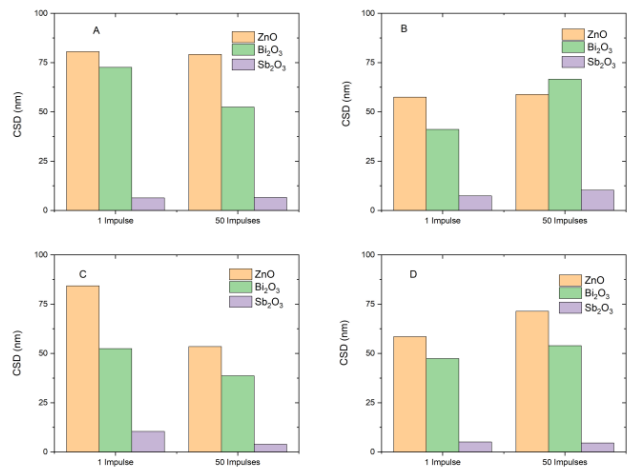
FIGURE 9. Values of coherent scattering domain for ZnO,  $Bi_2O_3$  and  $Sb_2O_3$  obtained from the line broadening analysis.

On the basis of these diagrams it may be ascertained that A and C samples have similar CSD sizes after 1 and 50 impulses. In the case of B varistors, a large increase of  $Bi_2O_3$  CSD can be observed, which is consistent with a hypothesis about overheating due to a large resistive component of the leakage current. The substantial differences between D samples can be explained by poor repeatability of these varistors rather than influence of an ageing process. The disproportions in the CSD values indicate on the lack of repeatability of technological processes in the production of surge arresters.

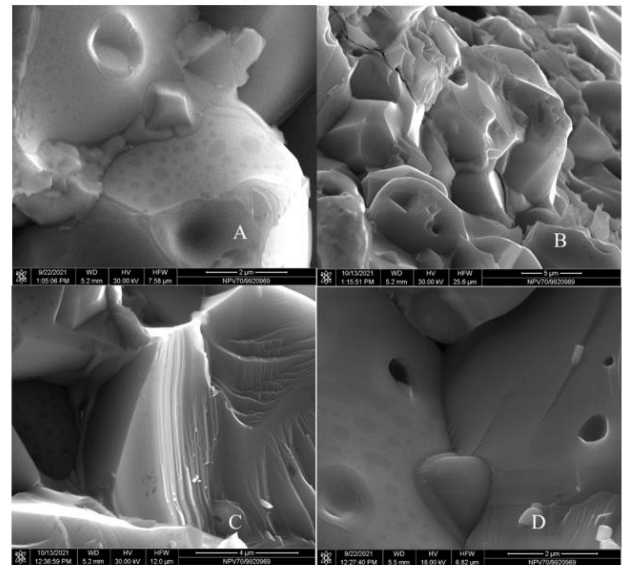
FIGURE 10. SEM images of varistors samples before ageing process.

The surface morphology of samples exhibit the presence of ZnO grains which have various sizes. Within the ZnO grain, submicron pores and traces of other phases can be observed (Fig S3 of the ESI). Images of varistors before an ageing process with higher magnification are presented in Fig. 10.

In each case ZnO grains with insertions of an additional phase are clearly visible. The most important differences between surge arresters can be seen in the interfaces, which are much broader for A and B varistors than for C and D samples. The non-ohmic properties of ZnO based varistors origin from grain boundaries between semiconducting zinc oxide grains [18]. For this reason varistors with broad interfaces may have a better ageing resistance, which was confirmed by electrical properties measurements. Moreover, in B varistor occur single crystalline inclusions with dimensions of approximately few micrometers. The shape of these

insertions suggest a  $ZnSb_2O_4$  spinel-like formation. These observations are in line with conclusions from pXRD measurements. It is worth noting that interfaces in the A varistor are cracked, which may result from improper parameters of the sintering process and cause the I-U characteristics to deteriorate.

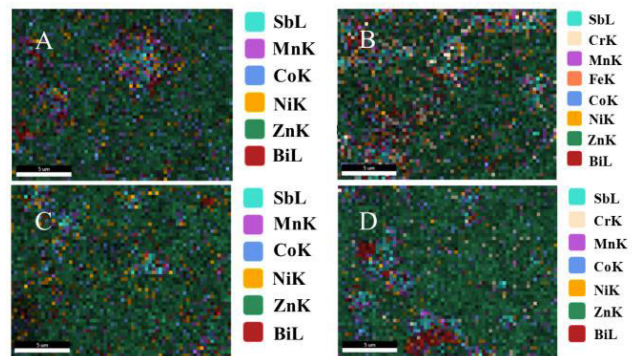
**FIGURE 11. Multi-element EDS mapping images of varistors before an ageing process.**

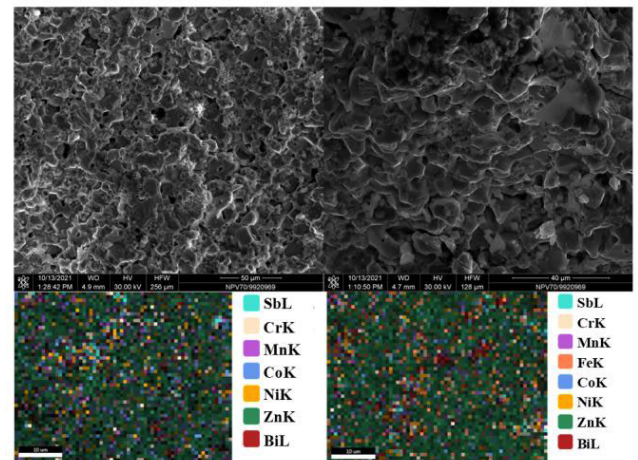
**FIGURE 12. Comparison of SEM/EDX images before (left) and after (right) an ageing process for A varistors.**

The influence of the ageing process on the studied samples was investigated through differences in microstructural properties and changes in chemical. Table 4 summarizes the chemical composition of samples after 1 and 50 impulses. For A, B and C varistors an ageing process cause a decrease of a concentration of a Sb and a Bi, which may be a result of the evaporation of these elements due to a Joule's heat generated during impulses. The potential losses of Bi and Sb result from their volatility and relatively low melting temperatures and may be of great importance for electric parameters of studied

materials. The opposite tendency may be observed in case of D sample, however it is probably a result of inhomogeneity of a precursor mixture. This hypothesis agree with a spread of electrical characteristics of D varistors. In Fig. 12 exhibited the comparison of SEM images and EDS mapping for A sample before and after ageing (data for other varistors are presented in Fig. S4 of the ESI). In the case of sample after 50 impulses the additional elements are more concentrated due to recrystallization process which led to a growth of grain boundaries. Additionally the ZnO grains stay similar to that before multiple lighting impulse currents, which is generally in line with our earlier results.
