## RESEARCH ARTICLE

# Quality Assessment of Low Voltage Surge Arresters

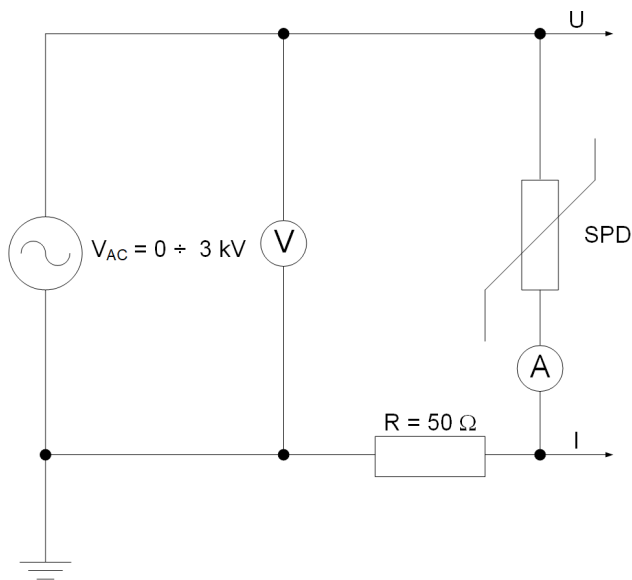
**FIGURE 2.** A scheme of test stand for leakage current measurements.

- total leakage current  $I_{LCT}$  and its resistive component ( $I_{LCR}$ ) at the highest continuous operating voltage  $U_C$  according to Table 1 measured at test stand from Fig.2.

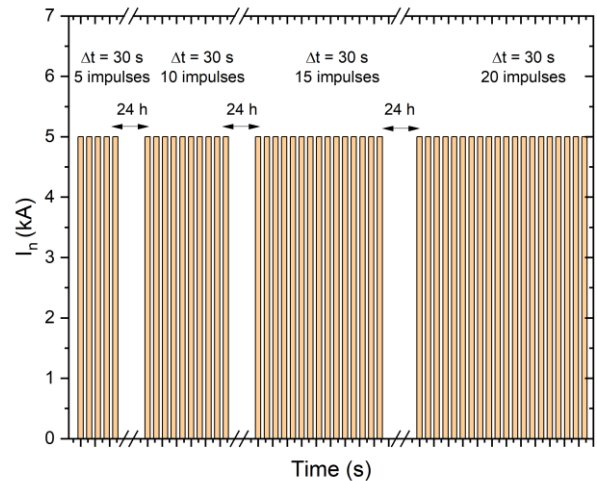
**FIGURE 3.** A procedure of aging of surge arresters.

Additionally, an aging process of the arresters was performed for a random samples of each manufacturer (1 out of 10 items). We deliberately applied a series of current surges up to 50 (5 strokes, 10 strokes, 15 strokes, 20 strokes, surge  $8/20 \mu\text{s}/\mu\text{s}$ ) following the procedure shown in Fig.3. The duration between impulses was  $\Delta t = 30 \text{ s}$  and its maximum current was equal  $I_n = 5 \text{ kA}$ . The 24 hour interval between each series of impulses was applied to avoid damage to the

surge arresters due to overheating. The electrical parameters of aged samples were checked by measurements of the leakage current (and additionally its active component) and the varistor voltage  $U_{1mA}$ .

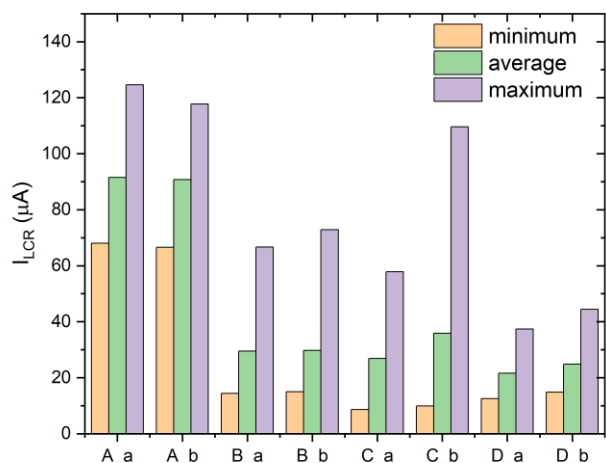
**FIGURE 6.** Statistical values of the active component of the leakage current (minimum, average and maximum values) for a different samples of LV surge arresters before (a) and after (b) an aging process.

The analysis of the resistive component of the leakage current, which is presented in Fig. 6 clearly indicates the highest values in the case of product A, which may cause greater heating of this limiter in the steady state and indirectly affect its current-voltage characteristics. The divergence between A samples and others manufacturers products may be a result of a different insulation method of these surge arresters. The analysis of the  $I_{LCR}$  value before and after the application of the current surge shows the greatest stability of the B population, where there was a slight increase in the statistical parameters of the resistance component compared to C and D (greater value change). A reverse trend was observed

for product A, as the values of the resistance component slightly decreased, which may be due to the stabilization of the parameters of samples with a significant leakage current.
