# HEALTH MONITORING OF A COMPRESSION IGNITION ENGINE FED WITH DIFFERENT LOW-SULPHUR MARINE FUELS BY ENDOSCOPIC IMAGE PROCESSING AND ANALYSIS

Zbigniew Korczewski\*

Gdansk University of Technology, Poland

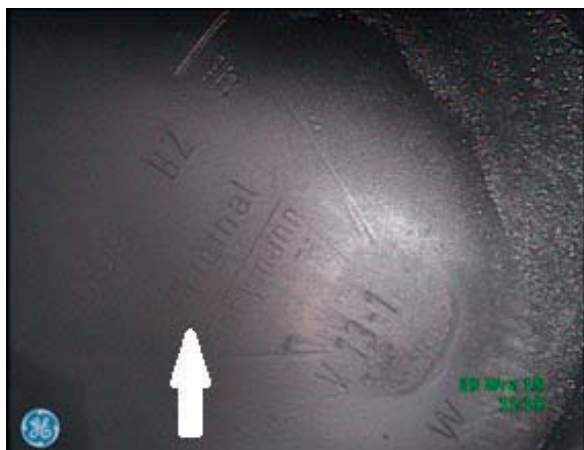
a) Piston head with visible identification number

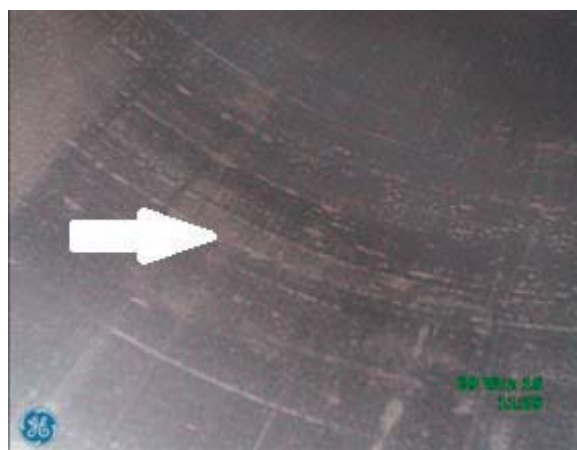
b) Cylinder sliding surface in the vicinity of BDC – traces of abrasive wear, no traces of the liner 'honing'

- the presence of longitudinal traces of slight abrasive wear of the cylinder liners
- (microslicings, scratchings, ploughings);
- the presence of small surface defects on the piston crown (mainly scratchings);
- slight deposits of impurities (mainly soot) on the bottom plate of the cylinder head, as well
- as on the surfaces of the cylinder's intake and exhaust valve heads.

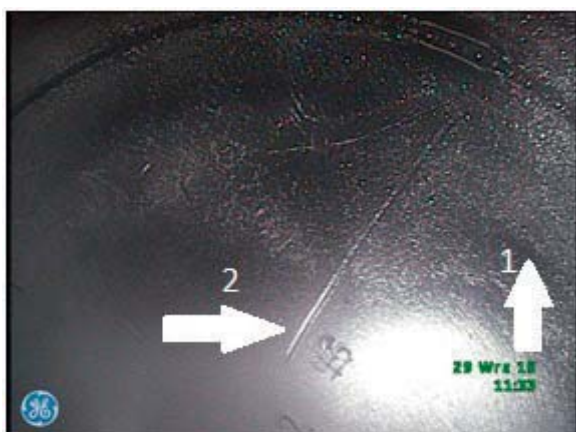
c) Piston crown – visible traces of carbon deposits (1) and scratches on the surface (2)

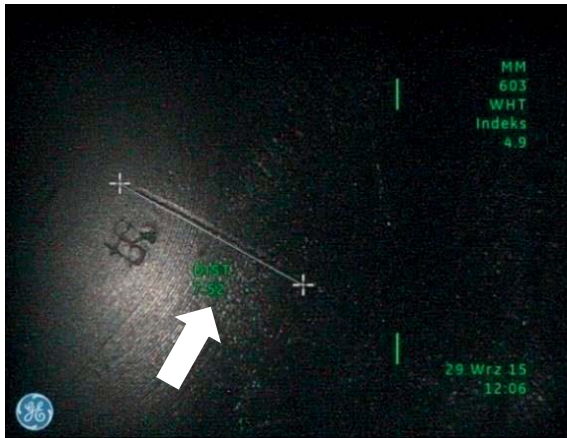
e) Measurement of the scratch length on the piston crown made by the 'Shadow' method – 7.52 mm, with an accuracy index of 4.9, corresponding to an absolute error of 0.3 mm

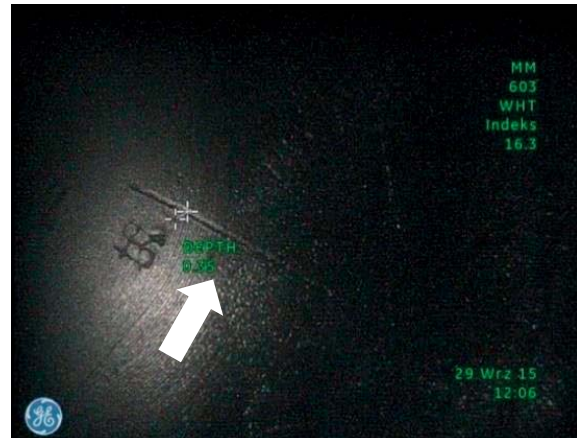
f) Measurement of the scratch depth on the piston crown made by the 'Shadow' method – 0.35 mm, with an accuracy index of 16.3, corresponding to an absolute error of 0.1 mm

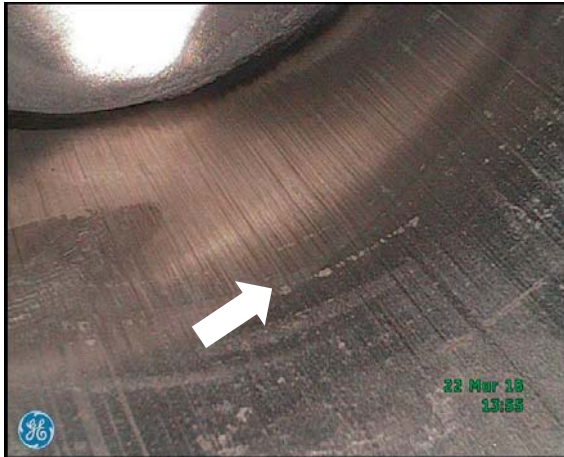
a) Cylinder surface in the lower part of the liner – traces of abrasive and erosive wear, no visible traces of honing of the liner

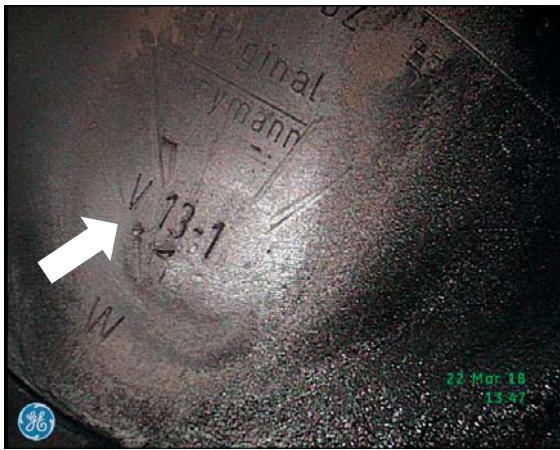
c) Piston crown – identification numbers visible

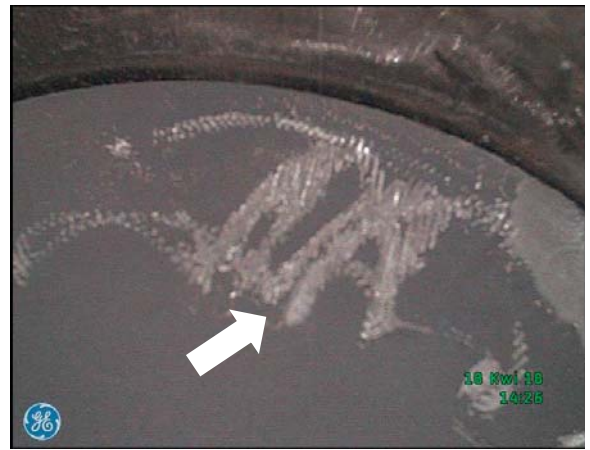
an increased amount of soot and ash is evident on the piston crown, bottom plate of the cylinder head and valve heads (Fig. 8). These are unambiguous symptoms of an incorrect fuel dose or injection advance angle, which indicate the need for engine adjustment. However, no additional surface defects were detected and earlier traces of abrasive, corrosive and erosive wear identified on the cylinder liner surface (i.e. at the beginning of the research engine operation) were conservative. Interestingly, the working space of the engine was self-cleaned of soot after switching to a different type of low-sulphur residual RMG380 marine fuel, with significantly lower chemical emissivity of exhaust gases [5] (Fig. 9). The registered results of the engine's endoscopic examinations were verified during direct inspection of its working space, after removal of the cylinder head at the end of the whole testing program for all marine fuels, see Fig. 10. The results confirmed the satisfactory technical condition of the engine, without any symptoms of destructive impacts on its structure from any of the tested low-sulphur marine fuels (apart from carbon deposits).

d) Piston crown – thick layer of soot, identification numbers not visible (visible trace after moving the video endoscope probe)

On the basis of the results recorded from the endoscopic examinations of the laboratory diesel engine after the completion of the entire testing program for low-sulphur marine fuels, it can be concluded that the technical condition of the available structural elements limiting its working space is satisfactory. The condition did not undergo significant changes under the influence of changes in the elemental composition of the fuel or the additives used to improve its lubricity. Also, changes in temperature and viscosity, during the implementation of transient processes in particular (e.g. rapid changes in a fuel dose during engine running), did not result in noticeable wear of the surface layers of the available structural elements of the working space. The detected surface defects, in the form of carbon deposits, indicate the need to adjust the fuel dose and the injection advance angle.

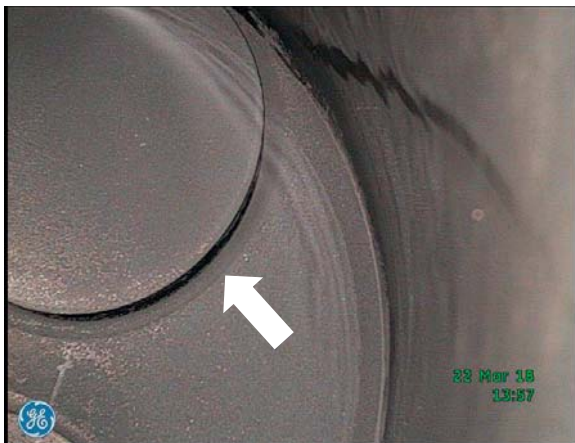
e) Bottom plate of the cylinder head – ajar outlet valve, closed inlet valve

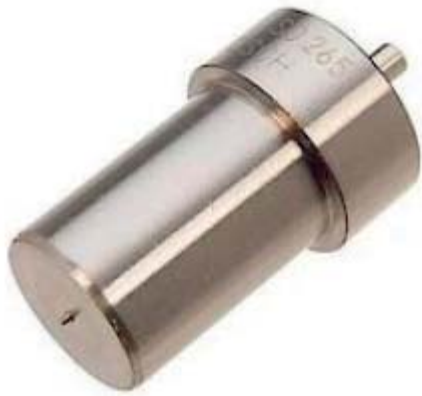
g) Fuel injector spray tip fitted immediately prior to parametric examinations

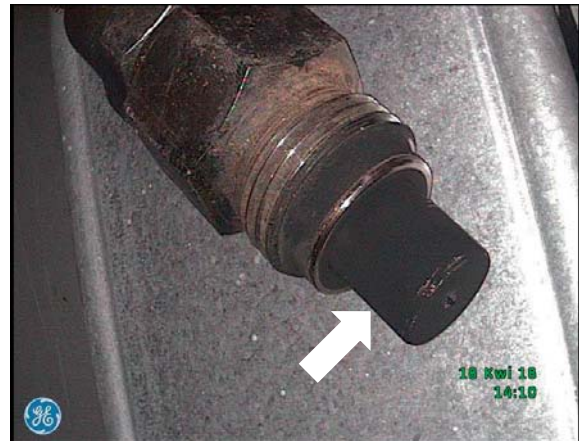
h) Fuel injector removed from the cylinder head – thick layer of soot on the spray tip

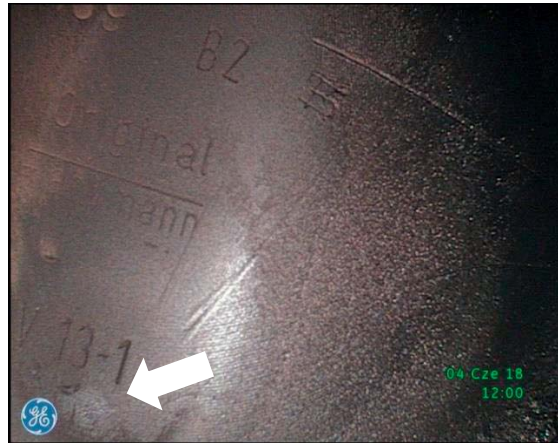
Fig. 9. Endoscopic image of the piston crown of the Farymann Diesel D10 research engine after testing RMG380 type marine fuel – surface clean, free of defects and contamination, identification numbers visible again

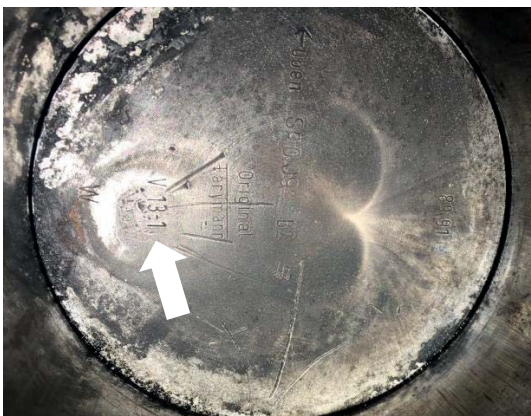
Cylinder liner closed by the piston head – clean surface, identification numbers visible

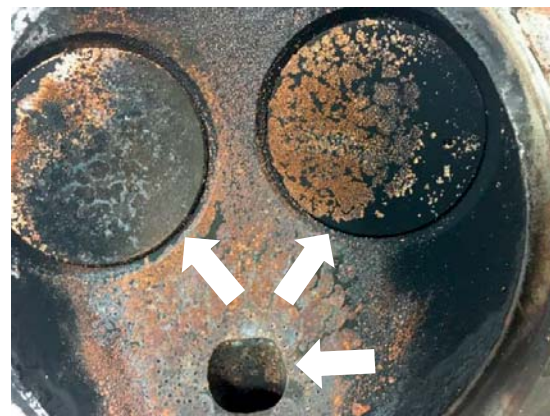
Bottom plate of the cylinder head – closed cylinder valves, a passage connecting the cylinder working space with the combustion pre-chamber, no traces of working medium leakage through the valve faces
