HEALTH MONITORING OF A COMPRESSION IGNITION ENGINE FED WITH DIFFERENT LOW-SULPHUR MARINE FUELS BY ENDOSCOPIC IMAGE PROCESSING AND ANALYSIS

This article characterises the methodology for the endoscopic testing of a laboratory diesel engine used for testing marine fuels. The 'Shadow' measurement method used in the XLG3 type EVEREST digital endoscope, for quantitative and qualitative identification of detected surface defects, was approximated. Representative endoscopic images of the elements limiting the working space of the research engine are demonstrated, having been recorded during the usable quality testing of newly produced, low-sulphur marine fuels, so-called 'modified fuels'. The main purpose of the endoscopic examinations was the final verification of the tested fuel's suitability for feeding full-size marine engines.

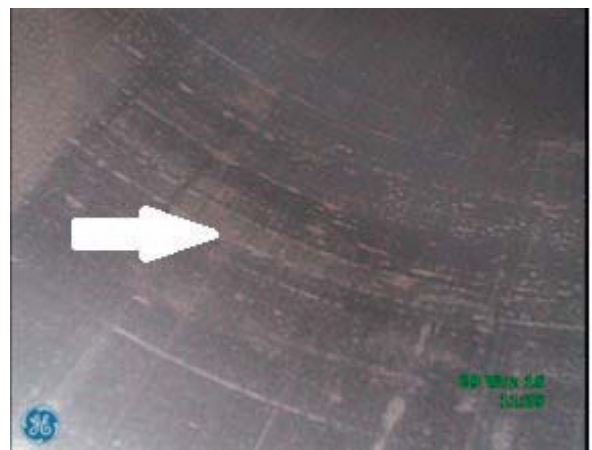
b) Cylinder sliding surface in the vicinity of BDC – traces of abrasive wear, no traces of the liner 'honing'

- the presence of longitudinal traces of slight abrasive wear of the cylinder liners
- (microslicings, scratchings, ploughings);
- the presence of small surface defects on the piston crown (mainly scratchings);
- slight deposits of impurities (mainly soot) on the bottom plate of the cylinder head, as well
- as on the surfaces of the cylinder's intake and exhaust valve heads.

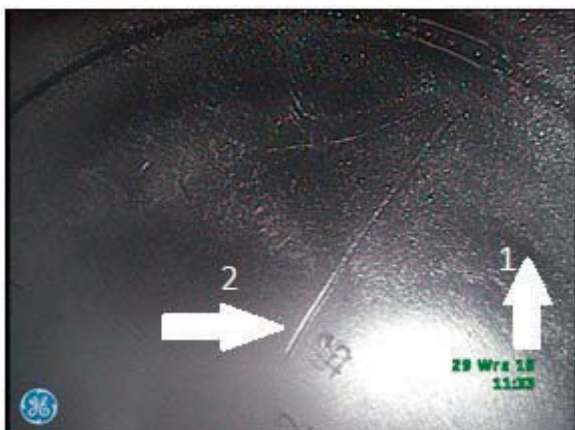
c) Piston crown – visible traces of carbon deposits (1) and scratches on the surface (2)

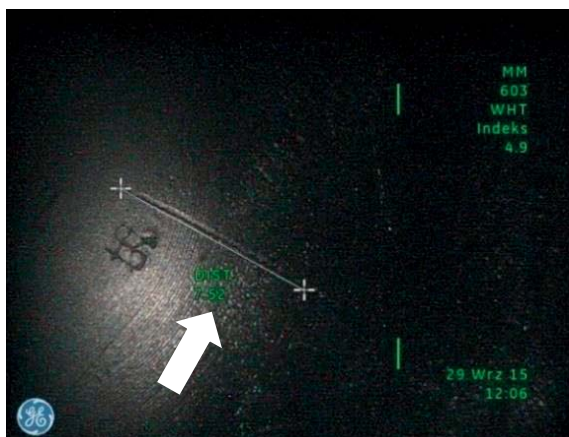
e) Measurement of the scratch length on the piston crown made by the 'Shadow' method – 7.52 mm, with an accuracy index of 4.9, corresponding to an absolute error of 0.3 mm

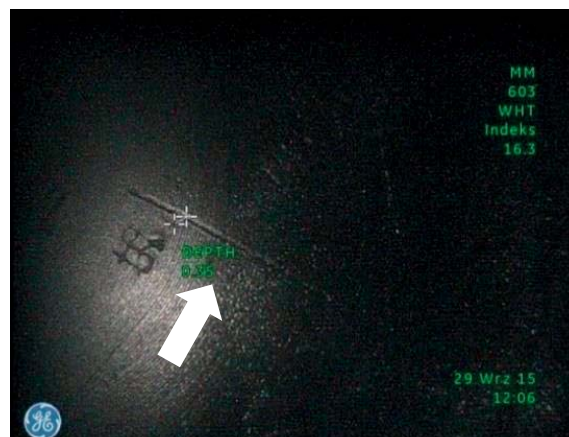
f) Measurement of the scratch depth on the piston crown made by the 'Shadow' method – 0.35 mm, with an accuracy index of 16.3, corresponding to an absolute error of 0.1 mm
