HEALTH MONITORING OF A COMPRESSION IGNITION ENGINE FED WITH DIFFERENT LOW-SULPHUR MARINE FUELS BY ENDOSCOPIC IMAGE PROCESSING AND ANALYSIS

Keywords: low-sulphur marine fuels, usable quality, engine tests, health monitoring, endoscopic examinations

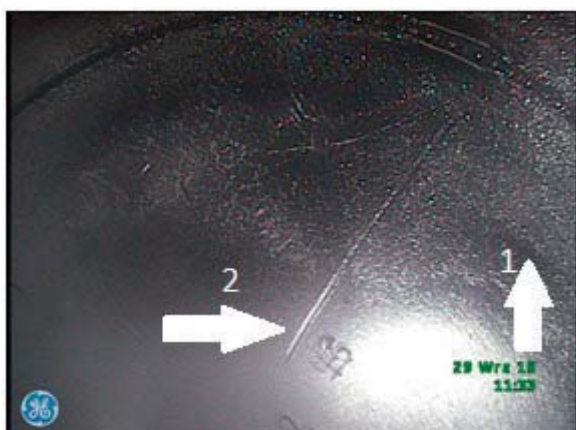
c) Piston crown – visible traces of carbon deposits (1) and scratches on the surface (2)

- the presence of longitudinal traces of slight abrasive wear of the cylinder liners
- (microslicings, scratchings, ploughings);
- the presence of small surface defects on the piston crown (mainly scratchings);
- slight deposits of impurities (mainly soot) on the bottom plate of the cylinder head, as well
- as on the surfaces of the cylinder's intake and exhaust valve heads.
