GUIDED WAVES IN SHIP STRUCTURAL HEALTH MONITORING – A FEASIBILITY STUDY

¹ Gdańsk University of Technology, Poland

² Universidade de Lisboa, Portugal

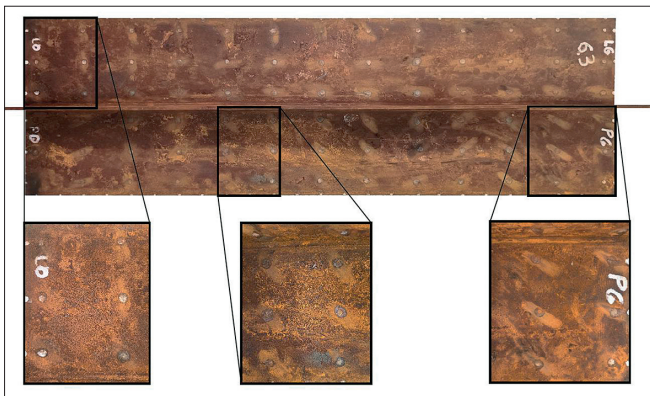
Fig. 4. Sample c12 (12% DoD): stiffener side view with close-ups of surface.

Figures 3 and 4 present photos of selected specimens. Figure 3 shows a close-up view of the intact and corroded plate surface. On the intact plate, the surface was as it arrived from the steel mill. The corroded surface was dried out and so the authors removed loose corrosion products and dusted up the surface. Figure 4 presents a stiffener side view on the c12 sample, with magnifications on given parts of the plate. Apart from specimen markings, there are visible white dots on the sample, indicating places where UT gauging was performed.
