## GUIDED WAVES IN SHIP STRUCTURAL HEALTH MONITORING – A FEASIBILITY STUDY

### ABSTRACT

**Keywords:** Corrosion, Guided Waves, Non-destructive Testing, Ship Structures

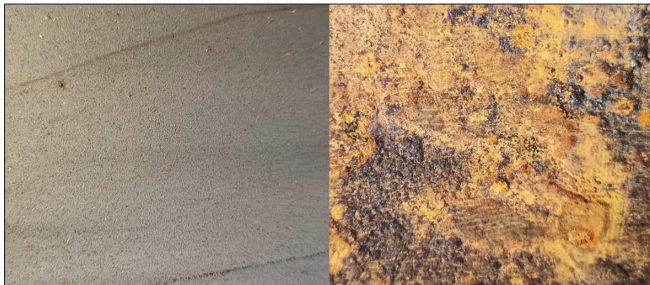
Fig. 3. Plate surface close-up. Left: intact plate. Right: c24 plate corroded and cleaned from corrosion products

Figures 3 and 4 present photos of selected specimens. Figure 3 shows a close-up view of the intact and corroded plate surface. On the intact plate, the surface was as it arrived from the steel mill. The corroded surface was dried out and so the authors removed loose corrosion products and dusted up the surface. Figure 4 presents a stiffener side view on the c12 sample, with magnifications on given parts of the plate. Apart from specimen markings, there are visible white dots on the sample, indicating places where UT gauging was performed.
