PROTECTION AND RENOVATION OF PUBLIC AREAS IN A MODERNIST CITY: THE CASE OF THREE STREETS IN THE HISTORIC CITY CENTRE OF GDYNIA

ABSTRAKT: This article concerns issues related to the preservation and restoration of public space in Gdynia's city centre, which was designed and built mainly in the 1920s and 1930s. In 2007, a major part of the city centre was entered into the register of monuments as a historic complex of urban architecture. Moreover, in 2015, the area was declared a Monument of History. Protection of a complex of urban architecture covers not only the renovation of historic buildings but also the protection of public spaces that comprise an integral part of the historic complex. Therefore, preservation of the historic shape and design of public space in the centre of Gdynia is one of the city's key conservation tasks. Since protection of urban space in relatively young historic centres (less than a hundred years old) is a novel issue from the perspective of conservation, it is therefore worth analysing. Issues connected with the protection and restoration of public space in the centre of Gdynia are exemplified by three historic streets, built in the late 1920s and loca

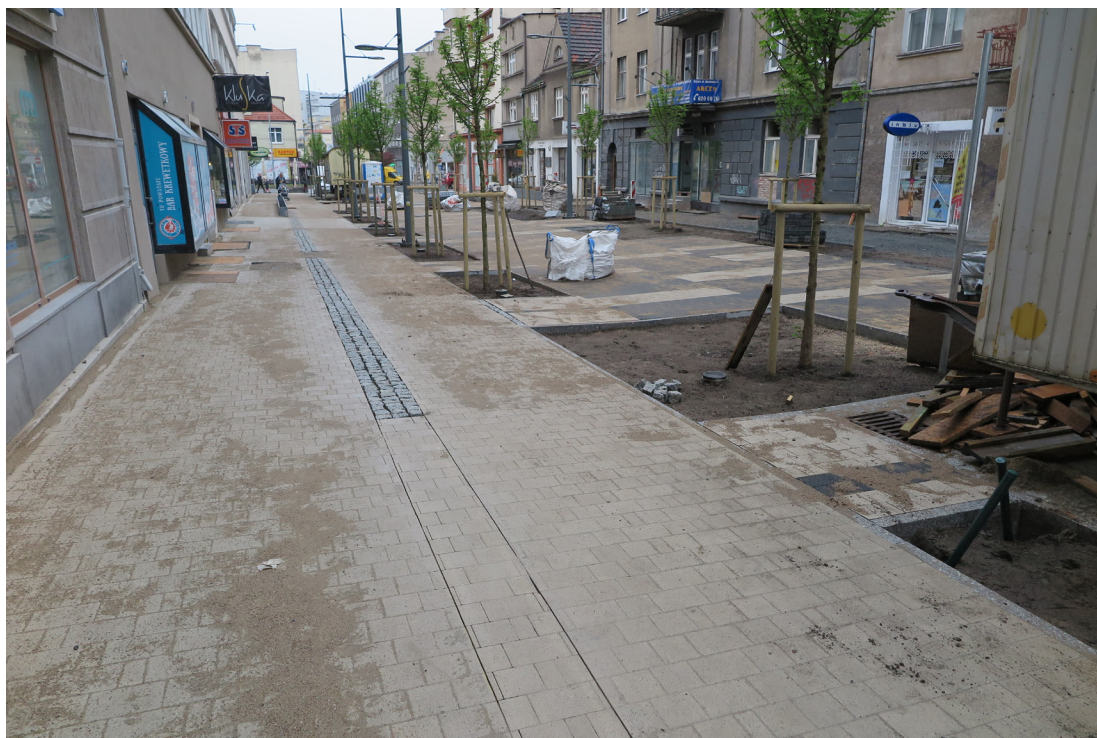
Fig. 5. Gdynia, Abraham Street, the section between Batorego Street and 10 Lutego Street, during the redevelopment into a so-called woonerf; photo from the archives of the Municipal Conservator's Office.

The described section of the street has been transformed to a high degree. No historical surfaces of roadways and pavements were preserved, and those that had been re-introduced were in poor technical condition. The road system was significantly changed due to the introduction of parking spaces. Moreover, since cars would park on the pavements, technical bollards of low aesthetic value were installed to prevent this. Lone trees in poor condition were the only remnants of the street's historic arrangement.

city authorities to cover, among others, the reconstruction of underground installations.¹³ The project intended to create a so-called *woonerf*, i.e. the first shared space in Gdynia where priority would be given to pedestrians and cyclists. A new surface with geometric patterns, made of two-coloured concrete slabs of various size (fig. 6), replaced the separation of the roadway and pavements (fig. 5). Car traffic was limited to a narrow lane in the middle of the street, and the speed limit was reduced to 20 km/h. Such reorganization of space facilitated the introduction of much greenery and many outdoor catering facilities. Additional street furniture was installed, including benches, bicycle racks and modern lamps. The project had to meet the accessibility standards of the city of Gdynia (Wysocki, 2013). Accordingly, directional guiding and warning systems were added to the pavements, and either they were adjusted to the level of house thresholds or ramps were built allowing unrestricted use of commercial premises located on the ground floor.¹⁴ The investment was commissioned in June 2019.
