PROTECTION AND RENOVATION OF PUBLIC AREAS IN A MODERNIST CITY: THE CASE OF THREE STREETS IN THE HISTORIC CITY CENTRE OF GDYNIA

ABSTRAKT: This article concerns issues related to the preservation and restoration of public space in Gdynia's city centre, which was designed and built mainly in the 1920s and 1930s. In 2007, a major part of the city centre was entered into the register of monuments as a historic complex of urban architecture. Moreover, in 2015, the area was declared a Monument of History. Protection of a complex of urban architecture covers not only the renovation of historic buildings but also the protection of public spaces that comprise an integral part of the historic complex. Therefore, preservation of the historic shape and design of public space in the centre of Gdynia is one of the city's key conservation tasks. Since protection of urban space in relatively young historic centres (less than a hundred years old) is a novel issue from the perspective of conservation, it is therefore worth analysing. Issues connected with the protection and restoration of public space in the centre of Gdynia are exemplified by three historic streets, built in the late 1920s and loca

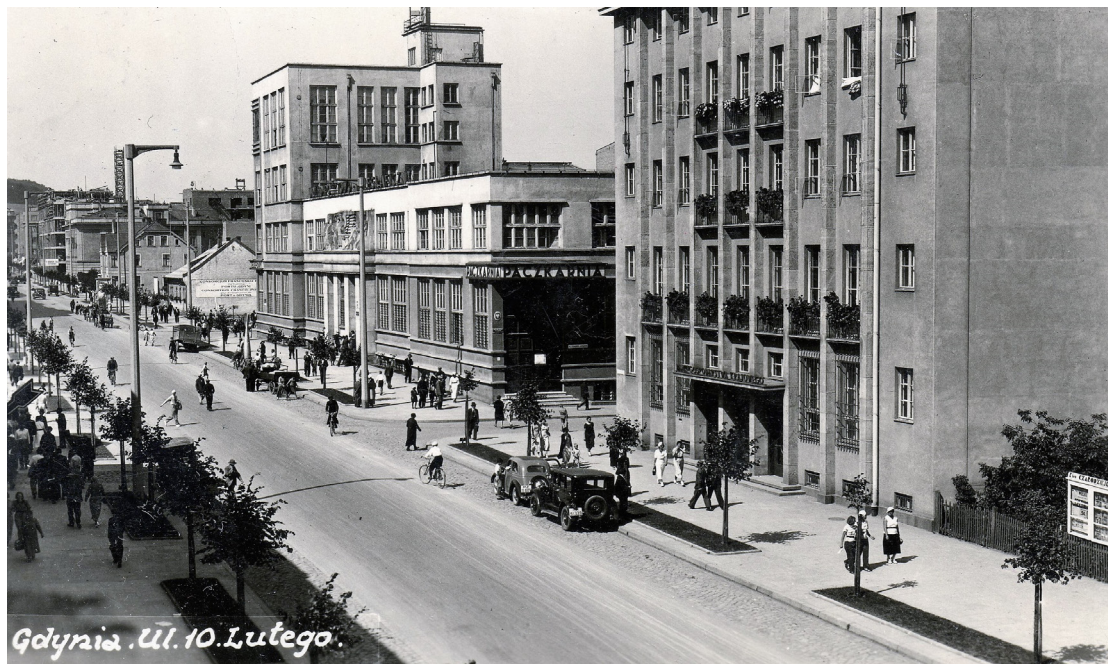
Fig. 1. Gdynia, 10 Lutego Street, the arrangement of the street in the second half of the 1930s; photo from private archives.

10 Lutego Street was arranged in place of Aleja Kuracyjna, which was planned at the beginning of the twentieth century to link the railway station and the beach. In the 1930s, 10 Lutego Street became one of the main compositional axes of the early modernist city centre (fig. 1). The width of the former avenue was then increased to 28 m. The street was laid out using a combination of modern bituminous surface and side lanes of cobblestones with curbs made of longitudinal basalt bricks. Cobblestone lanes were intended for the traffic of vehicles without tires, and as parking lanes (fig. 2). Rows of linden trees were introduced on both sides of the street. Encased in concrete enclosures, the trees were planted in twos, in regular square lawns.
