Finite Element Analysis of Occupant Risk in Vehicular Impacts into Cluster Mailboxes

Abstract: The deployment of cluster mailboxes (CMs) in the U.S. has raised safety concerns for passengers in potential vehicular crashes involving CMs. This study investigated the crashworthiness of two types of CMs through nonlinear finite element simulations. Two configurations of CM arrangements were considered: a single- and a dual-unit setup. These CM designs were tested on flat-road conditions with and without a curb. A 2010 Toyota Yaris and a 2006 Ford F250, both in compliance with the Manual for Assessing Safety Hardware (MASH), were employed in the analysis. The simulations incorporated airbag models, seatbelt restraint systems, and a Hybrid III 50th percentile adult male dummy. The investigations focused on evaluating the safety of vehicle occupants in 32 impact scenarios and under MASH Test Level 1 conditions (with an impact speed of 50 km/h). The simulation results provided insights into occupant risk and determined the primary failure mode of the CMs. No components of the mailboxes were found intruding into the vehicle's occupant compartment. For all considered cases, the safety facto

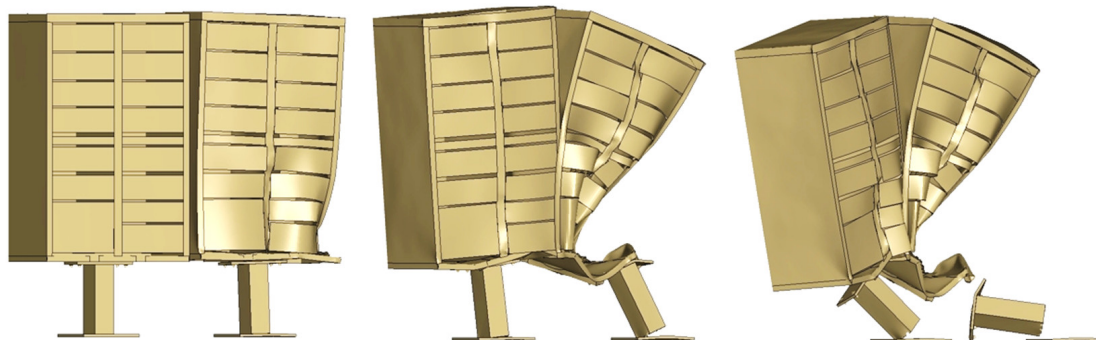
Figure 17. Sequential deformation of the dual-unit Type IV CM impacted by Toyota Yaris at 25° and at the nearest corner on a flat road. Time steps shown are 20, 80, and 120 ms.

Figure 17 shows the progressive structural deformation and damage of the dual-unit Type IV CM under impact of Toyota Yaris at a 25-degree angle at the nearest corner.

The initial phase of the impact generated high stress concentrations at the base of the pedestal columns and localized bending at the lower part of the CM upper unit. As the deformation progressed, the support columns underwent significant plastic deformation and failed at the base. This compromised the structural stability of the system and triggered a cascade of failures in the upper units. The main body of the CM experienced asymmetric crushing and folding, particularly in the regions directly under impact. Vertical panels displayed outward deformation due to axial compression, while horizontal panels exhibited bending and folding, forming localized plastic hinges.

The upper units of the CM exhibited progressive panel buckling and structural separation. The interaction between the vehicle and the CM caused a redistribution of forces, resulting in further deformation of the attachment points at the base and eventually rendering the unit detached from its foundation. Under impact by the Ford F250, the upper bodies of both units separated from the pedestals, and the vehicle ran over the second unit's pedestal while pushing the upper body forward, causing a large V-shaped dent on the hood of the Ford F250.
