# Finite Element Analysis of Occupant Risk in Vehicular Impacts into Cluster Mailboxes

**Abstract:** The deployment of cluster mailboxes (CMs) in the U.S. has raised safety concerns for passengers in potential vehicular crashes involving CMs. This study investigated the crashworthiness of two types of CMs through nonlinear finite element simulations. Two configurations of CM arrangements were considered: a single- and a dual-unit setup. These CM designs were tested on flat-road conditions with and without a curb. A 2010 Toyota Yaris and a 2006 Ford F250, both in compliance with the Manual for Assessing Safety Hardware (MASH), were employed in the analysis. The simulations incorporated airbag models, seatbelt restraint systems, and a Hybrid III 50th percentile adult male dummy. The investigations focused on evaluating the safety of vehicle occupants in 32 impact scenarios and under MASH Test Level 1 conditions (with an impact speed of 50 km/h). The simulation results provided insights into occupant risk and determined the primary failure mode of the CMs. No components of the mailboxes were found intruding into the vehicle's occupant compartment. For all considered cases, the safety

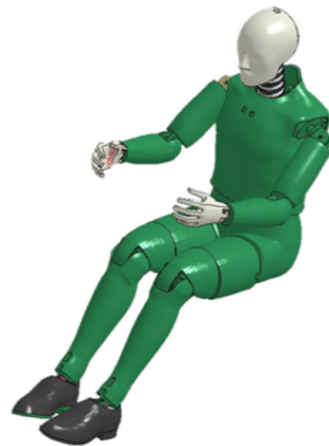
The 50<sup>th</sup> percentile Hybrid III male dummy, as shown in Figure 3, weighed 79.86 kg in the FE model. This dummy model was initially developed by the Livermore Software Technology Corporation, Livermore, CA, USA; it had a total of 349 components, 228,706 nodes, and 338,506 elements (including 186,808 solid, 151,455 shell, 242 beam, and 1 discrete element). Accelerometers were defined in the dummy model at the head, chest, spine, abdomen cavity, pelvis, knees, and ankles to collect acceleration data for safety evaluation. This crash test dummy was positioned into the two vehicles used in this study (see Section 2.1) following NHTSA's guidelines for crash testing, which stipulated that the right and left hands of the dummy be placed on the steering wheel.

**Figure 3.** FE model of a 50<sup>th</sup> percentile Hybrid III male dummy.

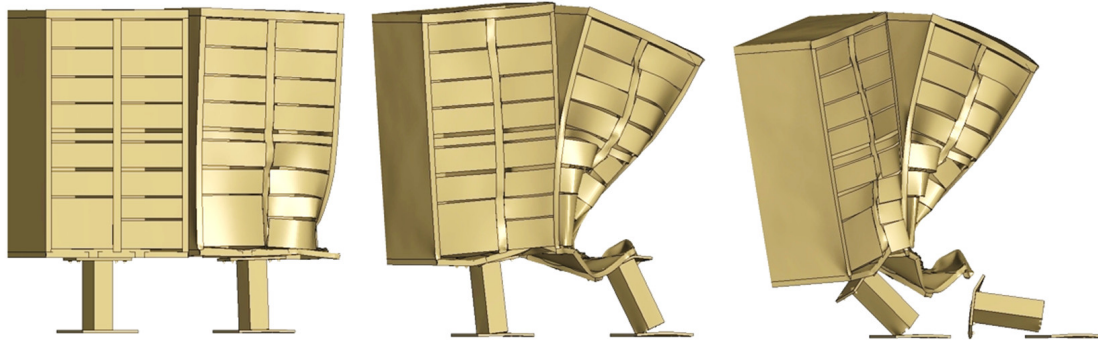
Figure 17 shows the progressive structural deformation and damage of the dual-unit Type IV CM under impact of Toyota Yaris at a 25-degree angle at the nearest corner.

**Figure 17.** Sequential deformation of the dual-unit Type IV CM impacted by Toyota Yaris at 25° and at the nearest corner on a flat road. Time steps shown are 20, 80, and 120 ms.

The initial phase of the impact generated high stress concentrations at the base of the pedestal columns and localized bending at the lower part of the CM upper unit. As the deformation progressed, the support columns underwent significant plastic deformation and failed at the base. This compromised the structural stability of the system and triggered a cascade of failures in the upper units. The main body of the CM experienced asymmetric crushing and folding, particularly in the regions directly under impact. Vertical panels displayed outward deformation due to axial compression, while horizontal panels exhibited bending and folding, forming localized plastic hinges.

The upper units of the CM exhibited progressive panel buckling and structural separation. The interaction between the vehicle and the CM caused a redistribution of forces, resulting in further deformation of the attachment points at the base and eventually rendering the unit detached from its foundation. Under impact by the Ford F250, the upper bodies of both units separated from the pedestals, and the vehicle ran over the second unit's pedestal while pushing the upper body forward, causing a large V-shaped dent on the hood of the Ford F250.
