TECHNOLOGICAL CONSIDERATIONS OF PERIODIC REPAIR WORKS OF CONCRETE INDUSTRIAL FLOORS

The paper presents a collection of practical information related to conducting periodic repair work on concrete industrial floors. The article is a case study and addresses specific situations related to the loss of serviceability of concrete industrial floors.

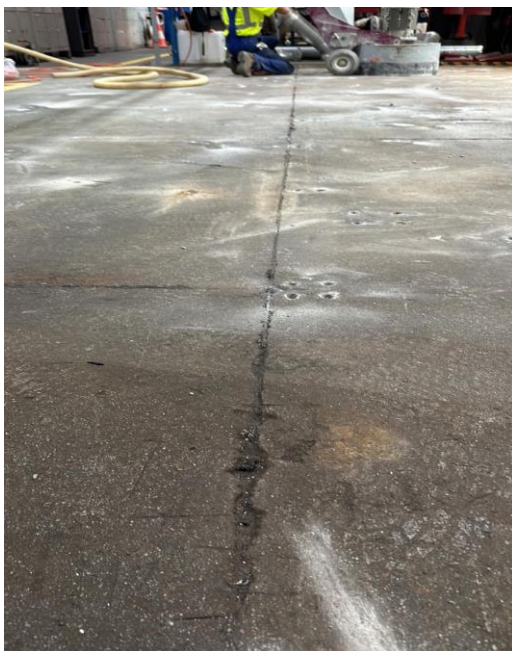
Example 1 is a floor in several years of use, located in a manufacturing plant in a section for welding steel components (Fig.2, Fig. 3).

Fig. 2. Degraded concrete industrial floor (Example 1): visible wear of the top layer, mounting anchors left over from equipment removal, and shrinkage joint damage [38]

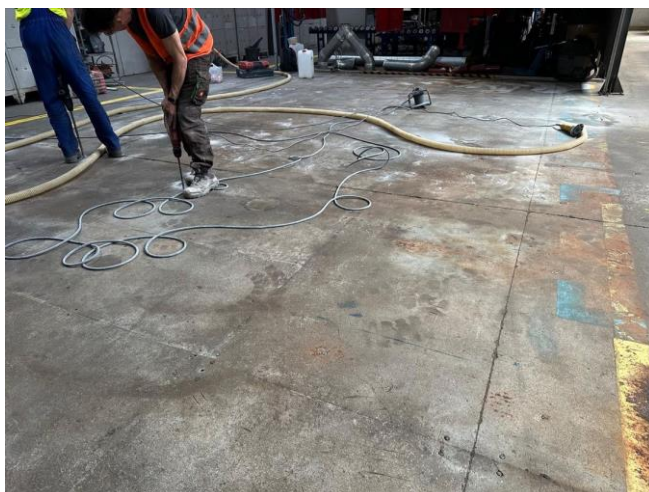
Fig. 3. Degraded concrete industrial floor (Example 1) during repair: damage inventory, removal of mounting anchors [38]

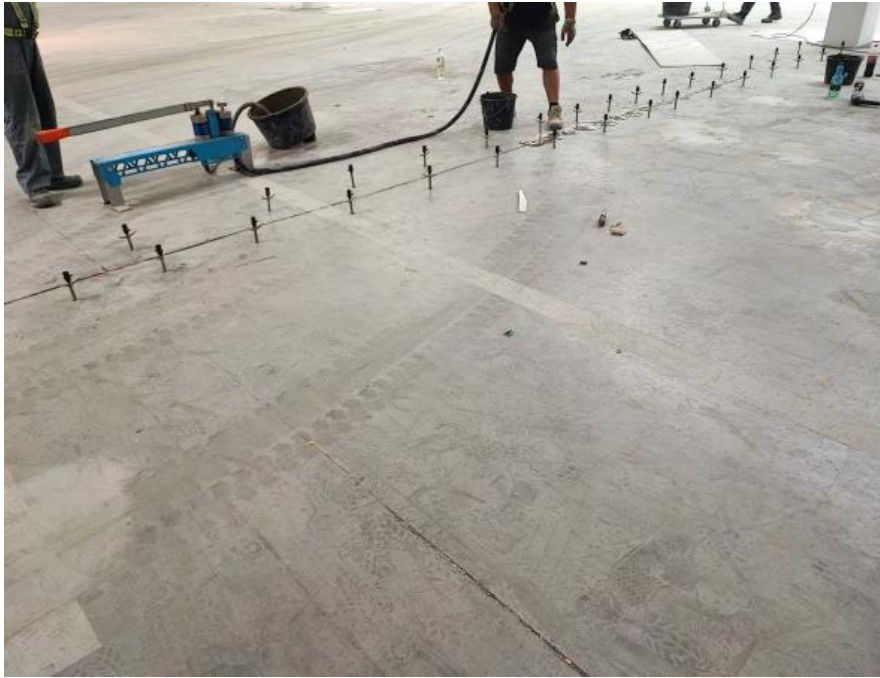
Fig. 16. Concrete industrial floor (Example 4) during repair: installation of packers and feeding of cement injection with a pump [38]

Control packers are made in the central part of the slab to monitor the consumption of the injectant (Fig.16). Then, through the drilled holes secured by the packers, the mineral cementitious liquid mass was applied using an injection pump.

The liquid cement paste fills the space between the lower edge of the floor, and the upper surface of the substructure. Manual control of the pressure and consumption of the material during application allows even filling of free spaces in the lower layers of the substrate and substructure under the floor.
