# Cavitation behaviour of the SUPERSTON alloy after laser treatment

**Purpose:** Results of laser treatment at cryogenic conditions and its influence on microstructure, microhardness and cavitation resistance of the SUPERSTON alloy are presented in this paper.

**Design/methodology/approach:** New method of the laser remelting specimens dipped in liquid nitrogen made by the CO<sub>2</sub> laser with 4000 W laser beam power and scanning velocity 0.5 and 1.0 m/min was employed. Observation microstructure was carried out by scanning electron microscope. Hardness of cross-section of the surface layer has been measured by the Vickers microhardness under load 0.49 N. Cavitation test in the water using rotating disc facility was done.

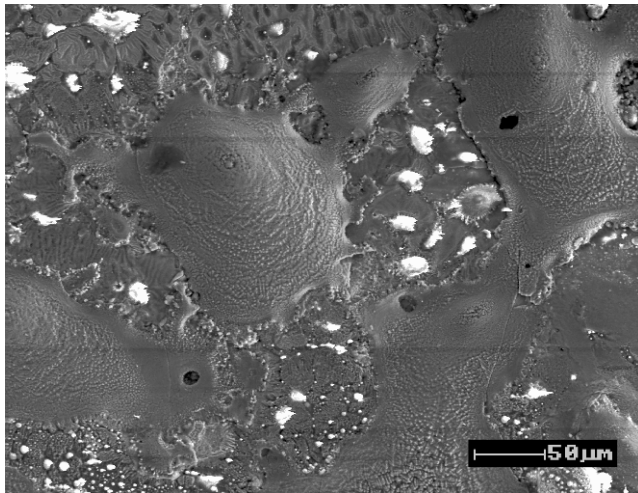
Fig. 1. Surface microstructure of laser remelted the SUPERSTON alloy (4000W, 0.5m/min)

Surface morphology of the SUPERSTON alloy remelted with 4000 W power, scanning velocity 0.5 and 1.0 m/min is presented in Figs 1 and 2.

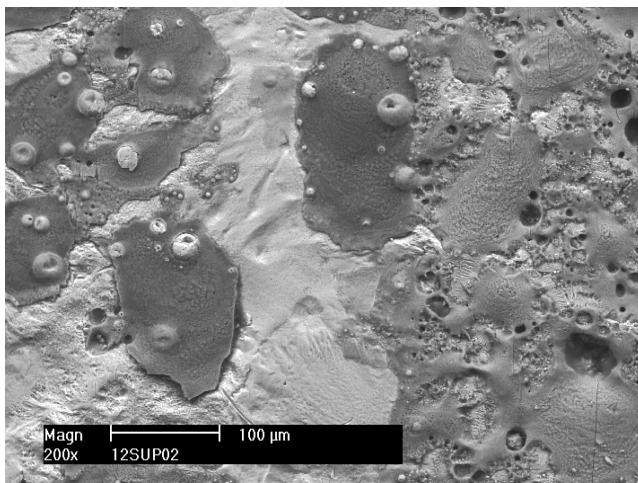
Fig. 2. Surface microstructure of laser remelted the SUPERSTON alloy (4000W, 1.0m/min)

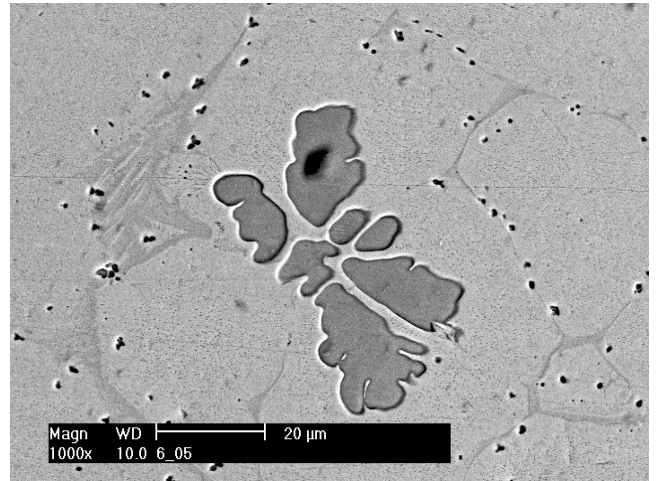
Fig. 3. Microstructure of the casted the SUPERSTON alloy

Microstructure of casted and remelted the SUPERSTON alloy is shown in Figs 3 and 4. Microstructure of the SUPERSTON alloy as coating consist of  $\alpha$  phase, eutectoid mixture and manganese-iron phase (Fig. 3). After laser remelting fine microstructure without cracks in the surface layer is observed. (Fig. 4).

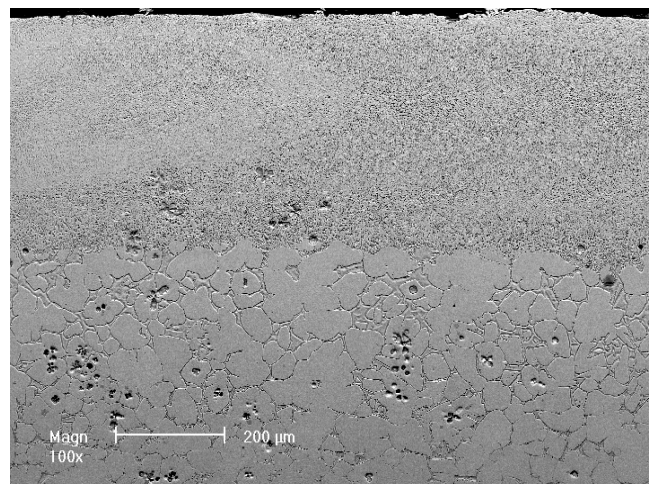
Fig. 4. Cross section microstructure of remelted the SUPERSTON alloy

Average thickness of the remelted layer is about 300 $\mu$ m and demonstrate a structural connection with base material (Fig. 4).

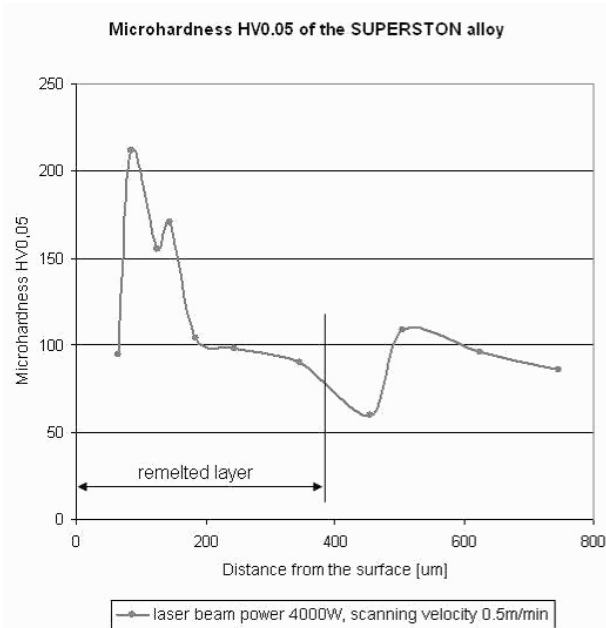
Fig. 5. Microhardness in cross-section of laser remelted layer of the SUPERSTON alloy (4000W, 0.5m/min)

Microhardness in the remelted layer of the SUPERSTON alloy made by the Vickers method under load 0.49 N.

Results of the microhardness measurements are presented in Figs 5 and 6.

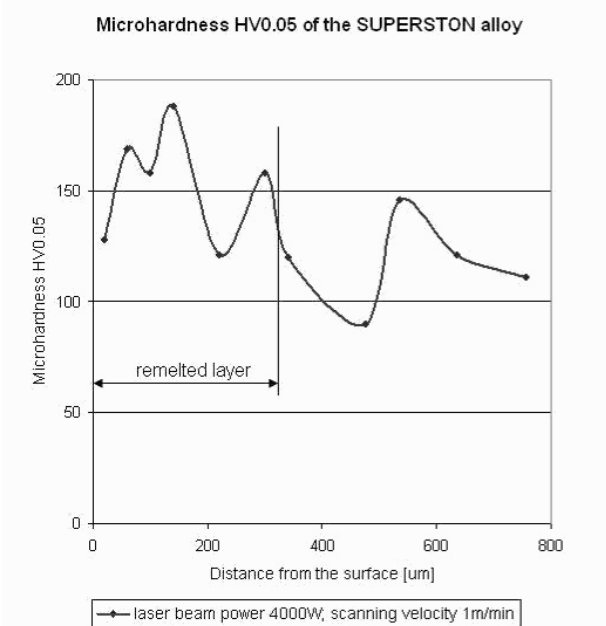
Fig. 6. Microhardness in cross-section of laser remelted layer of the SUPERSTON alloy (4000W, 1.0 m/min)

Laser remelting caused the increase hardness of the SUPERSTON alloy to 200 HV 0.05.

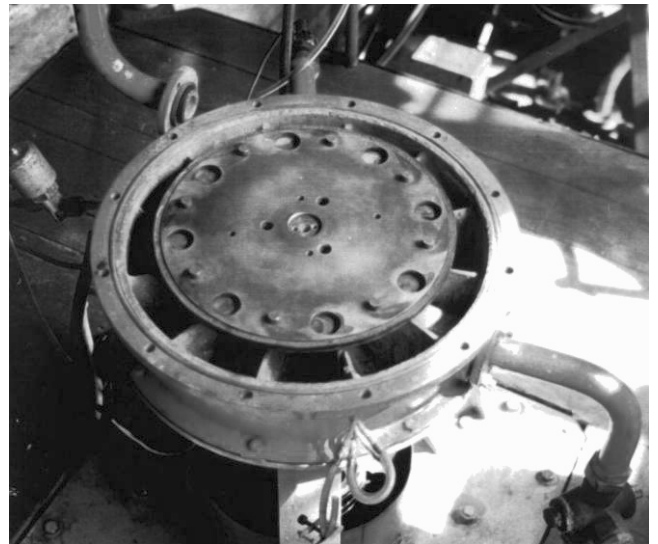
Fig. 7. The rotating disc facility for measurements of cavitation resistance

Cavitation test in the water (average temperature 20°C) was performed at rotating disc facility (Fig. 7). During the cavitation process the kinetics of the mass loss was determined.

The cavitation resistance test of the SUPERSTON alloy after laser remelting at cryogenic conditions was performed at the rotating disc facility Fig. 7.

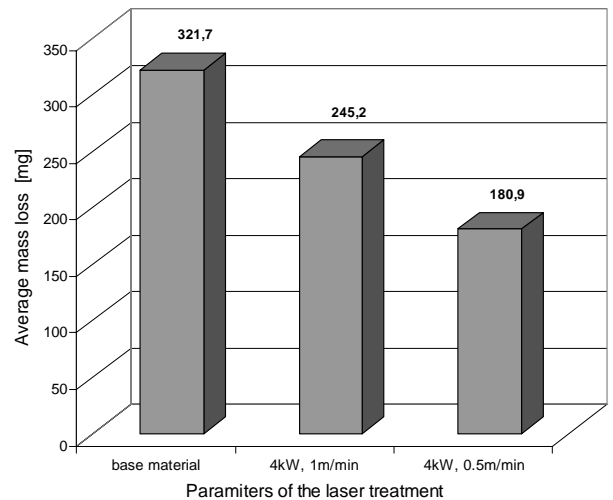
Fig. 8. Average mass loss of the SUPERSTON alloy remelted in the different conditions

Average mass loss of the specimens after 5.25h of the cavitation test is presented in Fig. 8.

Most beneficial increase of cavitation resistance (about 30%) obtained for laser remelting the SUPERSTON alloy with 4000 W power and 0.5 m/min scanning velocity.

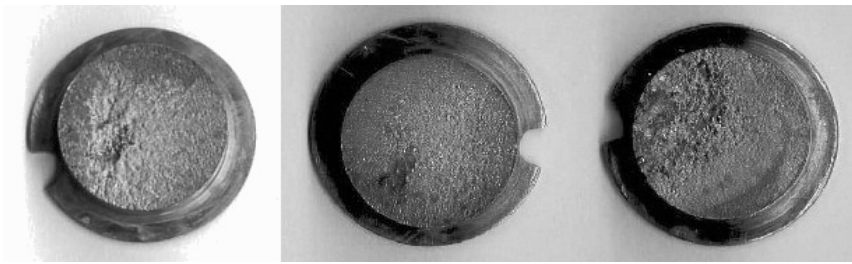
Fig. 9. Surface of the SUPERSTON alloy after cavitation test by 5.25h: a) 4000W, 0.5m/min; b) 4000W, 1.0m/min; c) base material - as casting

View of the base material and laser remelted specimens made of the SUEPRESTON alloy after cavitation test is shown in Fig. 9.
