**A. Zieliński, A. Dziadoń<sup>1</sup>, W. Serbiński, M. Jażdżewska**

Gdańsk University of Technology, Faculty of Mechanical Engineering, Department of Materials Science and Engineering, Gdansk, Poland,

## **SURFACE CRACKING OF LASER MELTED Ti-6Al-4V ALLOY**

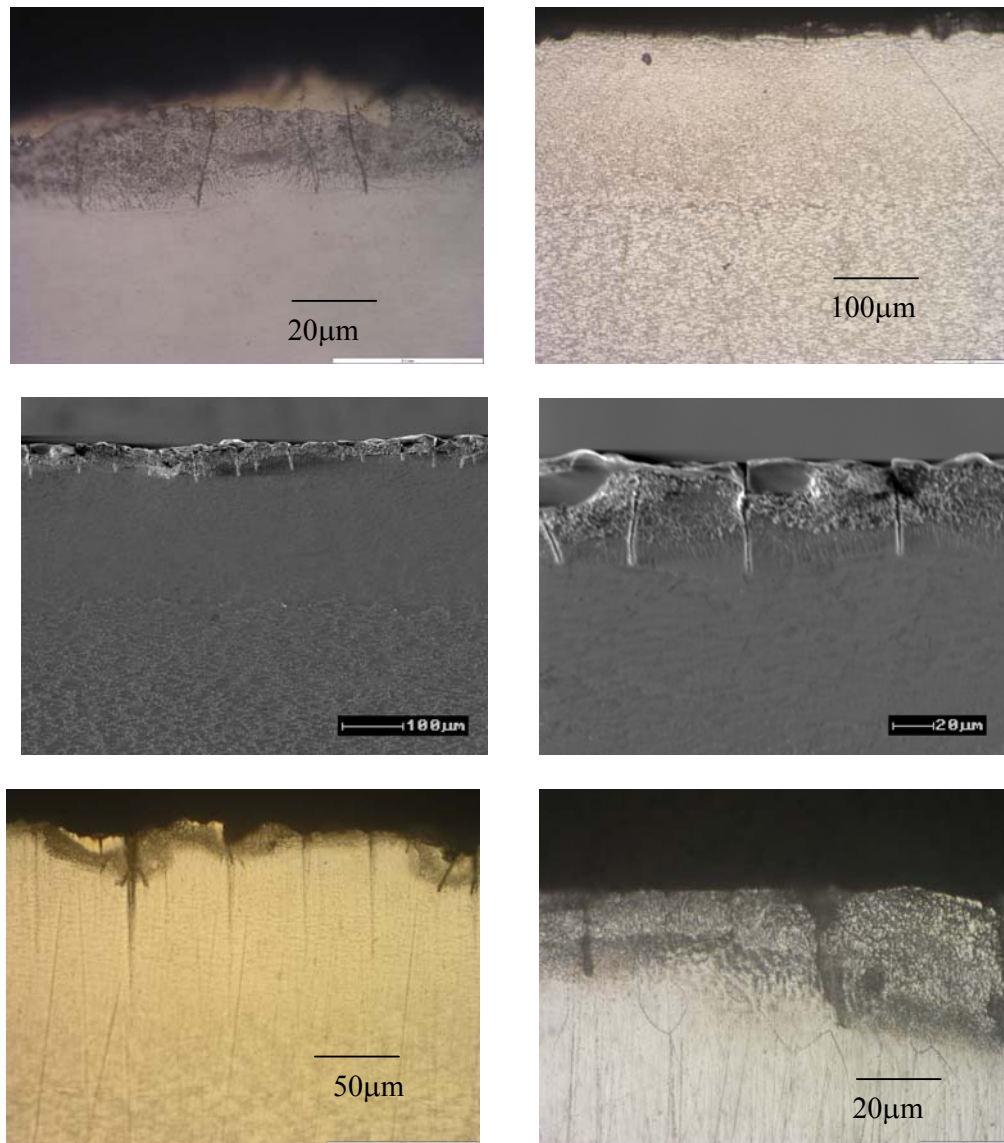
**Fig. 1.** Cracking of surface layers for specimens laser melted with CO<sub>2</sub> laser in liquid nitrogen at scan rate 1 m/min at power input (from top to the bottom): 3 kW, 4 kW, 5 kW and 6 kW

The results of performed tests are shown in Figs. 1-4. For every combination of tests parameters the view of the melted surface and cross-section are put together.

The cracks are evident to form at each condition. The depth of the crack is dependent on all variables. Generally, the higher power input and the lower scan rate, the longer cracks. The environment has also an effect: cracks are more significant during laser treatment in air and water. Pre-heating diminishes the cracking. The depth of the crack is always a significant portion of the melted zone and from this point of view, the laser melting in liquid nitrogen seems the most appropriate. The quantitative data are estimated and will be published in future.

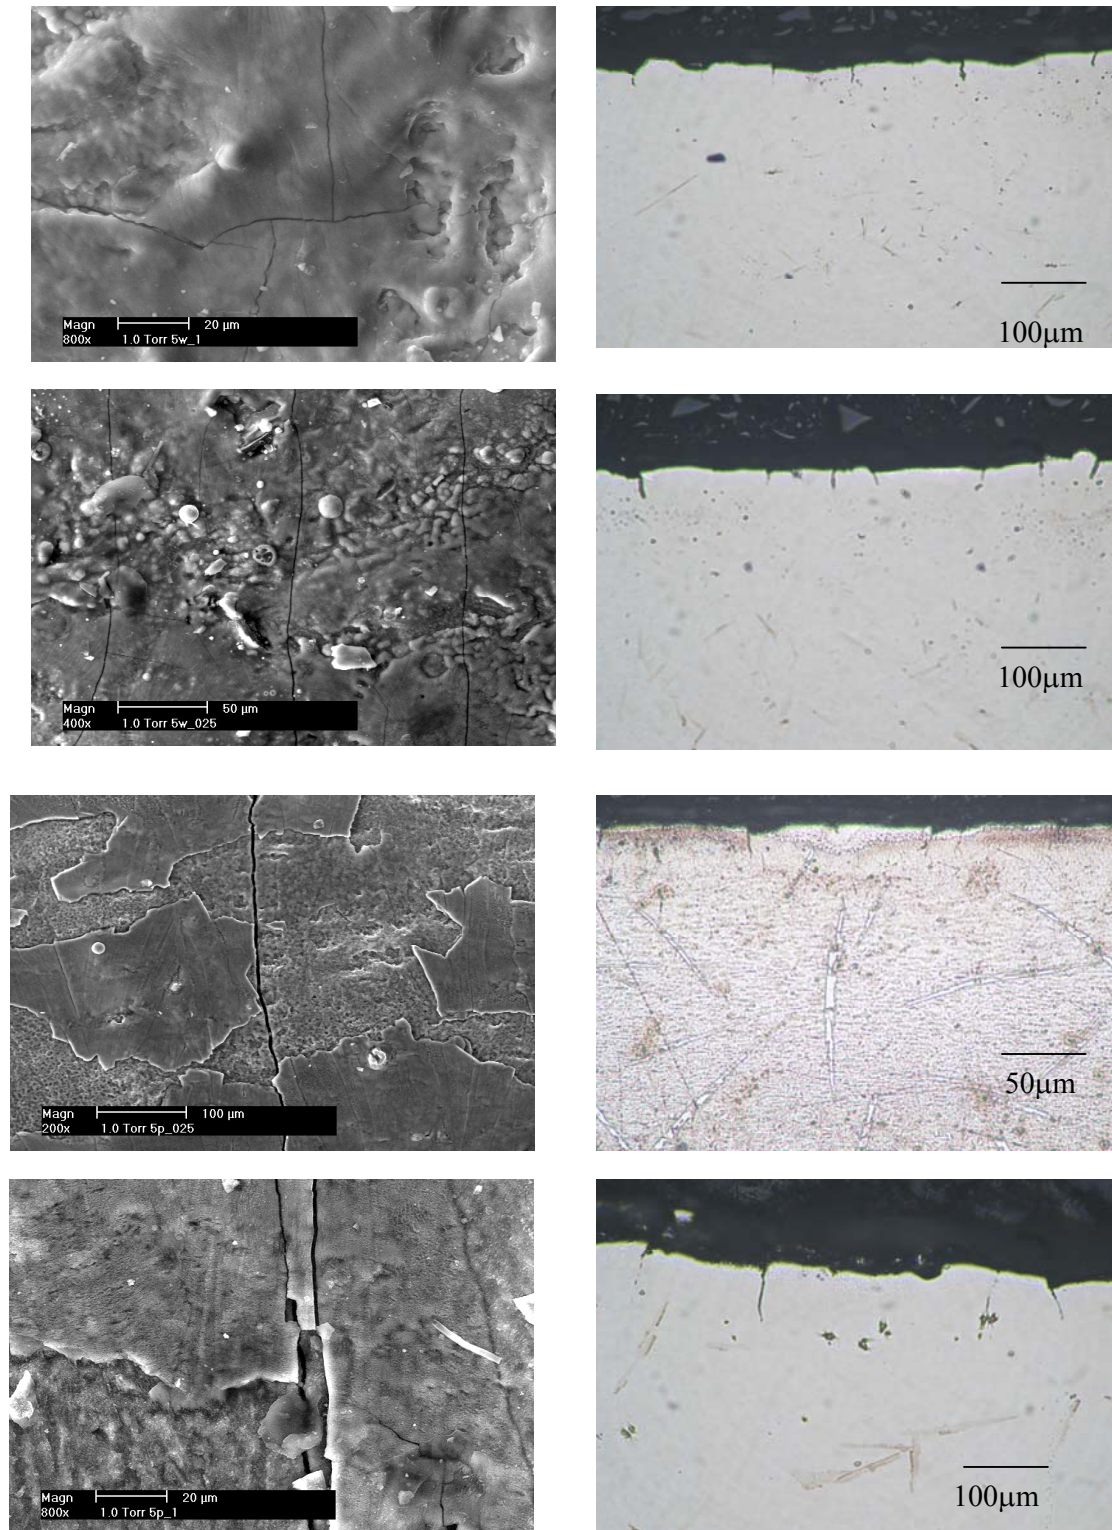
**Fig. 2.** Cracking of surface layers for specimens laser melted with CO<sub>2</sub> laser at 5 kW (from top to the bottom): in water at scan rate 1 m/min.; in water at scan rate 0.25 m/min.; in air at scan rate 1 m/min.; in air at scan rate 0.25 m/min

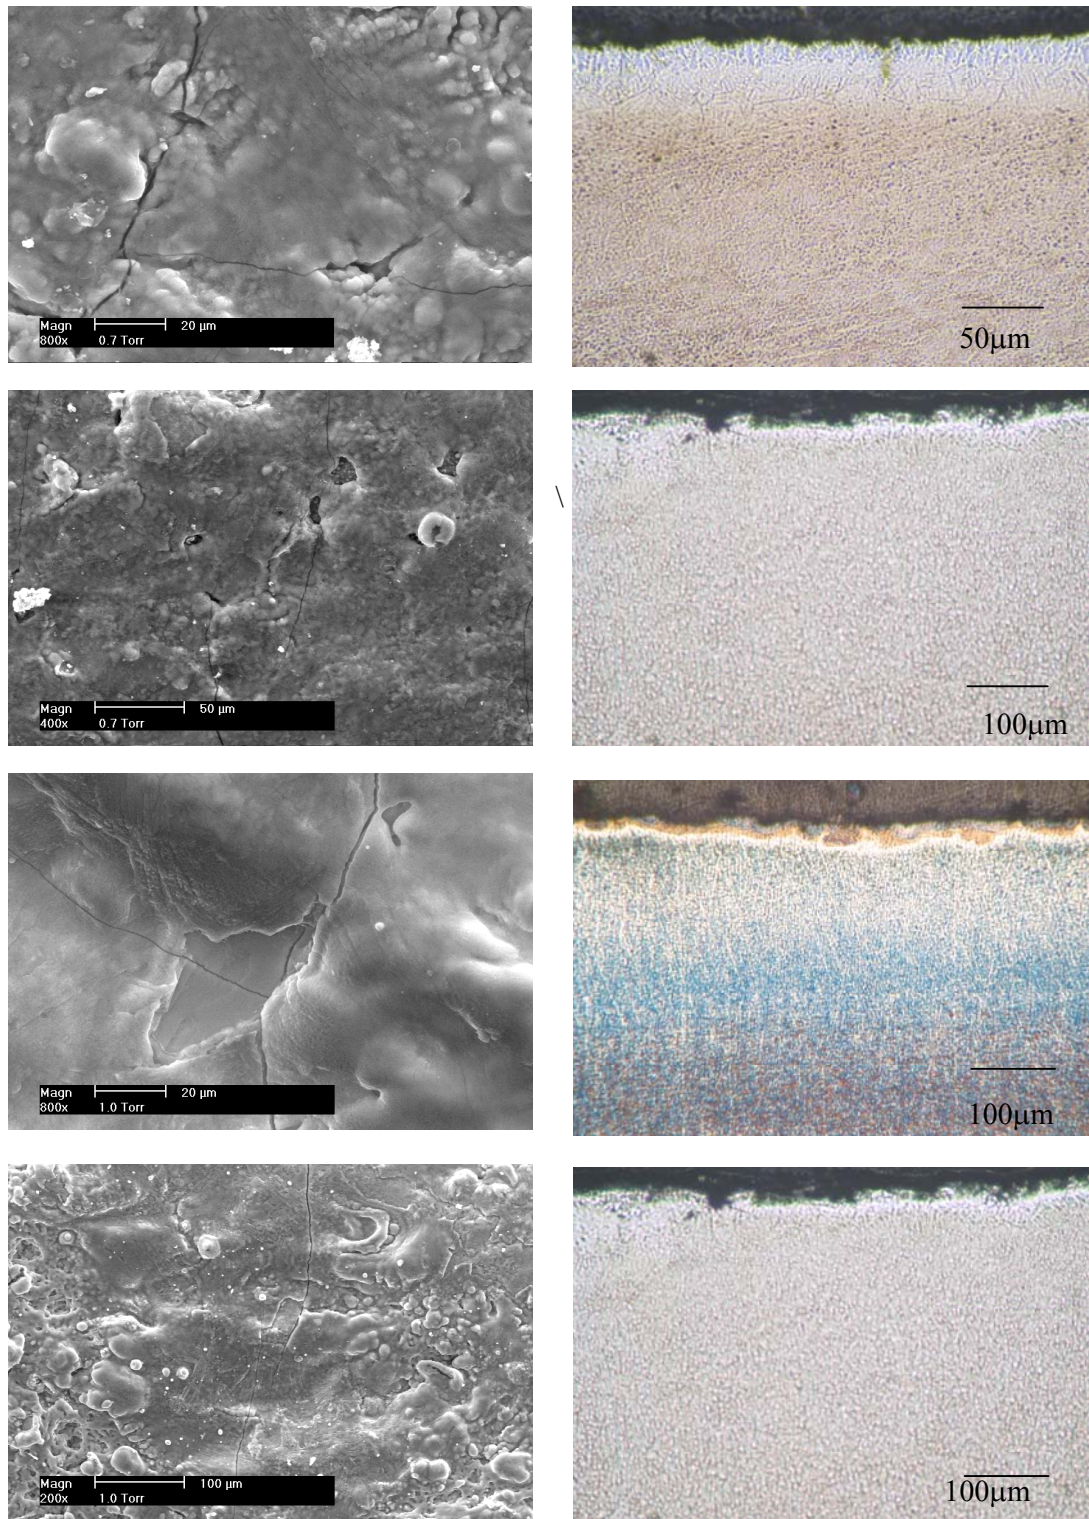
**Fig. 3.** Cracking of surface layers for specimens laser melted with CO<sub>2</sub> laser in air at 5 kW, at 1 m/min. scan rate and after pre-heating at temperature (from top to the bottom): 200, 300, 450 and 550 °C

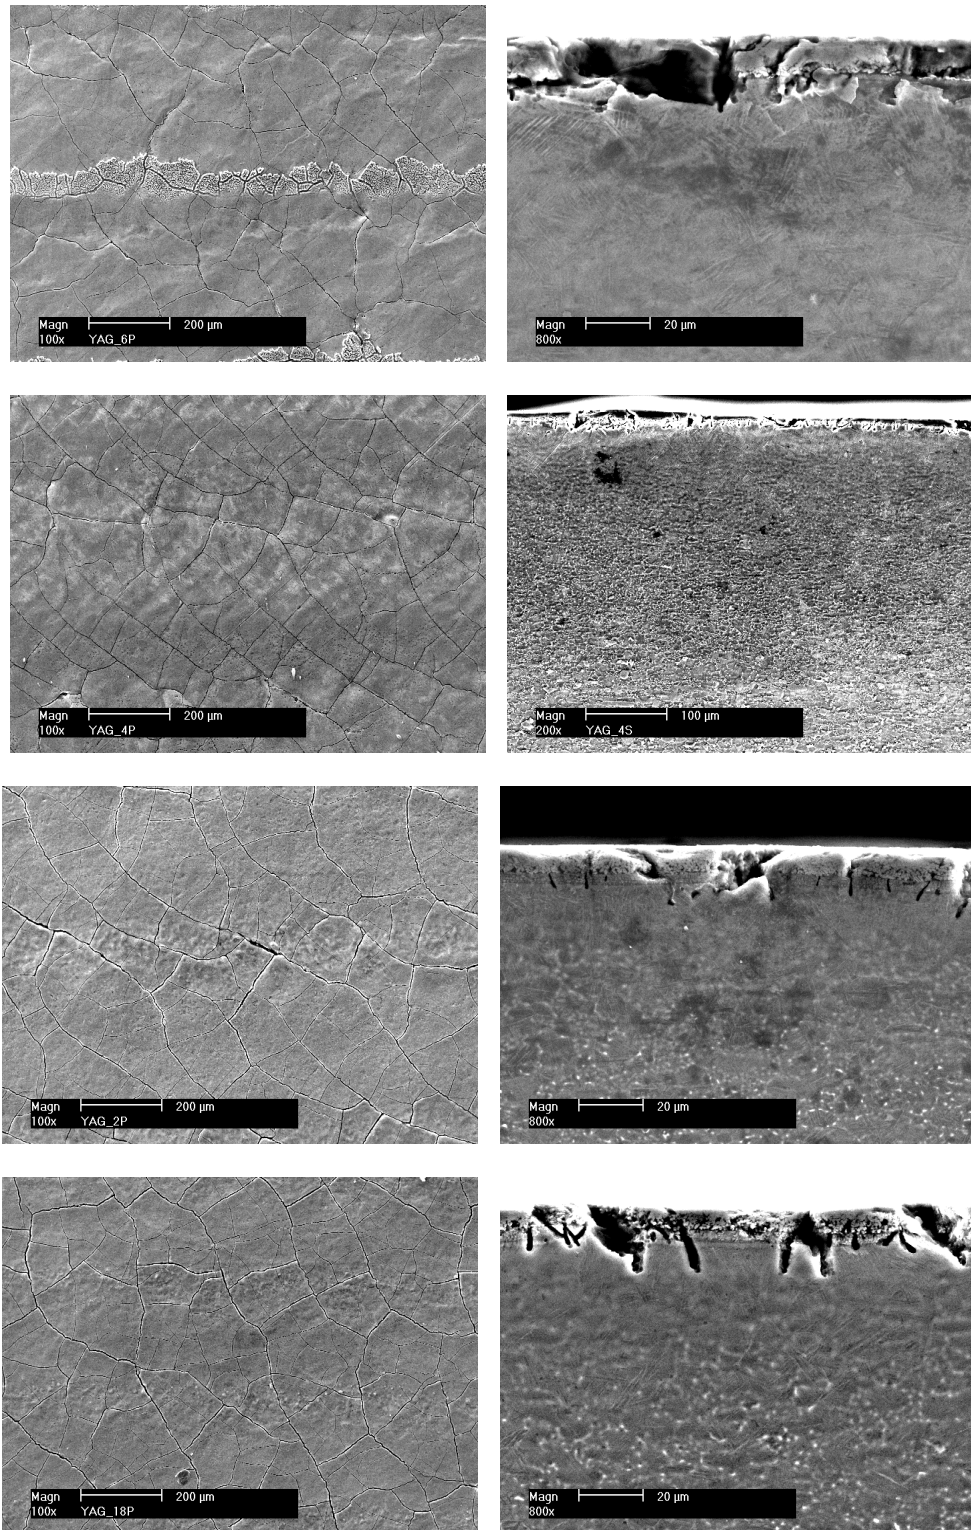
**Fig. 4.** Cracking of surface layers for specimens laser melted with Nd-YAG laser at 150 W and 50 Hz, with overlapping (from top to the bottom): 50%, scan rate 0.25 m/min.; 50%, scan rate 0.45 m/min.; 50%, scan rate 0.65 m/min.; 30%, scan rate 1 m/min

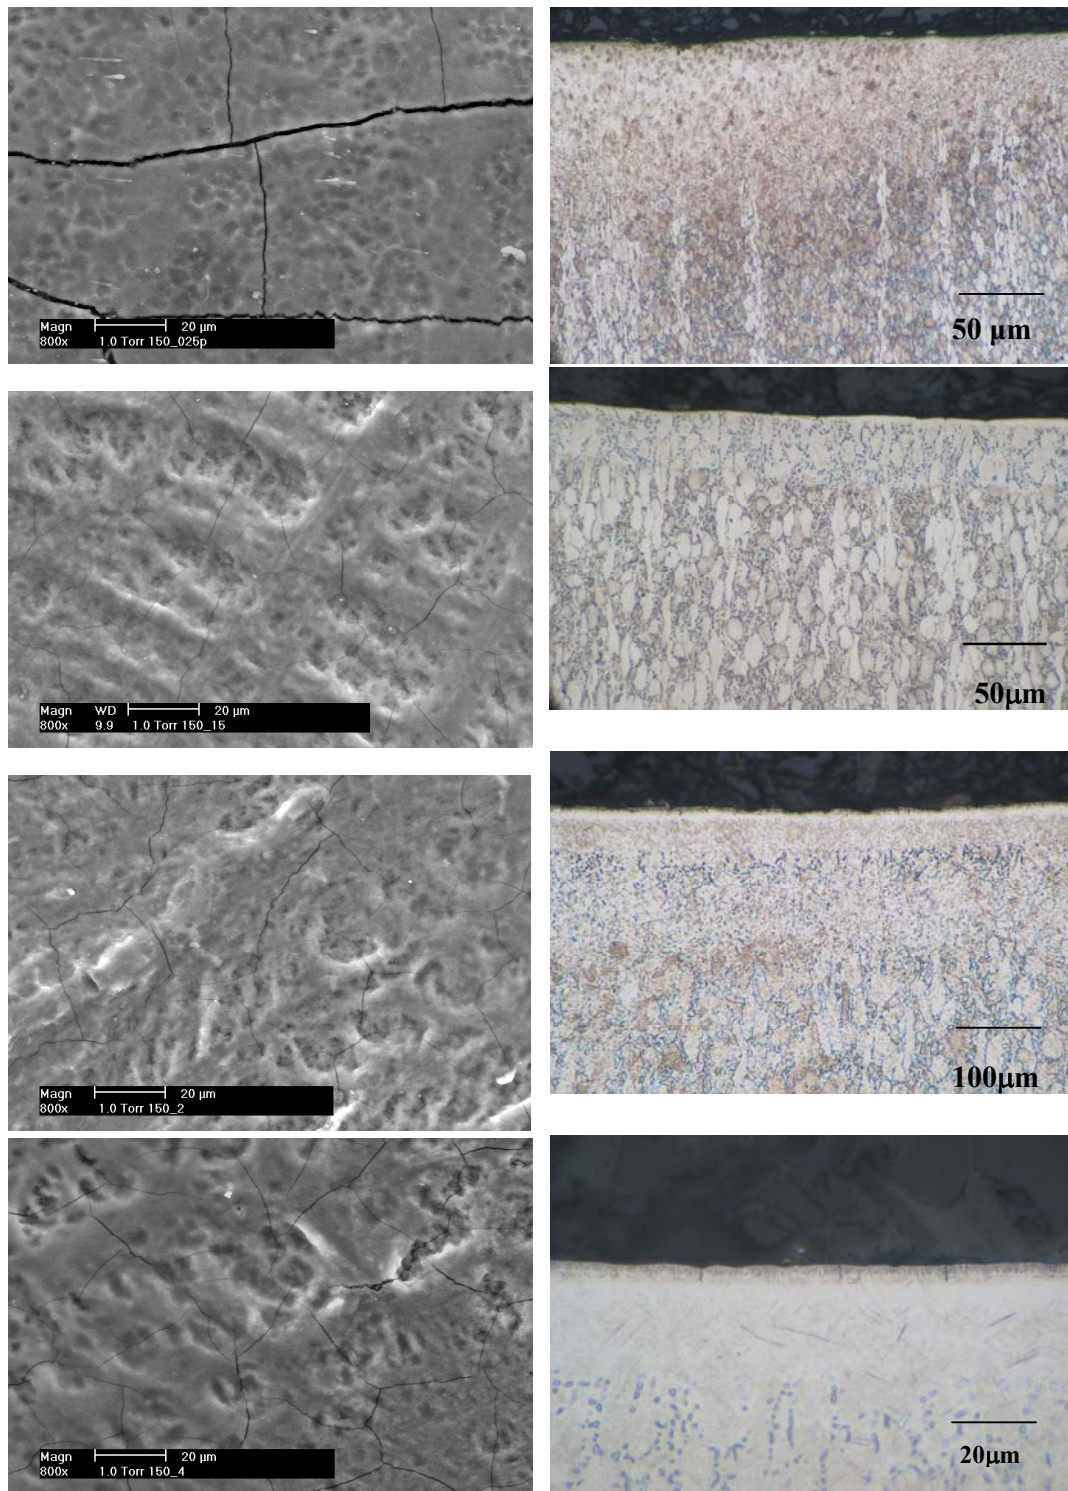
**Fig. 5.** Cracking of surface layers for specimens laser melted with Nd-YAG laser at 150 W and 50 Hz, without overlapping (from top to the bottom) at scan rate: 0.25 m/min., 1.5 m/min., 2 m/min, 4 m/min
