Results of acoustic emission tests of corrosion protection degree of ship steel tanks covered by means of protective coatings (Phase I)

Henryk Buglacki
Piotr Eichert
Gdańsk University of Technology

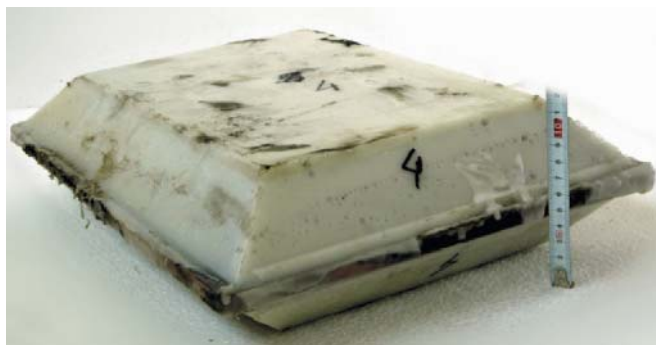
Fig. 2. The specimen covered with the polyurethane layer - concrete filler protective system

In Fig. 2 the specimen covered with the polyurethane layer - concrete filler protective system is shown.

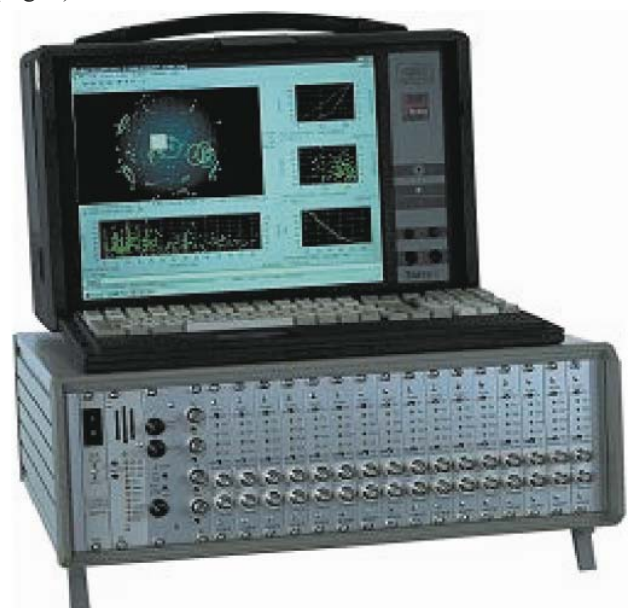
Fig. 4. AMSY5 system of the Vallen firm applicable to AE testing.

For measurements the 16-channel set of AMSY5 system and VS30-V, VS75-V sensors of the firm Vallen Systeme GmbH (Fig. 4) were used.
