Simulation of damage process of containership's side structure due to collision with a rock

This paper presents methods and results of a simplified numerical simulation of collision process of containership's side structure and a rock. Analysis of results of the modeling makes it possible to draw conclusions as to a character of the event as well as to estimate area and depth of damage caused by the penetrating rock, in order to select geometry of a filler and impermeable layer of 2nd protection barrier.

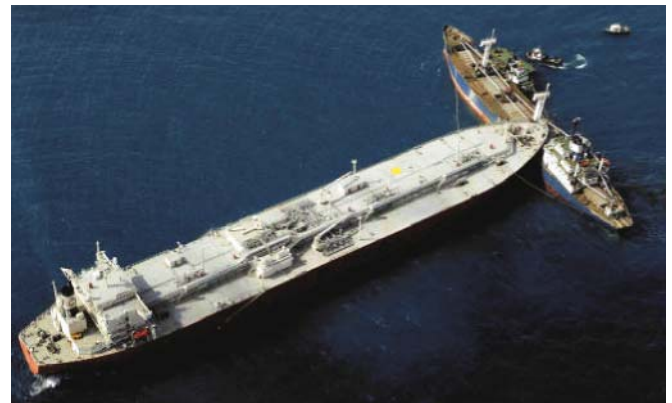
Fig. 1. Collision of m/t Gas Roman and m/v Springbok [2]

As shown below, the perpendicular hit of bow of one ship against midship part of the other is an often occurring case of collision, Fig. 1 and 2.

During such hit – if the hitting ship is fitted with a bow bulb – a damage of hit ship's plating and supporting structure in its bilge zone below waterline, is possible. In this zone fuel

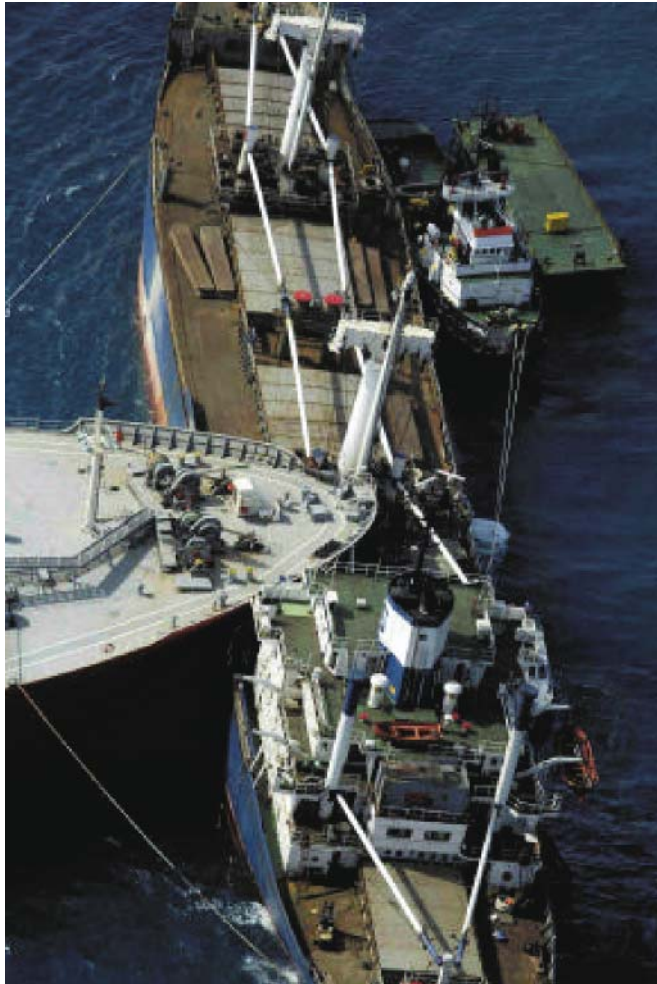
Fig. 2. A detail of side structure penetration during collision of m/t Gas Roman and m/v Springbok [2].

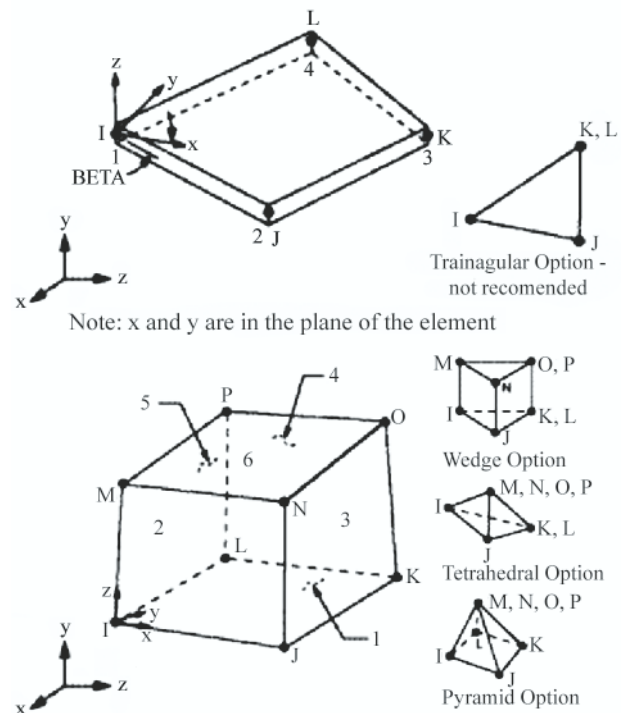
Fig. 3. Forms of finite shell and solid elements applied to the analysis

of the frames were modeled with finite shell elements, webs of the plating stiffeners in the zone between frame no. 86 and 121 – with finite shell elements, and in the remaining zones – with finite beam elements. And, flanges of the stiffeners and frames were modeled with finite beam elements within all the model, Fig. 3.

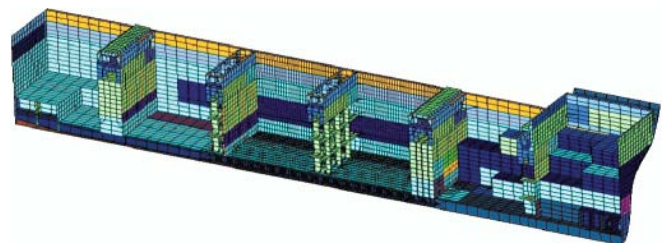
Fig. 4. FEM model – a general view from the side of plane of symmetry (PS), the model with assigned attributes and FE grid

To form the numerical model, 82574 shell elements and 1000 solid elements were used altogether, Fig.4.

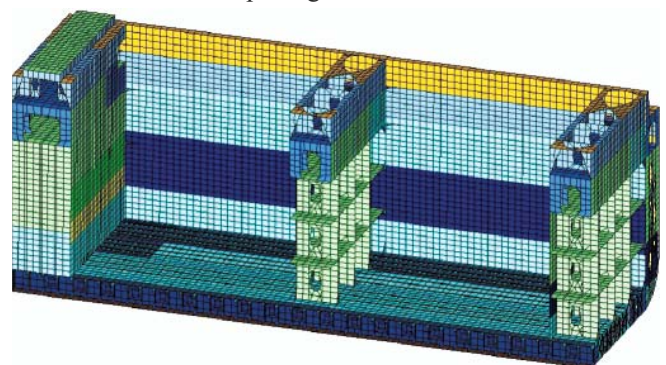
Fig. 5. FEM model – the enlargement of its hold part in the zone of the planned collision, seen from the side of PS

Below, an enlargement of the model of the cargo hold part in the zone of planned hit against the rock, is presented in Fig. 5 - showing its view from the side of PS, and in Fig. 6. – its view from the side of outer plating.

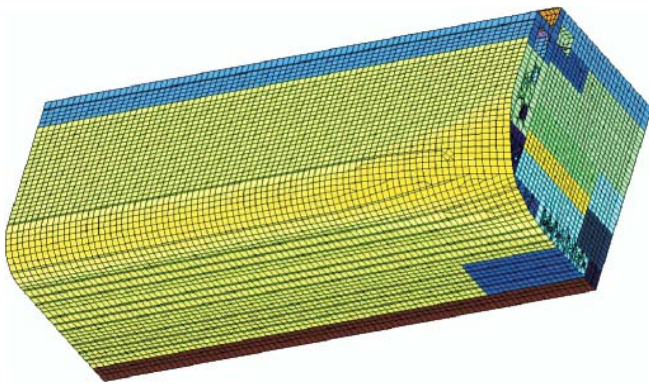
Fig. 6. FEM model – the enlargement of its hold part in the zone of the planned collision, seen from the side of outer plating

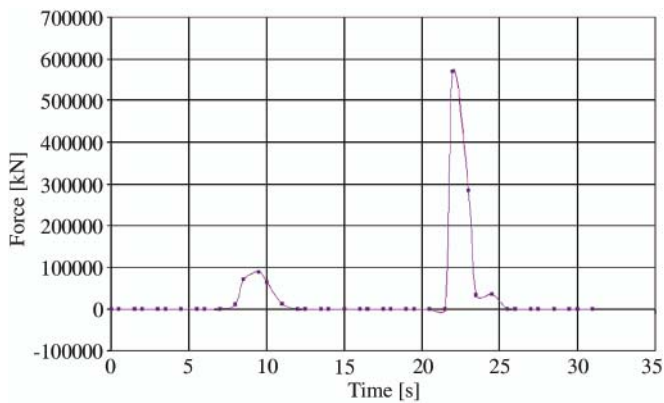
Fig. 10. The force-time diagram of interaction between the side plating structure and the „rock”

An analysis of force distribution in elements of the colliding model made it possible to determine changes in reaction of ship-rock interaction in function of time. In the diagram of the changes (Fig. 10) it can be observed that during the penetration process two points of maximum occurred. The first – after first 10 s of the collision, that corresponds with 200 mm depth of the penetration, the other – after 22 s of the collision, that corresponds with 440 mm depth of the penetration.

- The force-time diagram of interaction between the side structure and rock shows that the modeling method applied to the simulation yields a character of local peaks up to the instant when the exclusion conditions of elements (failure strain $>0,75$) is reached.
- More realistic values could be obtained if failed elements were left during simulation.
- Application of the excluding procedure of the failed elements made it possible to simulate the initial phase of penetration of the plating structure by the rock, and this way to capture the crucial moment of the collision.
