**B. Świczko-Żurek<sup>1</sup>, A. Szumlański<sup>2</sup>, J. Zorn<sup>1</sup>**

<sup>1</sup>Faculty Of Mechanical Engineering, Technical University of Gdansk, Narutowicza 11/12 Str., 80-952 Gdansk, Poland

## **ALLERGY TO IMPLANT COMPONENTS: CHROMIUM, NICKEL, COBALT AND TITANIUM**

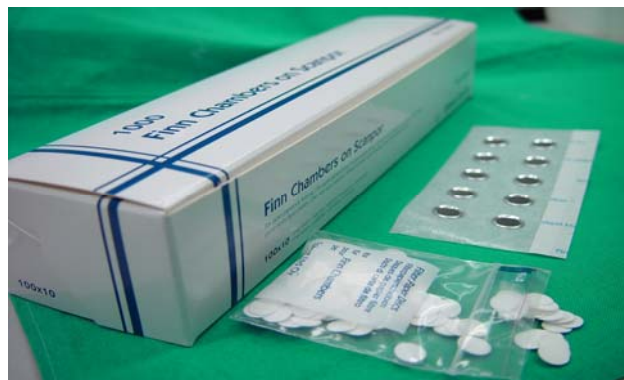
Fig.1. The patch tests were used for the research

The patch tests (Fig.1) were used for the research, which was carried on 6 selected patients, before and after surgical intervention.

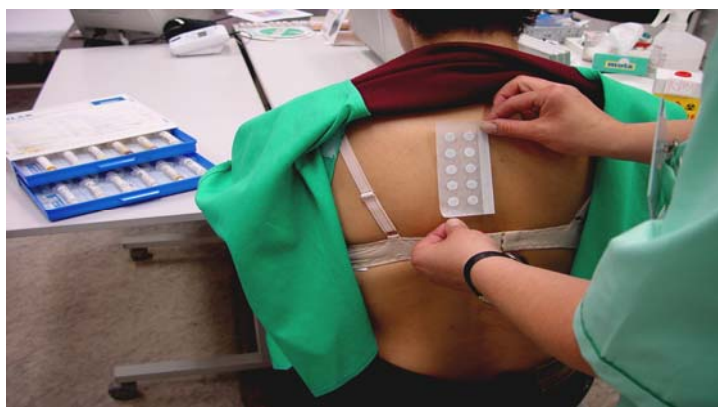
**Fig.2.** The way of attaching patch tests with the chosen allergic compounds to the body (Ni,Cr,Co,V,Ti)

The way of making the tests is shown in the Fig.2

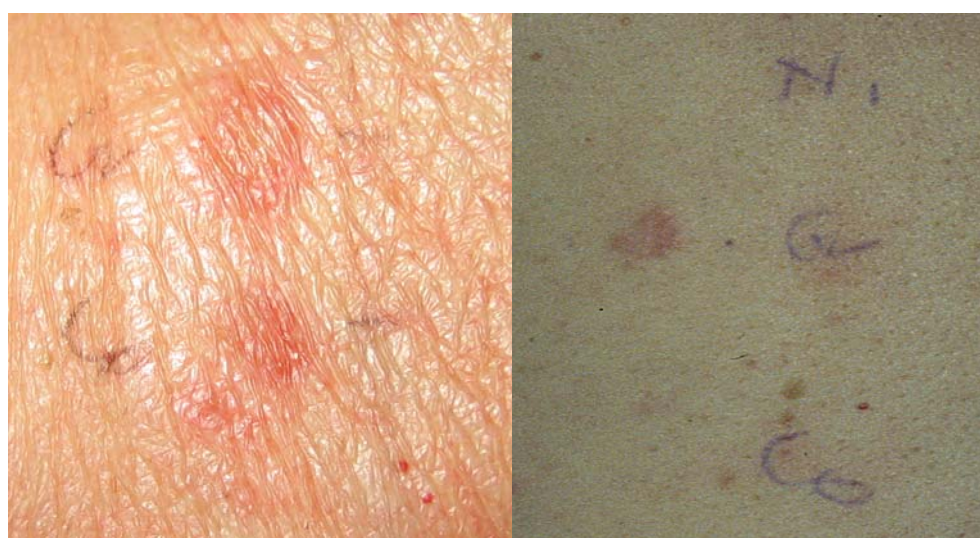
**Fig.3.** Skin changes after performing the tests

The patients (6) were subjected to the tests on the Ni, Cr, Co allergens (Fig.3).

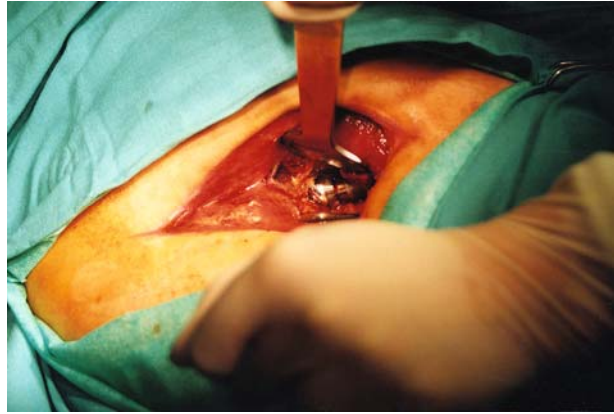
Two of them (1,2) had their implants removed due to aseptic loosening and intolerance of endoprosthesis. It resulted in pain, fistula serosa and edema. There were found to have oversensitiveness to Cr and Co. The allergic were not diminished by using antihistaminic drugs (Fig.4).

**Fig.4.** The hip implant removing caused by aseptic loosening

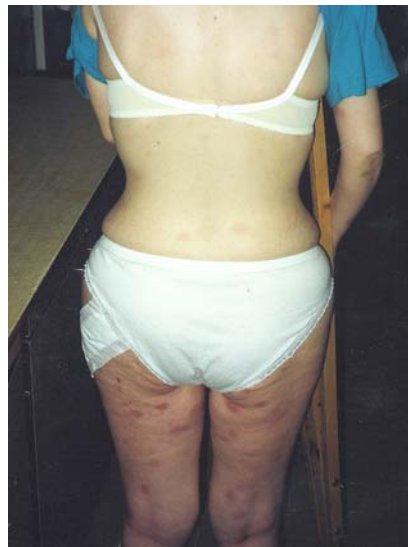
The patient (3) with Ni allergy suffered from skin imperfections after introducing hip implant (Fig.5). The symptoms decreased after applying antihistaminic drugs.

**Fig.5.** The patient with Ni sensitiveness after applying hip prothesis

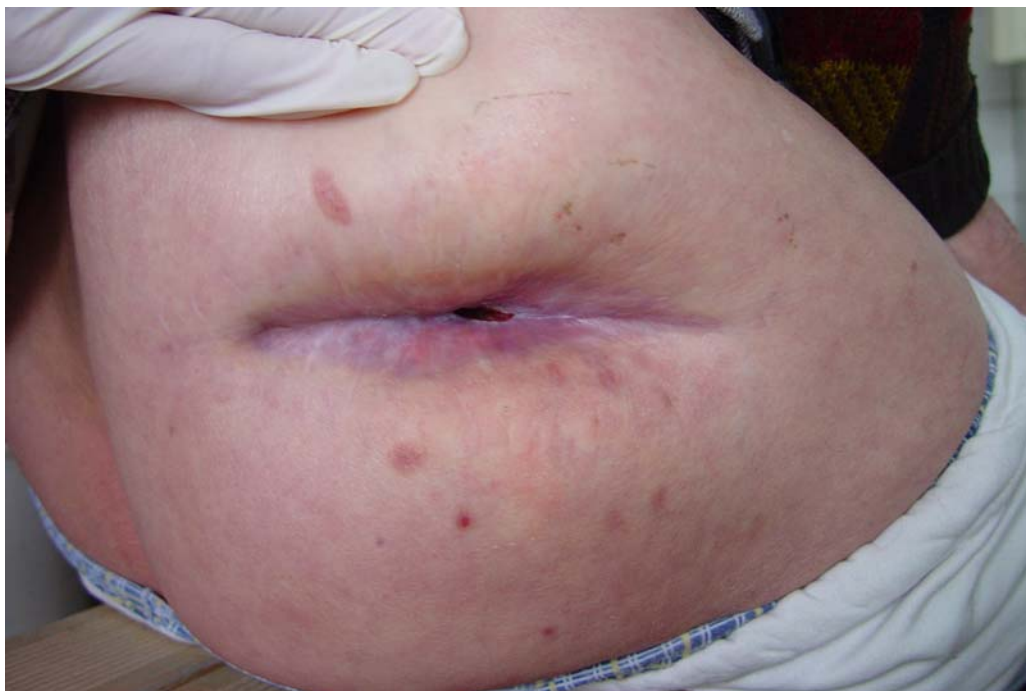
Another is the case with the patient (4) allergic to Ni and Co, who had no symptom of oversensitiveness up to 2 weeks. Then fistula serosa aseptica occurred in the hip (Fig.6). Patch tests were repeated. They showed allergy to Ti. The histaminic drugs decreased the symptoms.

**Fig.6.** The fistula serosa in hip after implantation

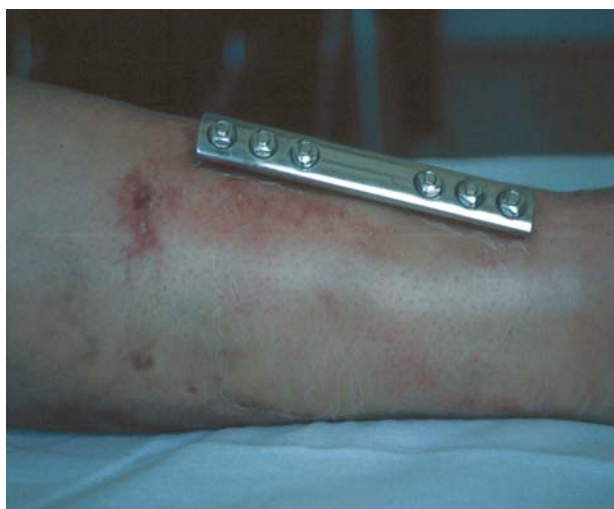
The patients (5,6) whose bones were joint with ZESPOL method, positive reaction to Cr and Ni was found. It appeared as contact dermatitis covering a large area of the skin, not only in the implant-tissue area (Fig.7). Some disturbances in the bone growth was observed. Treatment with antyallegic drugs was ineffective. After 4 weeks the implants were removed and the patients were treated in cast.

**Fig.7.** The contact dermatitis on the skin surface
