## Application a laboratory stand for multi-symptoms tests for high cyclic fatigue of constructional material

Andrzej Kaczmarek

Gdansk University of Technology  
Faculty of Ocean Engineering and Ship Technology  
G. Narutowicza 11/12, 80-233 Gdansk, Poland  
phone: +48 58 347 24 30, email: andrew925@wp.pl

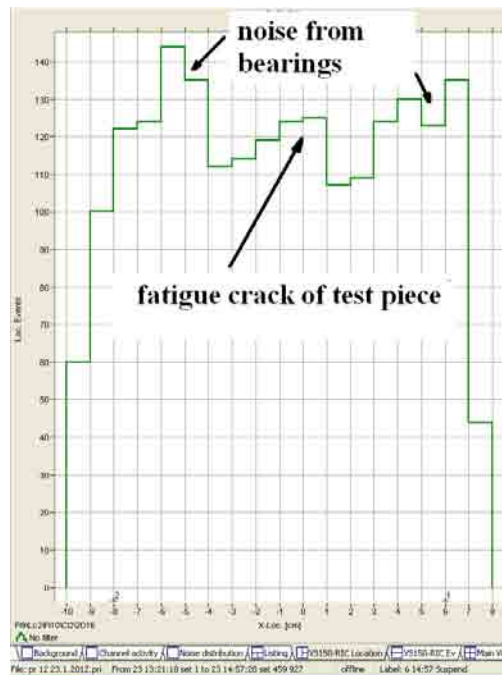
Fig. 5. The number of location events were measured in range between AE sensors

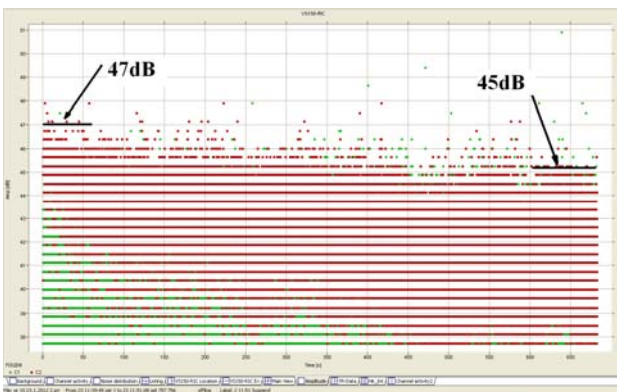
Fig. 7. The change of AE amplitude [dB] at moment of the strain hardening – 10. test piece

It is a correlation between amplitude of AE signal and fatigue state of material. At the moment of strain hardening (point on characteristic where strain-line is curved) the amplitude of AE is decreasing (tab. 1, fig. 7, fig. 8). The decrease is more clear for test pieces which have a low fatigue life (10 and 11 test piece). The decrease is weakly clear for test pieces which have a high fatigue life and unclear strain hardening (12 test piece). A change of AE amplitude is not visible for uncracked test piece (13 test piece). The moment of crack is described increase of AE amplitude. The general rule for energetic evaluation of multi-symptoms tests of fatigue material is described following: strain hardening – decrease of strain – lower energy – lower AE amplitude – stabilization of temperature.
