REDUCTION OF DERIVATIVE PIPELINE EFFORT IN WATER TURBINE

Abstract: The article presents an approach to evaluate and reduce the effort of the derivative pipeline in a water turbine of a hydroelectric power station in its vulnerable spots. Potential places of the biggest effort of the structure, as well as the coefficient of displacement and safety factor related to them were identified using FEM numerical method. Pipeline reinforcement was designed and made based on FEM analysis and non-destructive tests.

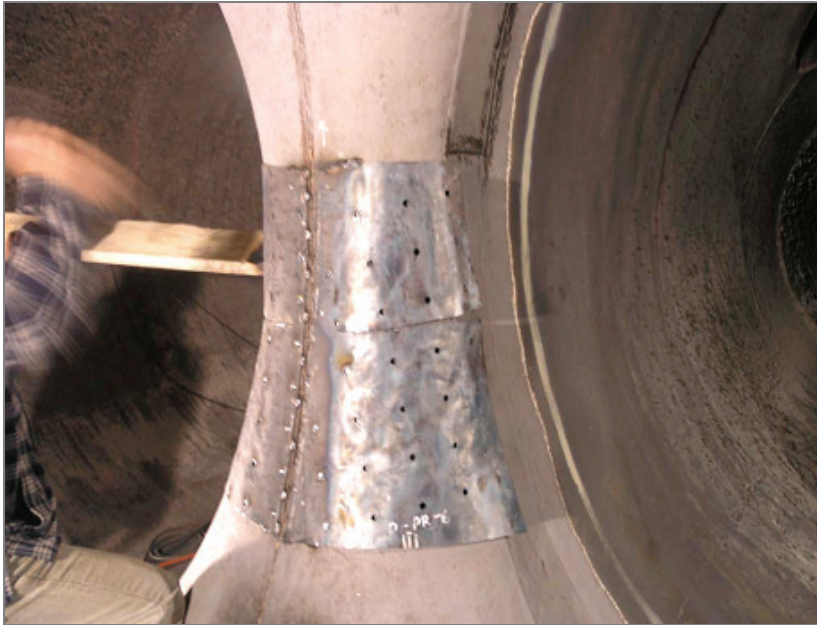
The assembly of the reinforcement components began from the central part (Figs. 16, 17). The reinforcement of the branch structure was divided into stages. First, the plating of the central part of the branch was laid, next the reinforcement plates of the bottom surface were laid symmetrically to the division plane. The last stage was creating the reinforced areas on the top surface of the branch. After careful fitting into the pipeline surface, each component was joined with tack welds along its perimeter, the plug welds were also made.

Fig. 16. Quadrangular components of the reinforcement in the process of tacking along centerline of the branch.
