Can Historic Interiors with Large Cubature  
be Turned Acoustically Correct?Tadeusz KAMISIŃSKI<sup>(1)</sup>, Andrzej KULOWSKI<sup>(2)</sup>, Roman KINASH<sup>(3)</sup>

The paper is a presentation of architectural interference in three historic interiors with large cubature leading to changes in their acoustic qualities. In two cases, the changes were beneficial to the functional qualities of the halls to satisfaction of the investors carrying out the renovation work. In the third instance, the architectural interference aimed at showing off the monumental valor of the interior resulted in significant degradation of its acoustics. To remedy the situation impairing the functional program of the facility, corrective measures are proposed neutral with respect to its historic character.

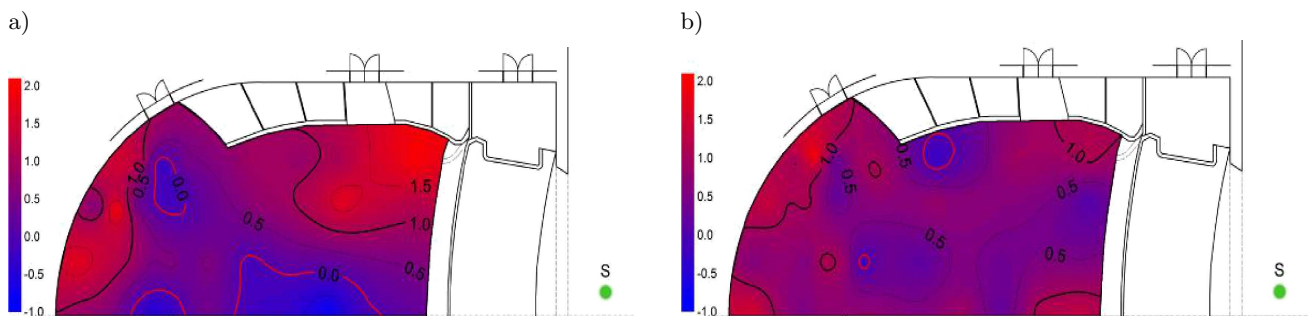
Fig. 15. The effect of mounting the diffusers on the sound strength  $G$ : a)  $G_{80 \text{ ms}, 4k}$  and b)  $G_{\text{Late}, 4k}$ .

the whole impulse response decay period (cf. Fig. 15a and 14b, respectively). This means that the impression of sound strength in the auditorium and the parameter  $G$  corresponding to sensation related to this quantity is created in the initial stage of formation of the impulse response. The observation is consistent with the generally accepted regularity concerning enhanced response of the human ear to early high-energy sound reflections.

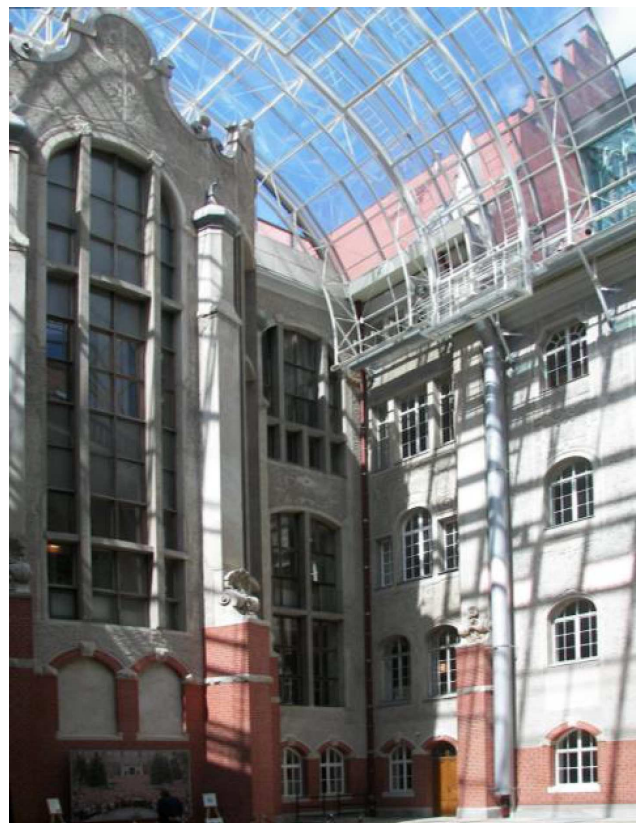
Fig. 20. A view of the Fahrenheit Courtyard.

The courtyards remained open-air spaces until 2004 when glazed roofs were installed over both of them. The load-bearing structure is based on arched steel trusses with the span reaching about 22.5 m. The roof shell is made of double-pane insulation glass units with voids filled with argon. The outer panes made of tempered glass are 10-mm and 8-mm thick, while the inner pane is a 2 × 4 mm glass laminate with plastic film glued between the layers (Figs. 18–20).

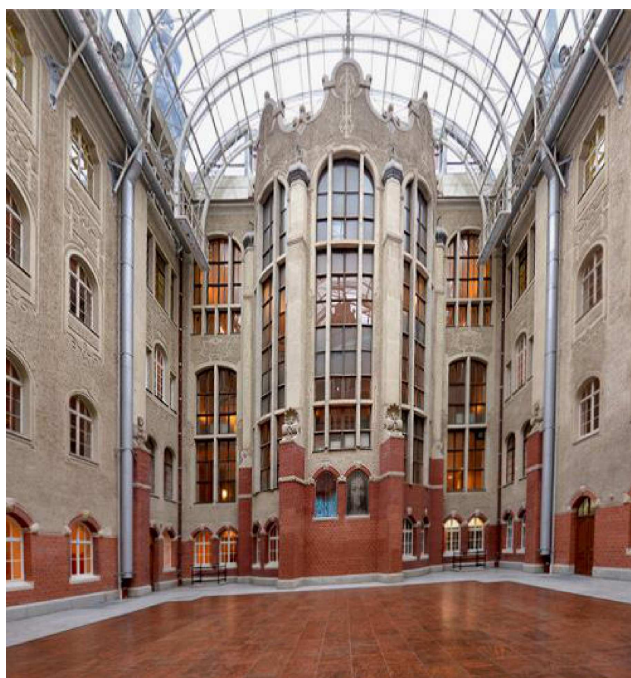
Fig. 22. The Fahrenheit Courtyard after laying a stone floor, June 2014. From Dziedziniec Farenheita (2015).
