Review Papers

Can Historic Interiors with Large Cubature be Turned Acoustically Correct?

The paper is a presentation of architectural interference in three historic interiors with large cubature leading to changes in their acoustic qualities. In two cases, the changes were beneficial to the functional qualities of the halls to satisfaction of the investors carrying out the renovation work. In the third instance, the architectural interference aimed at showing off the monumental valor of the interior resulted in significant degradation of its acoustics. To remedy the situation impairing the functional program of the facility, corrective measures are proposed neutral with respect to its historic character.

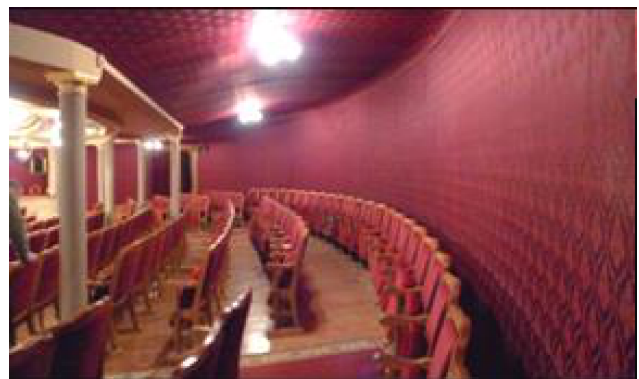
Fig. 8. The underbalcony space in the Lviv Opera House hall prior to installing the sound diffusing structures. The walls and ceiling were covered with a textile tapestry.
