Review Papers

Can Historic Interiors with Large Cubature
be Turned Acoustically Correct?Tadeusz KAMISIŃSKI⁽¹⁾, Andrzej KULOWSKI⁽²⁾, Roman KINASH⁽³⁾

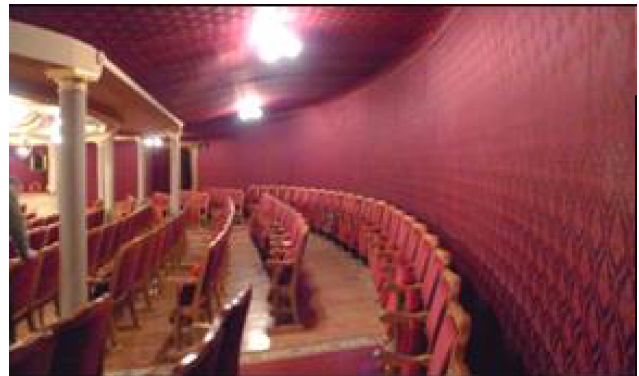
Fig. 8. The underbalcony space in the Lviv Opera House hall prior to installing the sound diffusing structures. The walls and ceiling were covered with a textile tapestry.

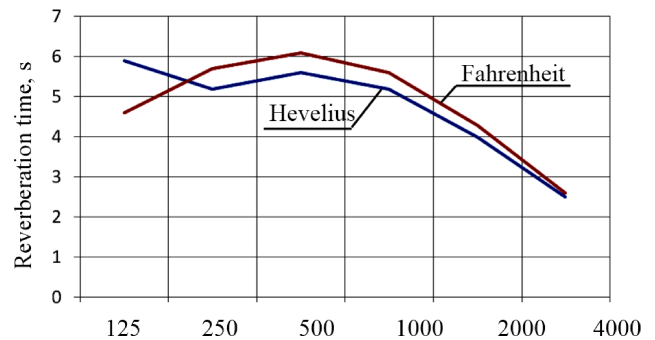
Fig. 21. Reverberation time of the courtyards after textural plaster renovation and face brick cleaning (July 2007).
