# Change in Heavy Metals Concentrations in Sediments Deposited in Retention Tanks in a Stream after a Flood

Our paper presents the results of heavy metal (HM) (Zn, Cu, Pb, Cd) content in bottom sediments from retention tanks along Oliwa Stream in Gdańsk, Poland, before a flood (BF) and after a flood (AF) 14-15 July 2016. The flood had a huge impact on the quality of bottom sediments and their displacement. The concentrations of HM differed significantly for research series conducted 3 months BF and 8 months AF. The concentration of Cu increased from 3.5 mg/kg to 88.8 mg/kg BF and from 12.1 mg/kg to 1,114.3 mg/kg AF, Zn from 27.4 mg/kg to 129.9 mg/kg BF; and 42.3 mg/kg to 244.8 mg/kg AF, Cd from 0.04 mg/kg to 0.47 mg/kg BF, and 0.08 mg/kg to 0.47 mg/kg AF. Also, the migration of some metals, mostly Cu to retention tanks located downstream, was observed, resulting from the washing away of sediments in the upper part of the stream. Since the stream inflows to the Gulf of Gdansk, urban flooding created a risk of migration of contaminants to the Baltic Sea.

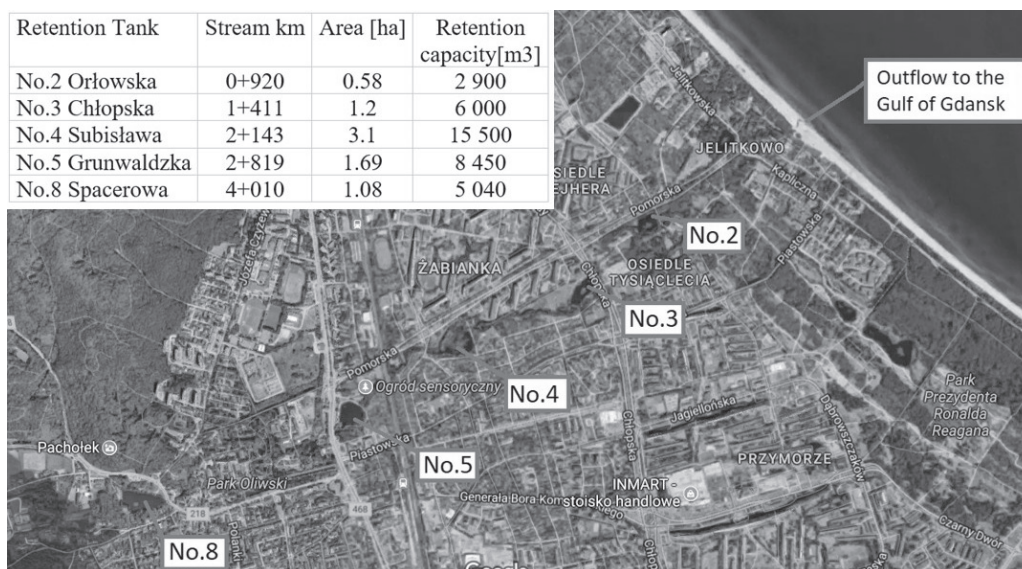
Fig. 1. Locations and retention capacities of analyzed retention tanks on Oliwa Stream.

Oliwa Stream is 9.6 km long and is the second longest stream in Gdansk, with the largest average flow rate  $Q = 158$  l/s. Its source is near the S6 express road. The total catchment area is approximately 3,050 ha. The stream inflows directly to the Gulf of Gdansk in Jelitkowo district. In the upper part, the stream flows through the forest area, called the Valley of Joy. Next in the middle part little by little it becomes surrounded by urbanized areas until finally in the lower part the riverbed runs through densely urbanized residential areas, close to traffic arteries. The most important inflow of Oliwa Stream is Rynarzewski Stream, which flows through the city zoological garden. Throughout its length, Oliwa is a receiver for the stormwater drainage system. There are 13 retention tanks on Oliwa, with a total capacity of 70,000 m<sup>3</sup> and total area about 13.5 ha. Fig. 1 presents locations and basic information on 5 retention tanks analyzed within this study.

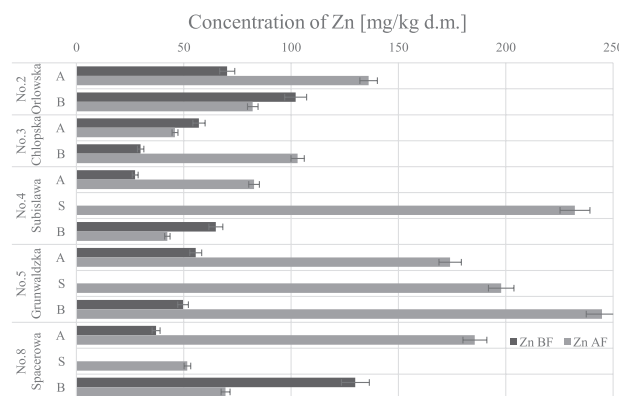
Fig. 4. Average concentrations of Zn in bottom sediments of retention tanks on Oliwa Stream before flood (BF) and after flood (AF).

Concentrations of Zn (Fig. 4) before the flood incident were between 27.4 mg/kg d.m. in No. 3 tank (inflow) to 129.9 mg/kg d.m. in No. 8 tank (outflow); compared to the LAWA classification this means that sediments were not contaminated. In relation to SQG, sediments were not toxic for aquatic organisms. The increase in

Zn content in bottom sediments AF occurred for tank Nos. 2, 4, and 5 at the inflow and tank Nos. 3, 4, and 5 in the middle part and at the outflow. The average content of Zn in sediments from the retention tanks is approximately 125 mg/kg d.m. In two cases – tank Nos. 4 (point S) and 5 (point B) – the boundary value of the II class of purity according to LAWA (more than 200 mg/kg d.m.) was exceeded. The increase in Zn content AF could be caused by intensive surface runoff (especially from streets with intensive traffic), which was stopped and deposited in the bottom sediments after the flood wave. Similar results were obtained for Pb (Fig. 5). The content range for Pb BF was between 8.5 mg/kg d.m. to 50.2 mg/kg d.m. – which refers to uncontaminated sediments according to LAWA classification. AF the Pb content rose at the same points as Zn. This supports the thesis that in contaminated sediments Zn occurs often together with Pb [14]. At inlet to tank No. 8 the Pb content was 160.6 mg/kg d.m., exceeding the second class of purity (LAWA). Additionally, the limit for PEC was exceeded in this case.

The results of HM concentrations in the sediments from retention tanks on Oliwa Stream are shown at Figs 4-6. The HM concentrations differed significantly between research series conducted BF and AF. There were no obvious trends in the distribution of HM along Oliwa Stream, but for most of the observed results the HM seemed to be moved to the tanks located downstream as a result of the flood.
