BIOVAC® WASTEWATER TREATMENT PLANTS

IN THE MOUNTAIN NATIONAL PARKS

Abstract

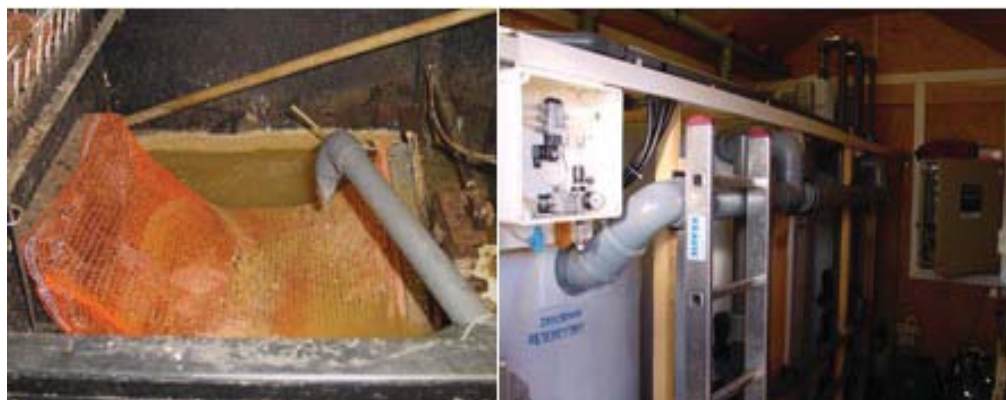
The vertical retention tank (Fig. 2) equalises the sewage flow/composition and serves as a buffer during large flow fluctuations. The tank houses submersible pumps that pump sewage to the SBRs.

Fig. 2. Biovac® wastewater treatment plant at West Spitsbergen a) bag screen , b) retention tank [10]

The mechanical (primary) sewage treatment is a stage where solids are removed from sewage. Biovac® plants usually employ basket screens and bag screens, although occasionally fine screens, sieves or screenings and grit separators (combined in a single unit) are used for larger wastewater treatment plants. The basket screen is a coarse screen made of stainless steel. This device is placed directly by the inlet in manholes or pumping stations to which wastewater is carried by pipe. It is guided by rails and has electric or hand hoist. Floating solids of a particular size are caught in the filtering compartment. The basket moves along the rails in vertical direction [10]. After being pulled out of the tank, the basket turns to a position that guarantees automatic unloading of screenings. The separated solids/screenings are transported to a storage tank or to a filter press via a gutter. The bag screen (Fig. 2) is mounted in front of the retention tank. The bag is made of plastic fibres and removes solids of a particular diameter. Similar bags can also be found in agriculture as a packing material for agricultural crops.

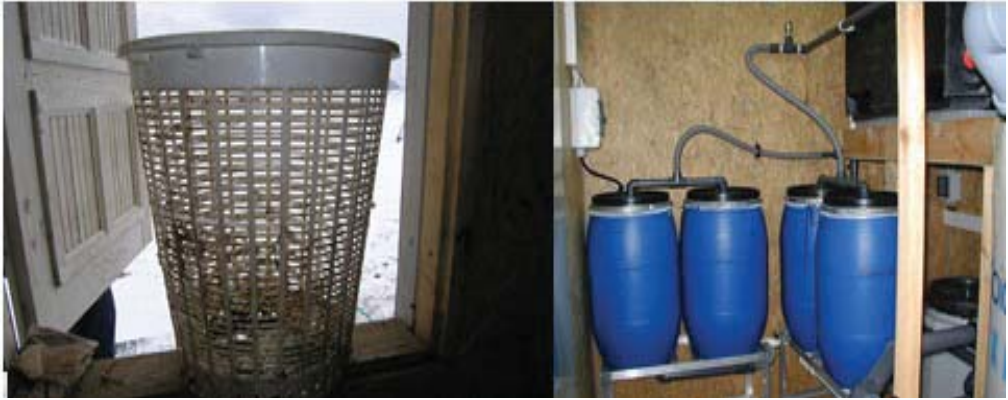
Excess sludge is directed to an aerobic stabilisation tank in which a cyclic aeration takes place via disc diffusers and a blower. After aerobic stabilisation, sludge becomes a stable product that can be stored without risk of odour. The stabilisation process also results in the partial or complete removal of pathogenic microorganisms [10–13]. The stabilised sludge is discharged to the dewatering units and subsequently dried in sludge dryers (Fig. 3).

Fig. 3. Sludge processing at the Biovac® wastewater treatment plant [10]

Sludge presses or centrifuges are used for the mechanical dewatering of sludge at larger wastewater treatment plants. Centrifuges (working in a batch or in continuous mode) separate the solids from the liquid with gravitational and centrifugal forces while filter presses, squeeze water out of the sludge [14–16].

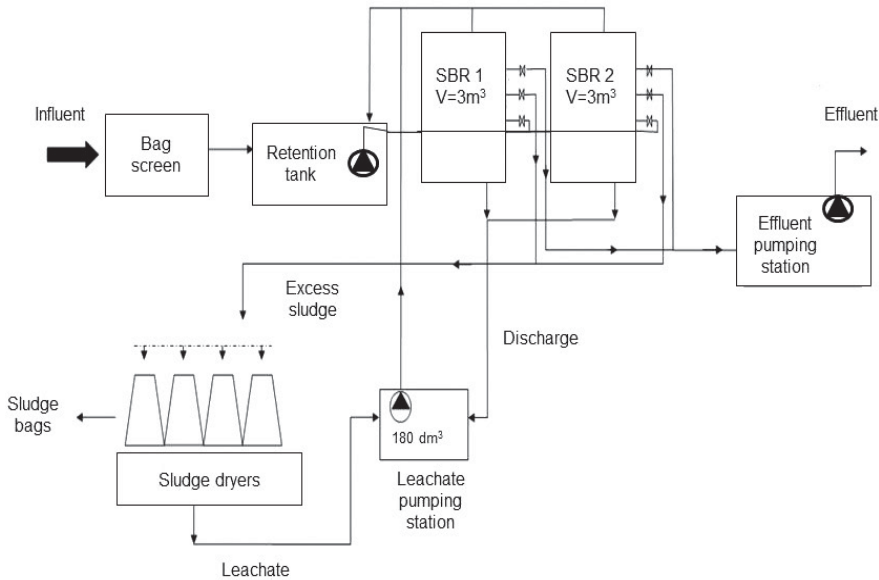
In August 2001, the Biovac® wastewater treatment plant with a capacity of $10 \text{ m}^3/\text{d}$ was launched at Spitsbergen. The new wastewater treatment plant replaced the rotating biological contactors (RBC), which had been in operation there since 1985 [10]. The following diagram shows the current sewage treatment technology.

Fig. 4. Flow chart of the West Spitsbergen wastewater treatment plant [10]

The SBR-type treatment plant at Spitsbergen treats mostly domestic sewage comprising toilet waste, food waste, surfactants, toilet paper, fats and detergents. The sewage composition shows high levels of phosphorus, nitrogen, and the presence of coliforms. The sewage composition is also influenced by the chemical laboratory located at the station where various types of chemical analyses are carried out over the year (mainly chemical analyzes of surface waters and rainwater) [10].

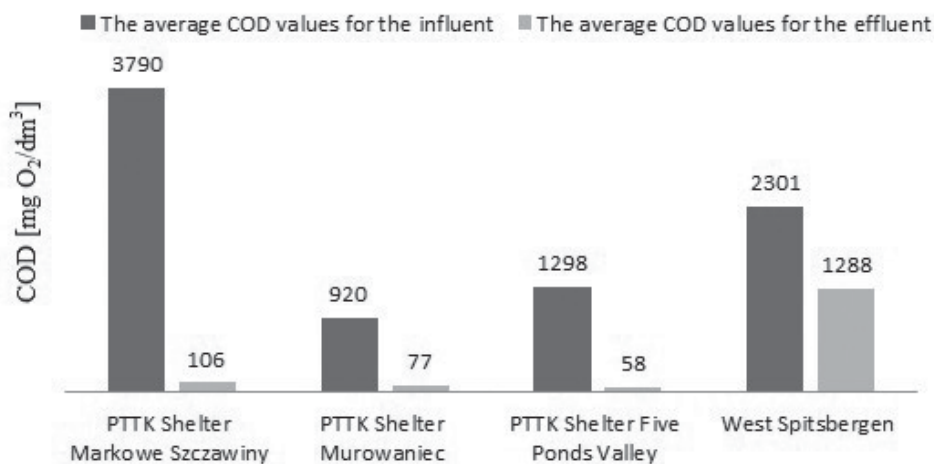
According to the studies, the average COD values in raw sewage at the wastewater treatment plants were as follows: Markowe Szczawiny, 3790 mg/dm³; Murowaniec, 920 mg/dm³; Dolina 5 Stawów, 1298 mg/dm³; West Spitsbergen, 2301 mg/dm³. The values were much higher than those found in typical domestic sewage.

The following average values of COD were observed in the effluent: Markowe Szczawiny, 106 mg/dm³; Murowaniec, 77 mg/dm³; Dolina 5 Stawów, 58 mg/dm³; West Spitsbergen, 1288 mg/dm³. The average COD removal efficiency was as follows: Markowe Szczawiny, 97%; Murowaniec, 92%; Dolina 5 Stawów, 95%; West Spitsbergen, 44%.

Fig. 8. COD in raw sewage and the effluent from the wastewater treatment plants located in the mountain hostels

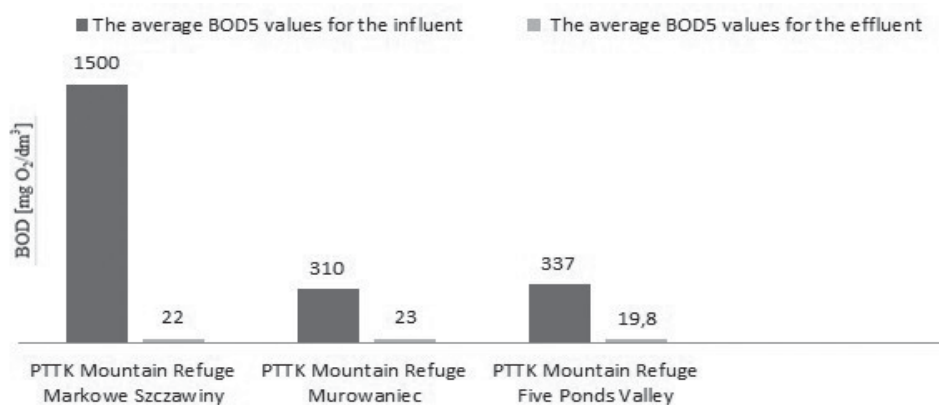
The average BOD₅ concentrations in raw sewage at mountain hostels were as follows: Markowe Szczawiny, 1500 mg/dm³; Murowaniec, 310 mg/dm³; Dolina 5 Stawów, 337 mg/dm³;

Fig. 9. BOD₅ in the raw sewage and in the effluent from the mountain hostels

The average BOD₅ concentrations in the effluent from the wastewater treatment plants were as follows: Markowe Szczawiny, 22 mg/dm³; Murowaniec, 23 mg/dm³; Dolina 5 Stawów, 19.8 mg/dm³; a Polish polar station at West Spitsbergen, 500 mg/dm³.

The average BOD₅ removal was: Markowe Szczawiny, 79%; Murowaniec, 92%; Dolina 5 Stawów, 96%.

the BOD concentrations in raw sewage from the Spitsbergen Polar Station were not determined since the samples were diluted before the BOD₅ analysis to match the expected content of organic compounds subject to biochemical oxidation. However, the dilution ratio turned out to be wrong since the BOD values were significantly higher than expected. Due to the fact that only a limited amount of the raw sewage was available, the BOD₅ analysis could not be repeated.
