Article

Wave Frequency Effects on Damage Imaging in Adhesive Joints Using Lamb Waves and RMS

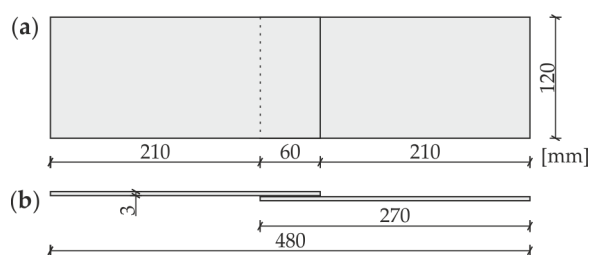
The investigations were conducted on the single-lap adhesive joints of steel plates. The geometry of the specimens is presented in Figure 1. The dimensions of each plate were 270 mm \times 120 mm \times 3 mm. The overlap surface was 120 mm \times 60 mm. The internal defect in the form of partial debonding was designed in the adhesive film in four variants (#1 to #4, as shown in Figure 2), from which the first one was chosen for experimental measurements. The defect (#1) was obtained by sticking a PTFE (polytetrafluoroethylene) tape of 0.2-mm thickness in the middle of the overlap before manufacturing the connection. To avoid creating unintended debonding areas, the overlap surface of each adherend was treated with fine sandpaper (grit size 120) and degreased with Loctite-7063 cleaner just before joining. The epoxy-based adhesive Loctite Hysol 9461 (Henkel, Düsseldorf, Germany) was used to join the plates. The measured bondline thickness was equal to approximately 0.2 mm. To control the expected geometry of the defect, the adherends were disconnected after the experiments. The separated plates are presented in Figure 3. The failure occurred in the interfaces between the glue layer and the steel plates (mainly the lower one); it has a purely adhesive character. There are visible leaks of adhesive into the area of the intended defect (on the upper plate). Moreover, the defect edges are irregular (visible mainly on the lower plate).

Figure 1. Geometry of investigated specimen: (a) plane view; (b) side view.

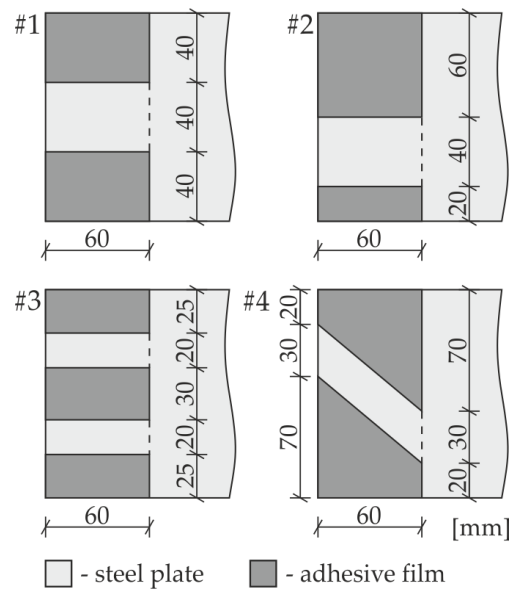
Figure 2. Variants of defects (#1 to #4).

The above considerations were conducted only for a single joint, #1. Next, the observed effects were verified on specimens #2 to #4 by the way of numerical calculations for three certain frequencies (100 kHz, 210 kHz, and 300 kHz). The normalized RMS maps are presented in Figure 12. It is visible that for the frequency of 100 kHz, higher RMS values were obtained for the damaged areas than for the intact joint (for all the analyzed specimens). The frequency of 210 kHz appeared to be inefficient for RMS damage imaging, i.e., the difference between the damaged and properly prepared area was not

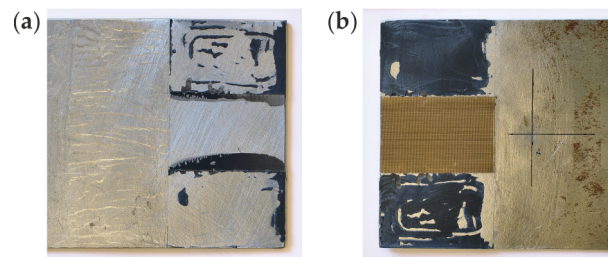
Figure 3. Photograph of experimental specimen after separation: (a) upper plate; (b) lower plate.

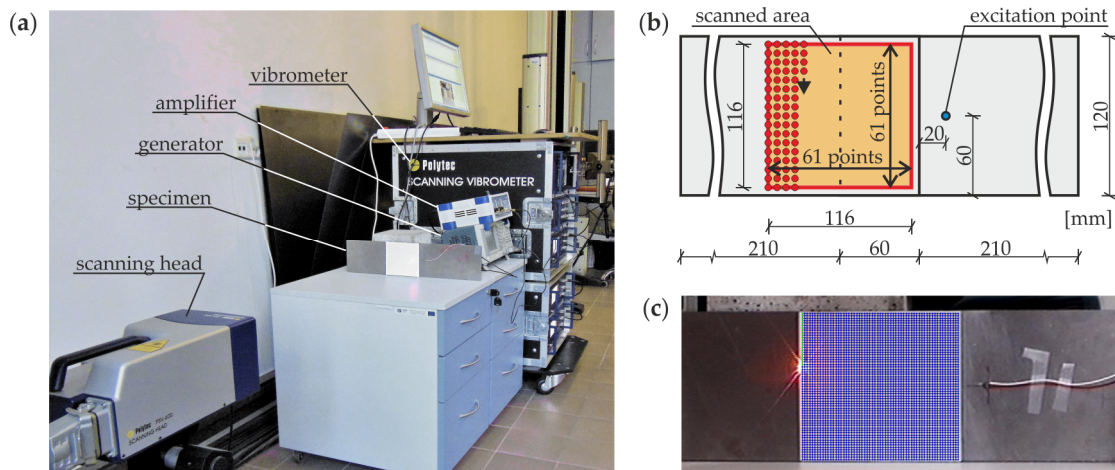
The experimental examination of prepared specimen #1 consisted of the excitation and the acquisition of the Lamb wave propagation signals in the specified area of the joint by the scanning laser Doppler vibrometry method. The experimental setup is presented in Figure 4a. The generation of the input wave signal was provided by the arbitrary function generator AFG 3022 (Tektronix, Inc., Beaverton, OR, USA) with the support of the high-voltage amplifier PPA 2000 (EC Electronics, Krakow, Poland). The plate piezoelectric actuator NAC2024 (Noliac, Kvistgaard, Denmark) with dimensions of 3 mm × 3 mm × 3 mm was used for the excitation of the guided wave field in one of the adherends. The actuator was attached to the top surface of the specimen by the petro wax 080A109 (PCB Piezotronics, Inc., Depew, NY, USA). The input signal was a wave packet obtained from the five periods of the sinusoidal function by the Hanning window modulation. The excitation frequency was individual for each measurement and varied from 20 to 350 kHz. The signals of the guided wave field were recorded by the scanning head of the laser vibrometer PSV-3D-400-M (Polytec GmbH, Berlin, Germany) equipped with a VD-07 velocity decoder. The sampling frequency was assumed to be 2.56 MHz. The improvement of light backscatter was provided by covering the scanned surface with a retro-reflective sheeting. The out-of-plane components of velocity values were acquired in the time domain in 3721 points distributed over the area featuring the overlap surface and the part of the plate after it (at the top side of the specimen); see Figure 4b,c. The scanning was performed point by point in the quadratic mesh of 61 rows and 61 columns, resulting in the resolution of about 1.93 mm. The representations of acquired signals for specific time instances show the propagation of the full guided wave field (SLDV maps).

Figure 4. Experimental measurements: (a) experimental setup for the generation and acquisition of Lamb waves; (b) view of a specimen with the position of a scanned area and excitation point; (c) investigated specimen with indicated scanning points.

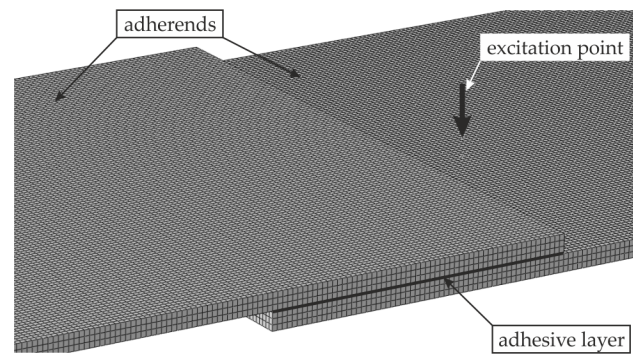
The numerical modeling of elastic wave propagation in composite structures, such as adhesive joints, is a complex problem, mainly because of material inhomogeneity and an uncertainty of contact at the interfaces between different materials. An effective contribution to this issue was made by Chronopoulos [50] and Apalowo and Chronopoulos [51]. In the present paper, numerical analysis of the guided wave propagation in the considered adhesive joints (#1 to #4) was conducted using the finite element method in Abaqus/Explicit software. Some assumptions were made to simplify the modeling process and shorten the calculations. Three-dimensional FEM models were prepared for a transient dynamic analysis. Each structure was discretized by eight-node solid elements with reduced integration (C3D8R) from the explicit element library. The appropriate mapping of the wave behavior requires at least 20 nodes for the shortest wavelength of interest [52]. According to this limitation, the mesh was initially assumed to be regular and consisted of cube-shaped elements with a global size of 1 mm, which was reduced to 0.2 mm for the thickness of the adhesive layer (see Figure 5). The mesh convergence test was conducted taking into account a few refined meshes. The out-of-plane velocity values in some randomly chosen points at specific time instances were assumed as the measure of the convergence. The relative differences between results were negligible; thus, the exact calculations were conducted with the use of the above-mentioned mesh with the global element size of 1 mm. The boundary conditions were free at all the edges. The materials were adopted to meet the assumptions of a homogenous, isotropic material model. The material parameters were: for steel $E_s = 195.2$ GPa, $\nu_s = 0.30$, $\rho_s = 7741.7$ kg/m³, and for adhesive $E_a = 5$ GPa, $\nu_a = 0.35$, and $\rho_a = 1330$ kg/m³. The material damping was neglected because of its marginal influence on the RMS damage imaging. Both adherends and the adhesive film were assumed to be independent structures combined rigidly at the part of their surfaces by means of a tie connection (compatibility of translational degrees of freedom at all the contacting nodes). The excitation of guided waves was applied at the lower adherend in the form of the concentrated force surface load with the amplitude varying in time in accordance with the wave packet signal. The excitation frequency range was extended in comparison to experimental measurements (20 to 500 kHz). The dynamic analysis was conducted with the use of the central difference method with a fixed time step of 10^{-7} s. This value meets the recommendation of at least 20 points per each cycle of the wave with the higher frequency [52]. The results of the analysis were out-of-plane velocity signals collected at 3721 points spread over the area of the joint corresponding with experimental measurements.

Figure 5. View of a discretized model for numerical calculations with an indicated excitation point.

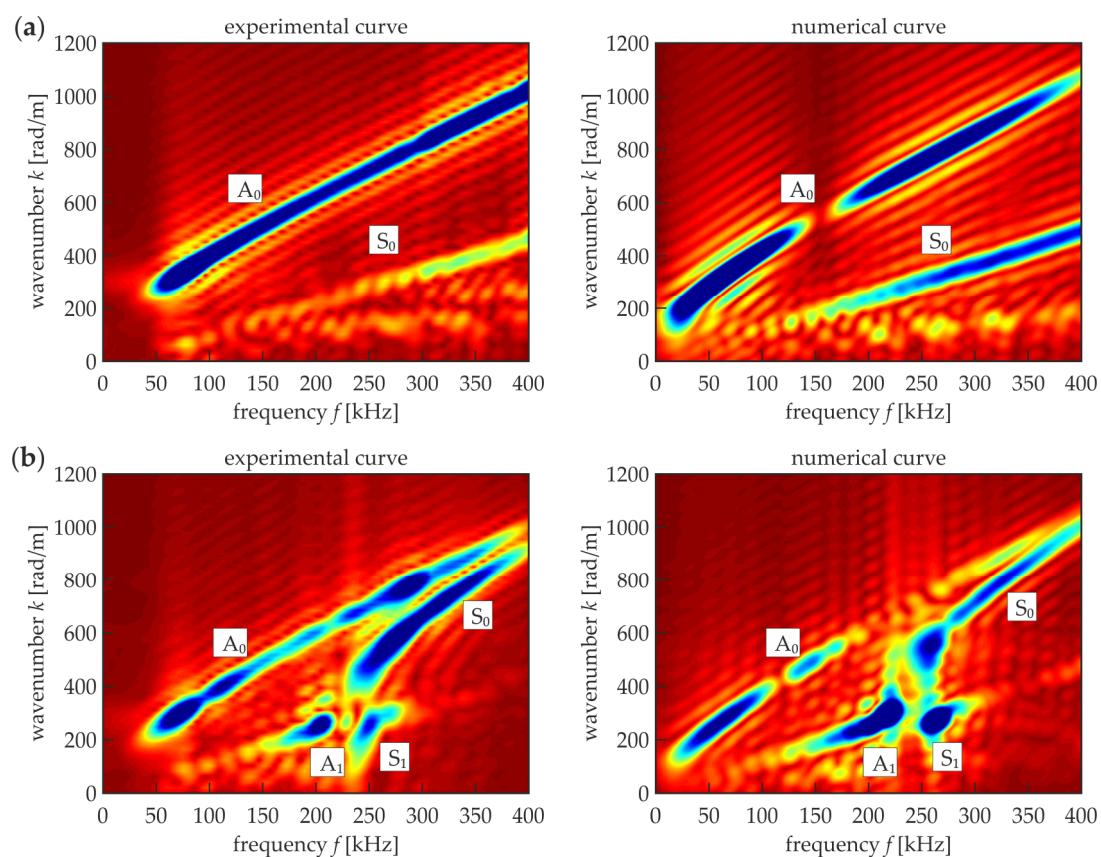
The initial step in the damage detection of adhesive joints was the comparison of Lamb wave characteristics in a three-layer medium (steel–adhesive–steel, simulating a properly prepared adhesive joint) and in a single-layer medium (single steel plate or disbonded area of the adhesive joint). For this purpose, dispersion curves were prepared experimentally and numerically for a steel plate with dimensions of 240 mm × 300 mm × 3 mm (sample D1) and for two plates with an adhesive film with a thickness of 0.2 mm bonding them together (sample D2). In each specimen, a wave packet in the form of a single-cycle Hanning windowed sinusoidal function was excited. The carrier frequency was changing in the range from 50 to 300 kHz with a step of 50 kHz. Additionally, for each frequency, symmetric and antisymmetric Lamb modes were excited independently. The velocity signals (out-of-plane components) were acquired in 101 points distributed along the straight line with a total length of 100 mm. The dispersion curves in the form of the maps representing wavenumber–frequency relations were obtained in the way of 2D-FFT (two-dimensional fast Fourier transform) calculations for each of 12 measurements (cf. [6,36,53]). The final result was the superposition of all the compound maps (Figure 6).

Figure 6. Experimental and numerical dispersion curves: (a) steel plate (sample D1)—single layer medium ($d_s = 3$ mm, $E_s = 195.2$ GPa, $\nu_s = 0.3$, $\rho_s = 7741.7$ kg/m³); (b) adhesive joint (sample D2)—three-layer medium consisted of two steel plates (parameters same as in (a)) and adhesive film ($d_a = 0.2$ mm, $E_a = 5$ GPa, $\nu_a = 0.35$, $\rho_a = 1330$ kg/m³).

A comparison of experimental and numerical curves led to the conclusion that both approaches gave consistent results. This also proved the appropriateness of the assumption of adhesive material parameters. To track the theoretical dispersion curves of Lamb waves in the investigated media, our own code was developed in the Matlab® software (9.3.0.713597, The MathWorks, Inc., Natick, MA, USA), implementing the transfer matrix method [54,55]. Figure 7a shows wavenumber–frequency relations for both media (samples D1 and D2). The shape of the curves is approximately the same as that shown in the maps in Figure 6. However, the possibility of the effective excitation of certain modes was not the same in the results of the measurements (in both experimental and numerical curves for the single plate and the joint). In sample D1 (Figures 6a and 7, black curves), only fundamental S_0 and A_0 modes can propagate in the considered frequency range, notwithstanding that the S_0 curve is not as strongly exposed as A_0 in the maps, which may be the result of the acquisition of only out-of-plane components on the upper surface that are related mainly to antisymmetric modes. In sample D2 (Figures 6b and 7, red curves), in addition to the fundamental pair, A_1 and S_1 modes are present starting from the frequencies of about 130 and 260 kHz, respectively. Moreover, the shape of the S_0 curve changes meaningfully compared with the single-layer plate. The shape of the A_0 curve does not change significantly in comparison to sample D1. The differences between the two types of media are also clearly visible on group velocity–frequency relations (Figure 7b), which will be useful in further considerations.

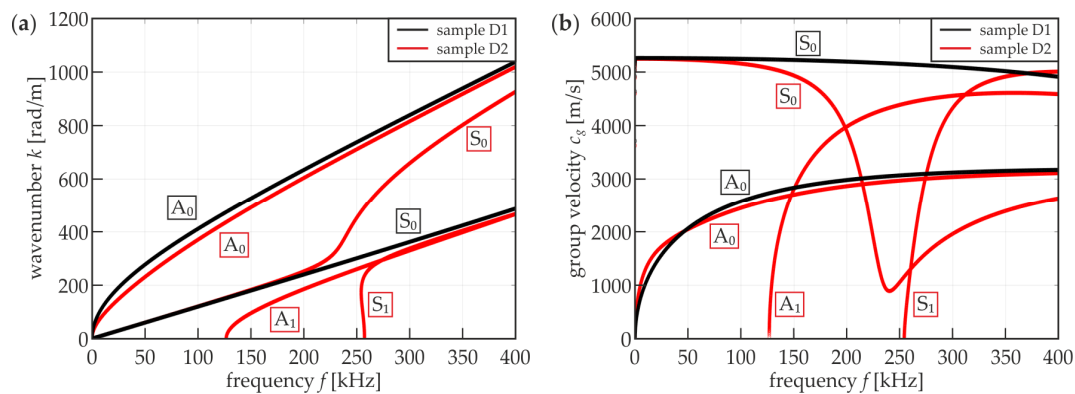
Figure 7. Theoretical dispersion curves for a steel plate (D1, black curves)–single layer medium ($d_s = 3$ mm, $E_s = 195.2$ GPa, $\nu_s = 0.3$, $\rho_s = 7741.7$ kg/m³) and adhesive joint (D2, red curves)–three-layer medium consisting of two steel plates (parameters same as above) and adhesive film ($d_a = 0.2$ mm, $E_a = 5$ GPa, $\nu_a = 0.35$, $\rho_a = 1330$ kg/m³): (a) wavenumber–frequency relations; (b) group velocity–frequency relations.

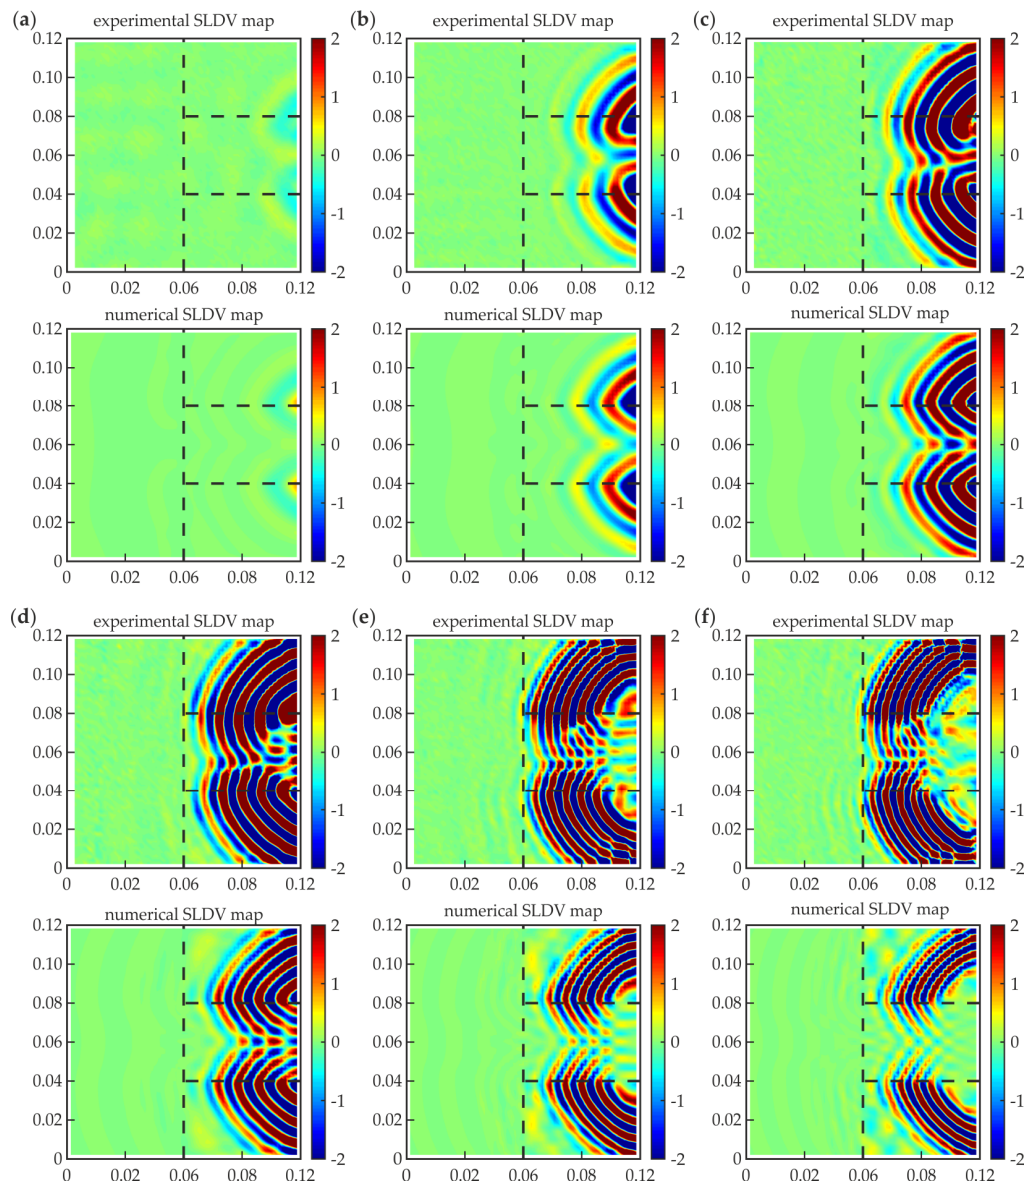
Guided wave fields representing out-of-plane velocity values were prepared for a specific time instance $t = 30$ μ s. Certain frequencies (50, 100, 150, 210, 300, and 350 kHz) were chosen for a comparative analysis of experimental and numerical results. The maps of propagating waves are presented in Figure 8. The comparison of presented snapshots revealed the variability of group velocity in relation to the excitation frequency. For the lowest frequency (50 kHz, Figure 8a), the wavefront is moderately visible (disturbance only at the initial part of the overlap). In the case of higher frequencies, the wavefront moved to the left side of the overlap, which suggests the greater speed of the excited wave packet. In fact, the individual selection of the time instance for each measurement can reduce these differences. Minor differences were observed between higher frequencies, because the group velocity was similar. Knowing that the excitation has an antisymmetric character, the A_0 mode is expected to be dominant. These observations agree with the dispersion curves (Figure 7b). The A_0 curve for the three-layer plate indicates significant growth in the group velocity value in the initial frequency range, and almost no variations in the further range. This explains why there are meaningful differences between snapshots for lower frequencies (50, 100, and 150 kHz), but wave fields are comparable for higher ones (210, 300, and 350 kHz), neglecting considerable changes in periods of wave packets.

Figure 8. Experimental and numerical guided wave fields (values in $\text{m/s} \cdot 10^{-3}$) for a specific time, $30 \mu\text{s}$, and different excitation frequencies: (a) $f = 50 \text{ kHz}$; (b) $f = 100 \text{ kHz}$; (c) $f = 150 \text{ kHz}$; (d) $f = 210 \text{ kHz}$; (e) $f = 300 \text{ kHz}$; and (f) $f = 350 \text{ kHz}$.

Comparing the experimental and numerical results, there are some slight differences. Firstly, the numerical maps are symmetric, whereas the symmetry of the experimental wave fields is vaguely disturbed, probably by an imperfect preparation of the specimen and an inaccurate assumption of the scanning area for measurements. Moreover, the wavefronts are disturbed sharply at the edges of the defect in the numerical snapshots, but this effect is not that demonstrable in the experimental results because of the irregularities in the shape of defect edges (cf. Figure 3). Additionally, the group velocity is slightly higher for the experimental maps. The reason might lie in the differences between the mechanical properties of both materials (steel, adhesive) or the geometry of plates and the adhesive film (especially thickness). The observation of each snapshot allows identifying the defect. Significant disturbances of the wavefront indicate the intended lack of the adhesive in the middle of the overlap. Nonetheless, the determination of the actual geometry of the damaged area is not possible, and additional signal processing is required.

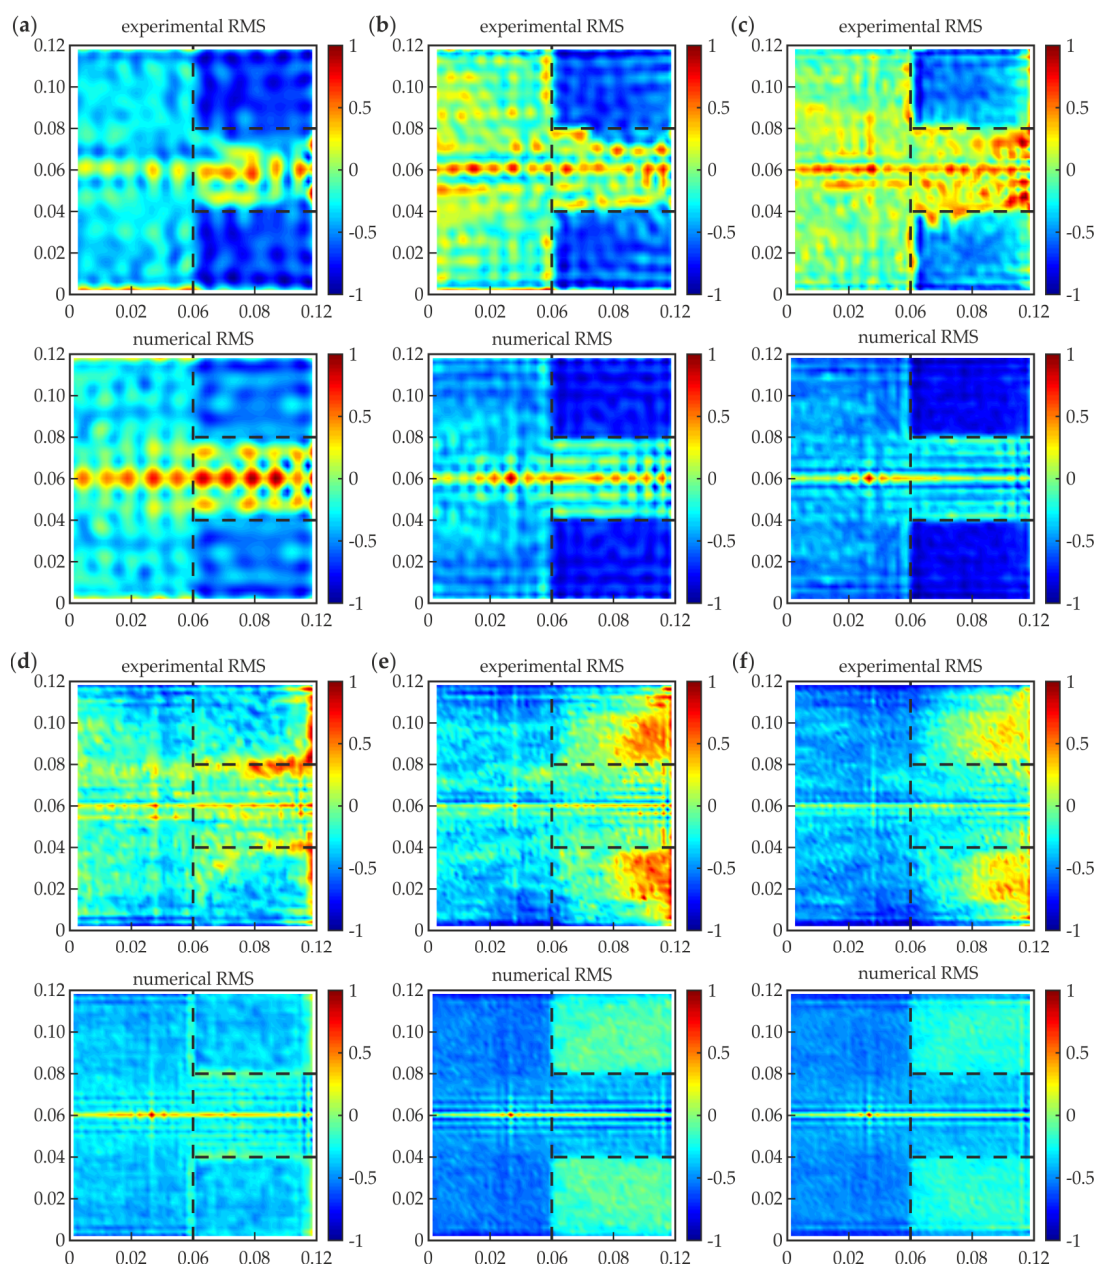
Figure 9 shows the RMS maps normalized to unity for experimental and numerical signals collected for specimen #1. The chosen frequencies were the same as those for the SLDV maps. Each RMS value was calculated with respect to Equation (2). The time window covered the whole time of signal acquisition, i.e., $T = 3.2 \text{ ms}$. The individual characterization of a single-layer medium (steel plate, such as the damage area) and a three-layer medium (properly prepared adhesive joint) should result in the clear difference of the calculated RMS values. However, it is undeniable that excitation frequency is an essential factor affecting the effectiveness of RMS damage imaging. For the lower frequencies (50 kHz, Figure 9a; 100 kHz, Figure 9b; 150 kHz, Figure 9c), the damaged area is characterized by highest RMS values rather than an appropriately prepared joint (similar to the single plate after the joint). The difference between these two areas is clear. Some differences between experimental and numerical maps result from irregularities in defect geometry (cf. Figure 3). It is worth noticing that at the lower excitation frequency, the lower resolution can be obtained in the map and, as a result,

Figure 9. Experimental and numerical root mean square (RMS) maps for different excitation frequencies: (a) $f = 50$ kHz; (b) $f = 100$ kHz; (c) $f = 150$ kHz; (d) $f = 210$ kHz; (e) $f = 300$ kHz; and (f) $f = 350$ kHz.

the larger defects can be omitted. This may be very important in the case of small defects; however, for the considered damage area, it is not essential. The frequency 210 kHz (Figure 9d) give an ineffectual result: there is almost no difference between the defect and intact joint, especially in the numerical map. In the experimental RMS, some boundary effects (intensification of the wave energy on the irregular edge) led to higher RMS values. This example shows that the invalid choice of the excitation frequency can make the measurement results useless. For the frequencies higher than 210 kHz (300 kHz, Figure 9e; 350 kHz, Figure 9f) the RMS values are lower in the damaged area than in the intact joint. The correlation between RMS values for these two areas is inverted. What is important is that the visual assessment of RMS maps shows that the distinction between the damaged and intact area of the joint is much more pronounced in the lower frequency range, especially for experimental maps, where the whole area of the adhesive layer does not have the same value. This may be the effect of the limitations of the used experimental setup. What is more, the increase in the excitation frequency is related to the increase in the wave attenuation.

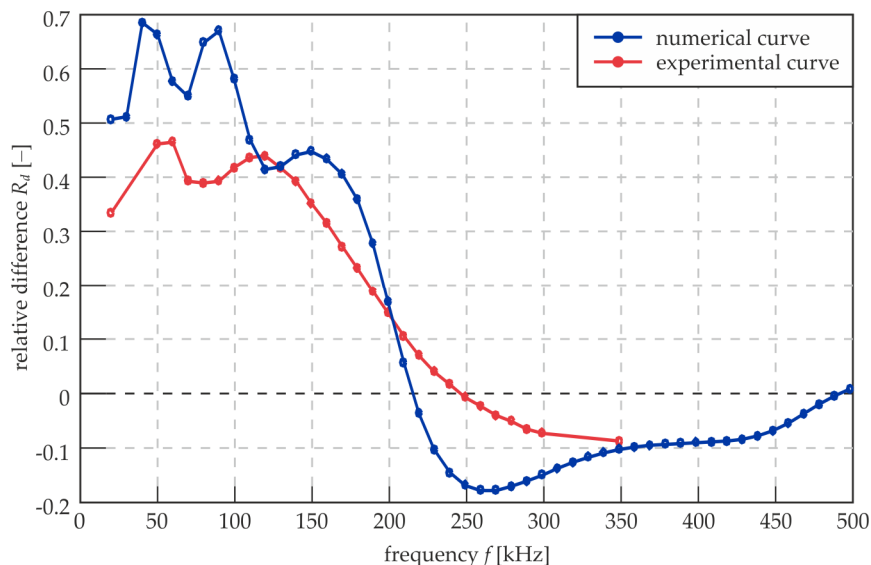
Figure 10 shows the relation between R_d and excitation frequency for experimental and numerical results. The curves are slightly different, but both have some characteristic points. The first one is a local maximum for 50 kHz. For this value, the A_0 modes for single and three-layer plates are crossing on dispersion curves (cf. Figure 7b). Then, there are some fluctuations that differ between the two curves. Another peak repeating for both experimental and numerical curves is for about 120 kHz, when the A_1 mode for the three-layer plate appears. Further, the curves are falling monotonically. The numerical curve has the root equal to approximately 215 kHz, and this is the frequency value for which the damaged area and intact joint are not distinguishable (cf. Figure 9). For the experimental curve, the root is translated to approximately 250 kHz. This may be the result of the energy intensification on the edges of the defect (cf. Figure 9d). The global minimum for the numerical curve is attained for approximately 260 kHz (the appearance of the S_1 mode for the three-layer plate). This is the frequency for which the joint and the defect can be distinguished with maximal efficiency in the frequency range above 210 kHz. Further, the curve is slightly rising until obtaining another root (about 500 kHz) at the end of the frequency range. The experimental curve does not obtain the local minimum above 210 kHz; instead, it is constantly falling to the end of the assumed frequency range up to 350 kHz. Generally, the positive values of R_d are obtained when the damaged area is characterized by higher RMS values than the intact joint. Negative values indicate on the inverted relation. If R_d equals zero, there is no possibility of identifying the defects. What is important is that the absolute values of R_d are higher below the first root (about 215 kHz), which suggests that the lower frequencies allow obtaining a better differentiation of three-layer and single layer media. However, the above-mentioned decrease in map resolution cannot be neglected. To compromise both of these factors (the differentiation between defect and intact joint and the map resolution), the excitation frequency should be chosen from an approximate range of 120 to 180 kHz. The determination of an optimal frequency value requires mathematical optimization and a proposition of an objective function containing components linked with the image resolution and the R_d value.

Figure 10. Relative difference between mean RMS values for damaged and intact areas of overlap for experimental (frequency range from 20 to 350 kHz) and numerical results (frequency range from 20 to 500 kHz).

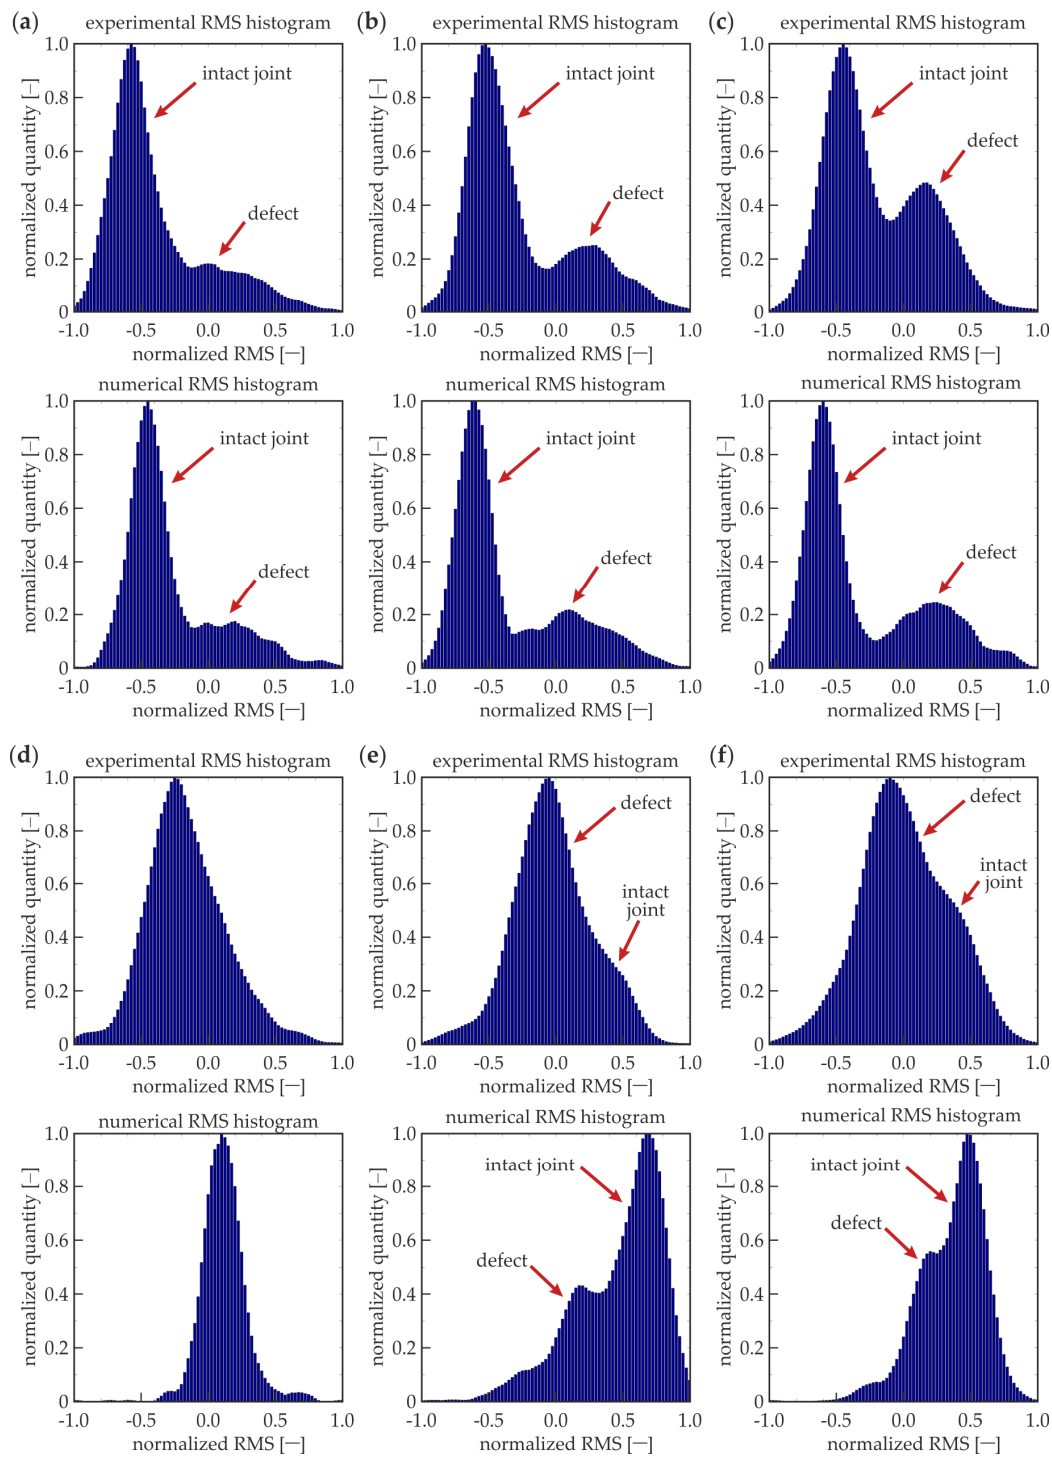
Figure 11 presents RMS histograms that have been prepared for certain frequencies (the same as for the RMS maps). The results are normalized, both for the RMS value and the quantity axes. For the lower frequencies (50, 100, and 150 kHz), bimodal distributions were obtained for the experimental and numerical data. The first mode is characterized by the lower RMS values and related to the intact joint area (cf. Figure 9a–c). The second mode indicates the defect existence (higher RMS values), and it obtains less quantity than the first mode, because the defect surface is twice as small as the intact joint surface. For 210 kHz (Figure 9d), the histograms are unimodal, which results from the equality of mean RMS values calculated for the defect and intact joint ($R_d = 0$, not efficient damage imaging). The experimental histogram is not as narrow as the numerical one, which is related to the translation of root of curves from Figure 10. For higher frequencies (300 kHz, 350 kHz), the distributions are not unimodal; the damage can be identified, and its mode is related to the lower RMS values. The dissociation of modes is not as clear as for lower frequencies—this effect is related to the lower absolute values of R_d for higher frequencies. In numerical histograms, the defect mode is characterized by the lower intensity than the intact joint mode (compatibly with the relation of surfaces of damaged and intact areas). The experimental histograms do not cover the same rule; the intact joint mode has a lower intensity because higher RMS values are not obtained in the whole area of the properly prepared joint (cf. Figure 9e,f). To sum up, the histogram analysis can reveal the existence of damaged areas, but it has some limitations. Firstly, the geometry of the defects cannot be determined. Moreover, the method is not efficient for small defects, because the damage modes would be of small quantity, which makes it impossible to identify them on the histograms.

Figure 11. Experimental and numerical RMS histograms for different excitation frequencies: (a) $f = 50$ kHz; (b) $f = 100$ kHz; (c) $f = 150$ kHz; (d) $f = 210$ kHz; (e) $f = 300$ kHz; and (f) $f = 350$ kHz.

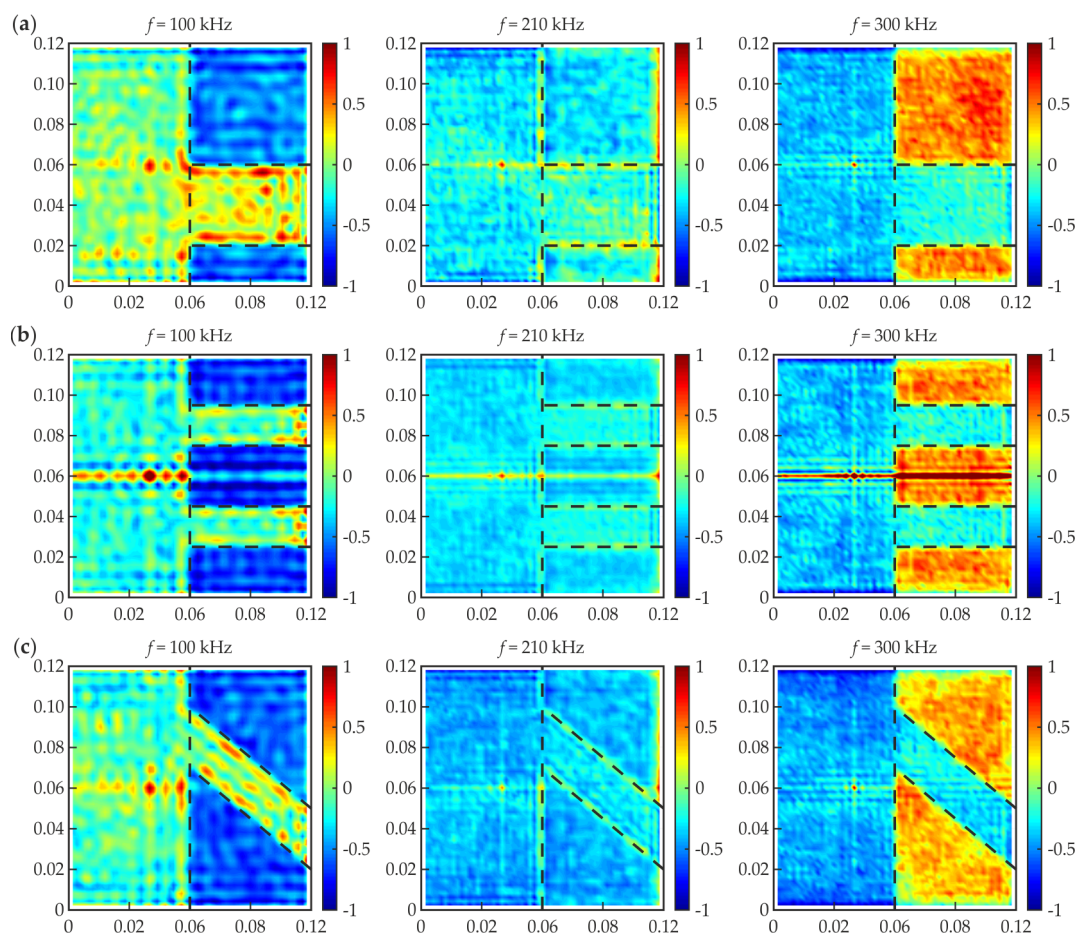
Figure 12. Numerical RMS maps for different excitation frequencies (100, 210, and 300 kHz) and different defects: (a) #2; (b) #3; and (c) #4.

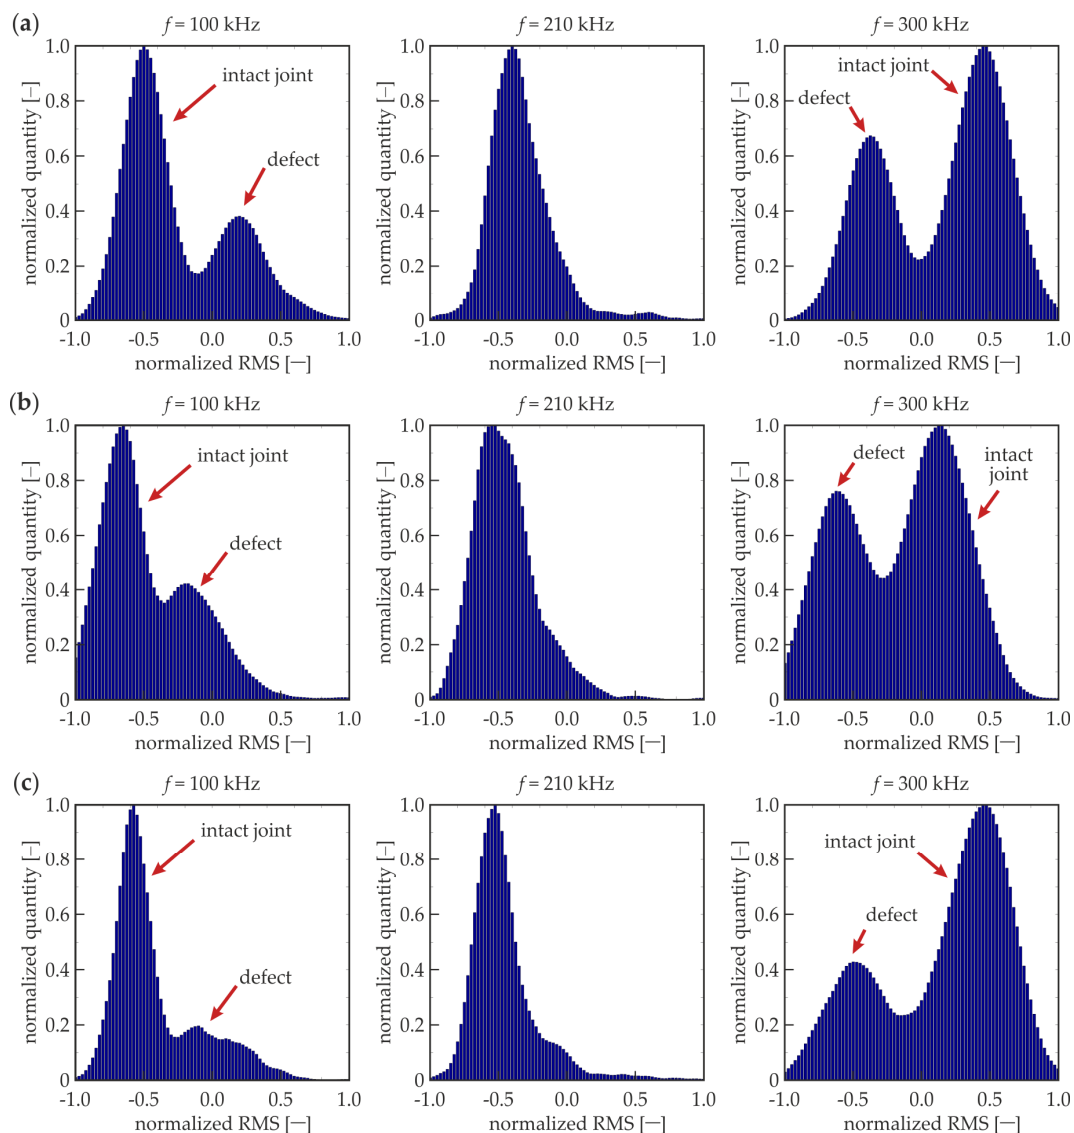
significant. The frequency of 300 kHz resulted in lower RMS values in the damaged area. Moving to the histograms (Figure 13), the frequency 210 kHz gave the unimodal distribution (no difference between the defect and intact joint). The histograms for 100 and 300 kHz gave bimodal distributions, but for lower frequencies, the defect mode was related to higher RMS values, whereas for higher frequencies, it was related to lower RMS values. The quantity for the defect mode was always smaller than that for an intact joint. The considerations for joints #2 to #4 provided the same results as for specimen #1. Summarizing, the efficiency of a measurement with a specific excitation frequency does not change with the geometry of a damaged area. It is a satisfying conclusion, because generally, the geometry of the damaged area is unknown. This means that an additional preliminary study consisting of numerical calculations can reveal the appropriate excitation frequency value and reduce the number of measurements. However, the possibility of the damage identification due to a frequency value depends strongly on the characteristics of the considered media, so they need to be determined.

Figure 13. Numerical RMS histograms for different excitation frequencies (100, 210, and 300 kHz) and different defects: (a) #2; (b) #3; and (c) #4.
