Technical Limitations in Merging Secular and Sacred Functions in Monumental Churches

Ksenia Piatkowska¹

¹ Gdansk University of Technology, Narutowicza 11/12, 80-233, Gdansk, Poland

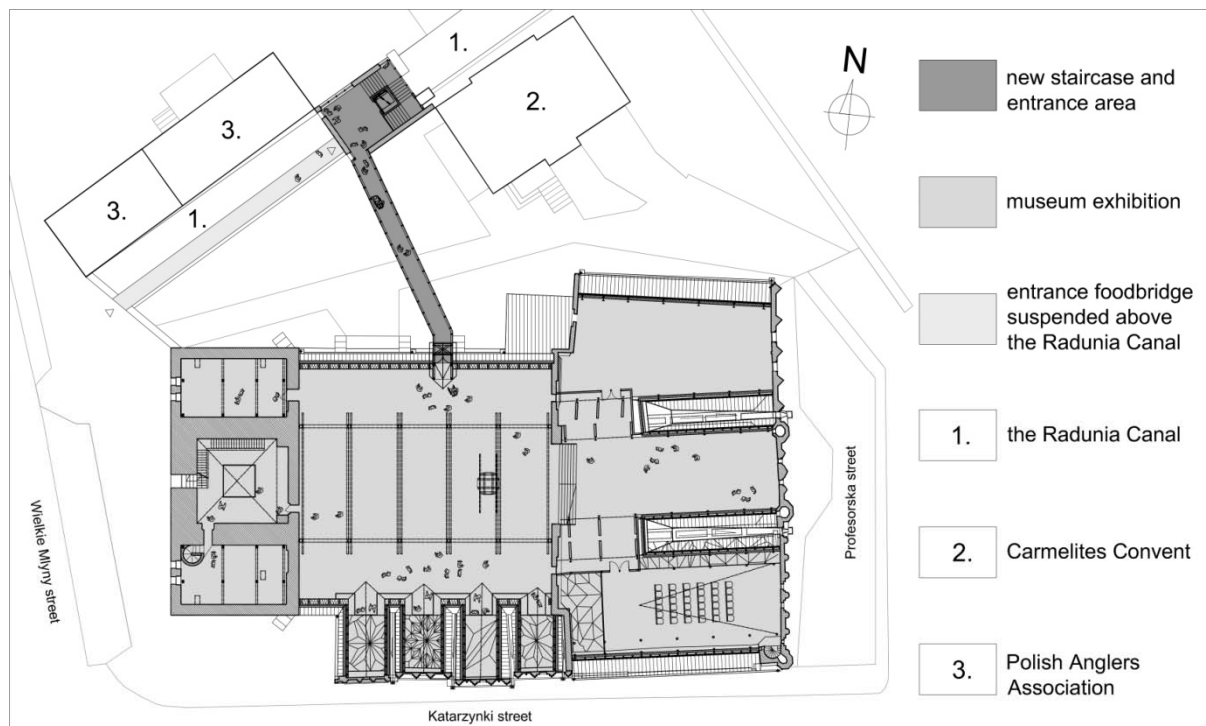
Figure 1. The museum exhibition and the new staircase building with the entrance area - plan on the level +11.70 m.

The scheme of functionality relevant to the architectural design for the New Museum of Science was developed by the Historical Museum of the City of Gdansk. It consisted of the following areas: entrance area for ticket sales and info point, a small museum shop and cloakroom, a zone for permanent and temporary exhibitions, conference hall and educational zone, areas for preparing exhibitions, toilets for visitors, museum offices and social facilities for the museum staff (figure 1).

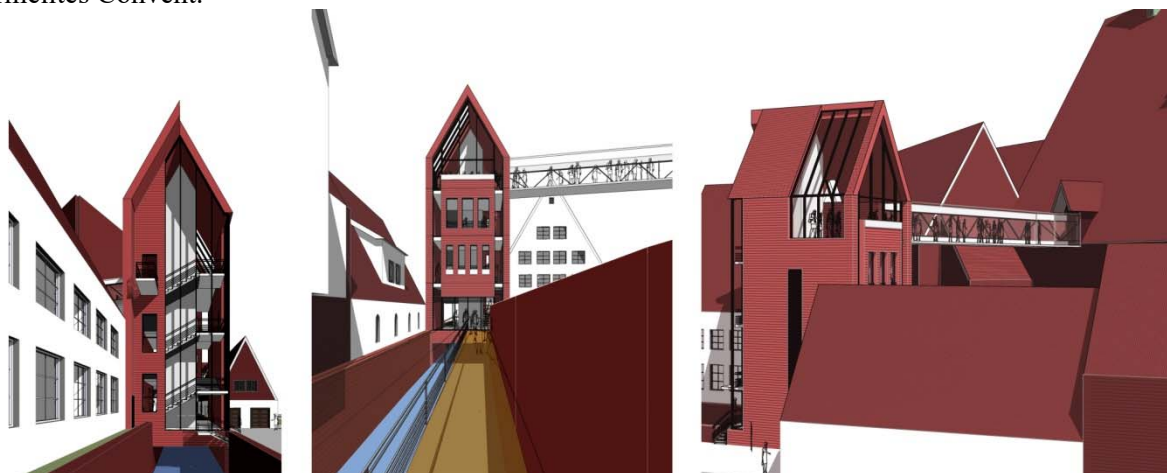
Figure 2. The new staircase building with the entrance area viewed from different perspectives.

building of the monumental Small Mill. The new construction was designed over the Radunia Canal, based on both sides of its structural walls (figure 2). This made it possible to ensure a representative approach to the entrance of the museum, while preserving the privacy of the site belonging to the Carmelites Convent.
