Article

Detection and Imaging of Debonding in Adhesive Joints of Concrete Beams Strengthened with Steel Plates Using Guided Waves and Weighted Root Mean Square

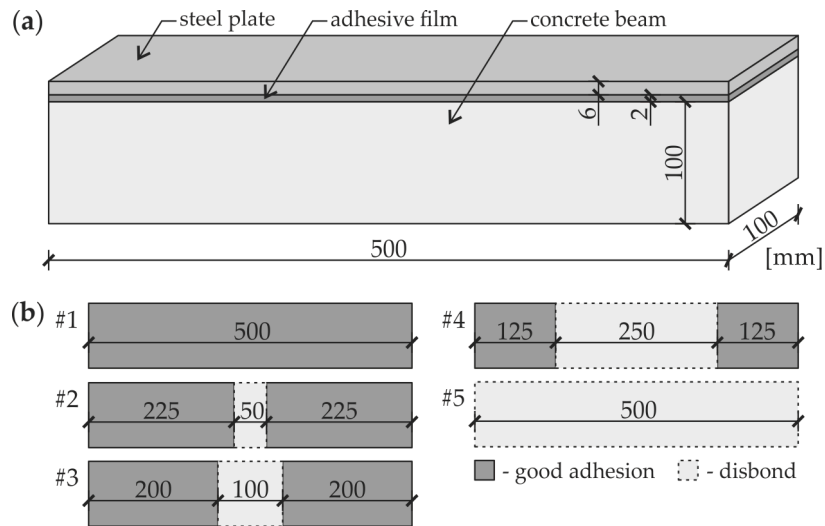
Figure 1. Analyzed specimens: (a) geometry of beams and (b) variants of defects.

The object of investigations (Figure 1a) was a beam with a square cross section of 100 mm × 100 mm and a length of 500 mm. The beam was made of concrete class C30/37 and strengthened with a steel plate of dimensions 100 mm × 6 mm × 500 mm fixed to the upper surface of the beam by an adhesive film. Five specimens were analyzed (Figure 1b). The first specimen was an intact composite beam (#1) with a full connection between both elements. Three partially damaged beams (#2, #3, and #4) had defects in the form of a debonding, covering a different area of the joint (relative defect surface was 10%, 20%, and 50%, respectively). The last sample was a steel plate (#5), which was laid freely on the beam to simulate a fully debonded joint. The defects were obtained by sticking a Teflon (PTFE) tape

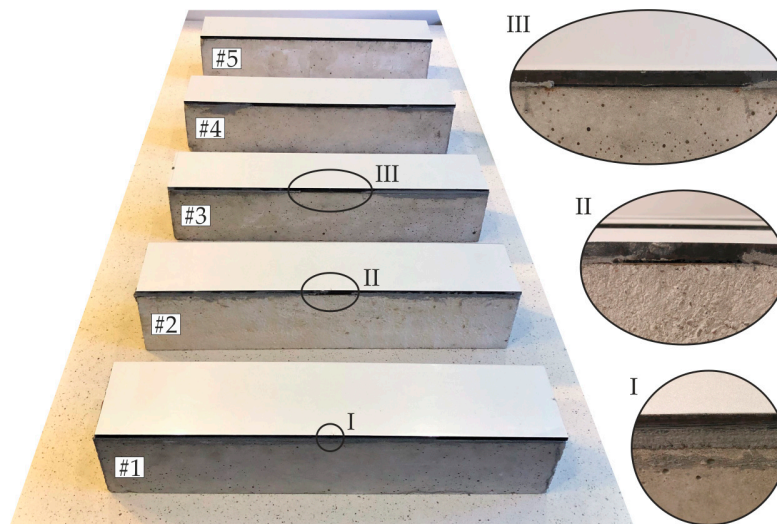
Figure 2. Photograph of prepared specimens (#1–#5) with close-up views of adhesive films in beams #1, #2, and #3.

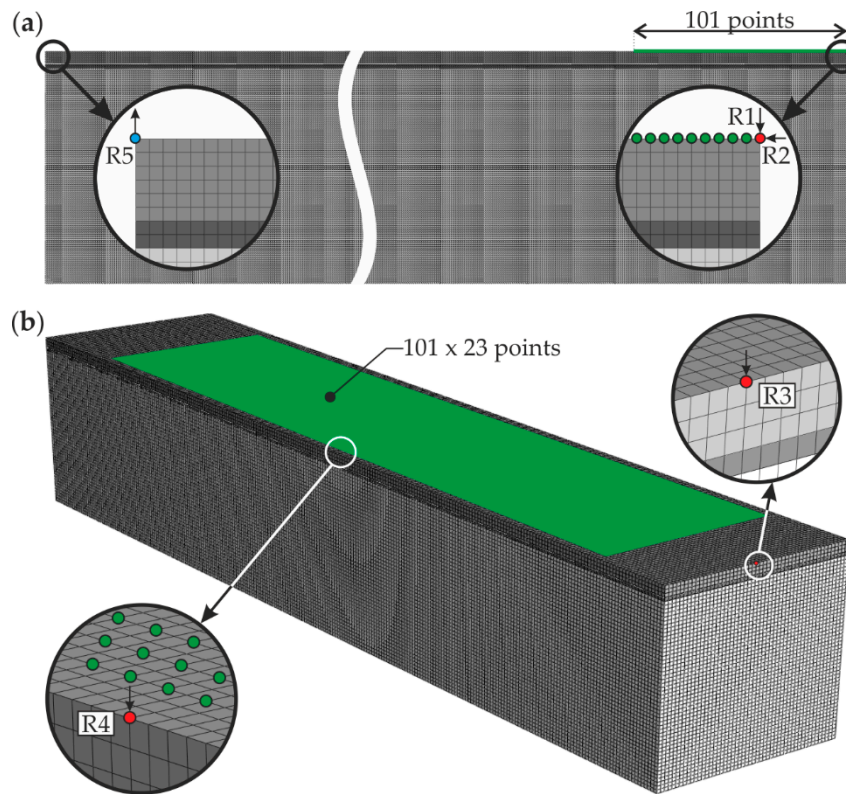
Figure 4. Numerical models for specimen #1: (a) 2-D plane model and (b) 3-D spatial model.

Two kinds of models were prepared for different purposes, plane (2-D) and spatial (3-D). Two-dimensional models (example in Figure 4a) were prepared for specimens #1 and #5 to analyze the differences between guided wave fields in a single-layer plate and a three-layer medium. Two-dimensional four-node plane strain elements with reduced integration (CPE4R) were used. The element size was constant and equal to 1×1 mm² throughout the whole model. This value satisfies the requirement of the appropriate mapping of wave behavior (at least 10 nodes for the length of the shortest considered wave) presented in [48]. The calculations were conducted with a fixed time step with a value of 10^{-7} s that meets the recommendation of at least 20 integration points per cycle of the wave with the highest frequency of interest [49]. For initial analysis, the wave was excited at one end of the plate (point R1) and its signal was collected at another end (point R5) to determine the time-of-flight (TOF) of the wave through the length of the specimen. In the same simulation, guided wave field was saved for the whole model. The excitation had the form of a concentrated force varying in time in accordance with a 5-cycle tone burst with a center frequency of 10, 23, and 100 kHz (three different simulations). The plane models were also used to determine the numerical dispersion curves, similarly as in the experimental investigations (cf. Figure 3b). The input signal was applied in points R1 and R2 (independently) as a wave packet modulated from a single-cycle sine function with a different frequency (50, 100, 150, 200, and 250 kHz), resulting with ten consecutive simulations. The guided wave responses were obtained at 101 points distributed along the line with a length of 100 mm, giving 1 mm spacing between each point. It is worth noting that the measurement path was oriented perpendicularly to the one in experimental investigations. However, the results of both approaches could be compared, as long the materials used were modeled as isotropic and only the initial parts of signals were further analyzed. Three-dimensional models (example in Figure 4b) were prepared for specimens #1–#5 to verify the results of experimental measurements. Eight-node linear brick elements

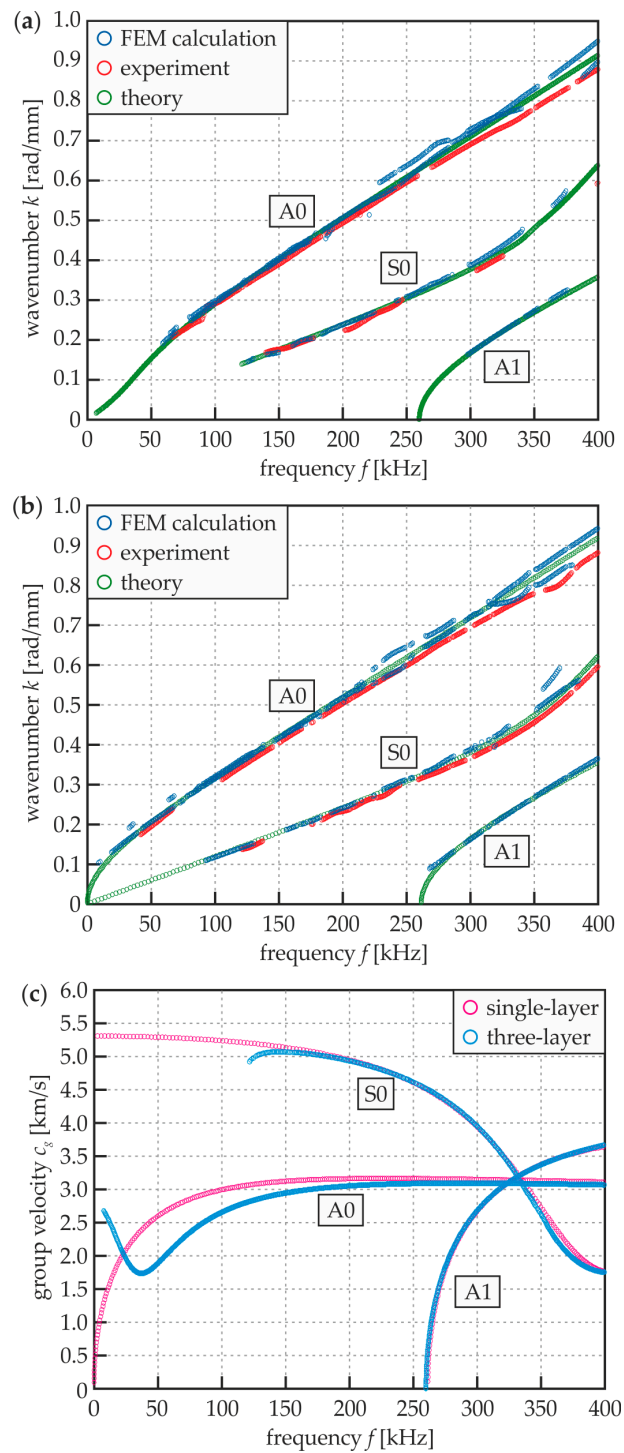
Figure 5. Dispersion curves for analyzed specimens: (a) wavenumber vs. frequency for three-layer plate #1; (b) wavenumber vs. frequency for single-layer steel plate #5; and (c) theoretical group velocity vs. frequency for three-layer plate #1 and single-layer plate #5.

The dispersion curves obtained from the three approaches are presented in Figure 5. The wavenumber–frequency relations for specimen #1 (Figure 5a) reveal the fact, that two flexural (A_0 , A_1) and one longitudinal (S_0) modes can propagate in the frequency range up to 400 kHz. It is essential to note, that the fundamental S_0 mode does not appear in the range up to 122 kHz and the A_1 mode is present for the frequencies above 260 kHz, thus only one mode can propagate for the assumed excitation frequency equal to 100 kHz. The comparison of the three approaches allowed concluding that the overall agreement between the numerical, experimental and theoretical results was very good. However, the higher mode A_1 was not identified in the experimental approach, probably due to the setup limitations. It is also important to note that neither experimental nor numerical calculations detected A_0 in the range up to 60 kHz, what could have been caused by the strict tolerance level. However, the increase of l would significantly decrease the legibility of the curves obtained. The analysis of dispersion curves for specimen #5 (Figure 5b) leads to similar conclusions. Compared with the results for beam #1, the S_0 mode can propagate in the whole assumed frequency range, such as A_0 . The dispersion relations for both specimens for the frequencies above 150 kHz are comparable. The important differences are observable in the lower frequency range. To expose these dissimilarities, the theoretical dispersion curves for group velocity were prepared for both #1 and #5 specimens (Figure 5c). No significant difference can be seen for the A_1 curve. The shapes of A_0 and S_0 curves are also very similar for the higher frequency range. As mentioned above, S_0 mode is not present in the lower frequency range. To be noticed, it is important to analyze the shape of the A_0 mode, because for the damage imaging, measurements the waves were excited perpendicularly to the plate surface and the out-of-plane velocity signals were collected. It is interesting that in the frequency range up to about 23 kHz it propagates with higher velocity in the specimen #1, whereas above this limit, the velocity of propagation is higher in specimen #5.

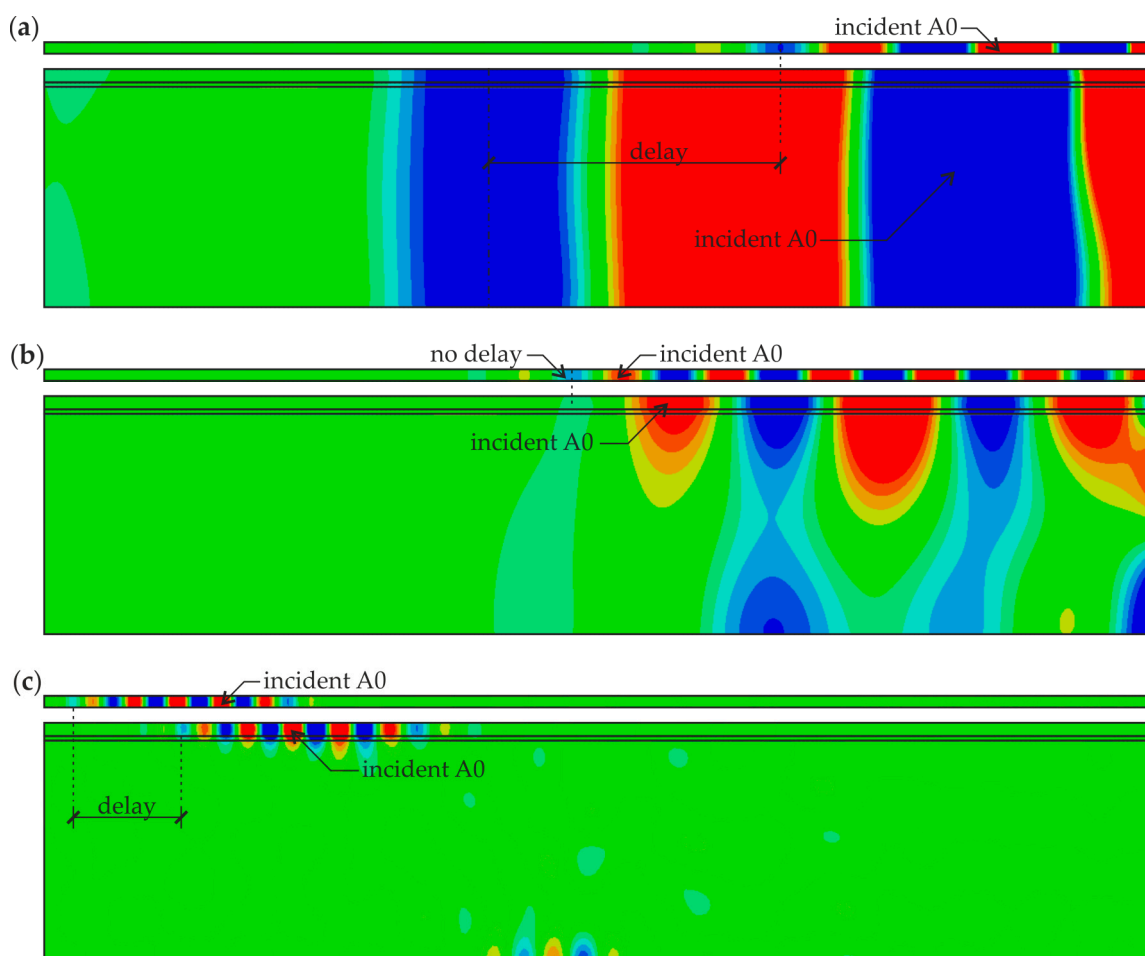
Figure 7. Numerical wave fields in 2-D finite element method (FEM) models of specimens #1 and #5 ($t = 0.17$ ms) for different excitation frequencies: (a) 10 kHz; (b) 23 kHz; and (c) 100 kHz.

In addition to the analysis of the time signals, the guided wave fields representing the propagation of A_0 mode for specimens #1 and #5 for a specific time instance 0.17 ms are shown in Figure 7. It is visible that the incident wave with the frequency of 10 kHz propagates faster in beam #1 compared with plate #5 (Figure 7a), what stays in the agreement with the comparison of dispersion curves. What is also important, the wave propagates through the three-layer medium as a single waveguide,

although the wave was excited only in the steel plate. It is possible because the A_0 wavelength is large enough (271 mm), compared to the overall sample thickness (108 mm). The length of the A_0 mode in beam #1 is significantly smaller (74 mm), but much greater than the thickness of the plate (6 mm). For the frequency equal to 23 kHz (Figure 7b) the wave packets in both specimens propagate with similar velocity. The distribution of the wave field through the thickness of specimen #1 is not uniform, the amplitude decreases with the depth because the wavelength (107 mm) is slightly smaller than the specimen thickness. The interesting situation takes place when the excitation frequency increases to 100 kHz (Figure 7c). The wave propagation velocity in specimen #1 is smaller compared with specimen #5 (what is confirmed by the dispersion curves), but the wave propagates mainly in the steel plate and adhesive film. The reason is that the wavelength is now much smaller (22 mm) than the overall specimen thickness. For the concrete part, only the Rayleigh waves can be observed propagating at the interface between concrete and adhesive and the bottom boundary. The length of the wave propagating in plate #5 is comparable with the one present in the beam #1 and equal to 20 mm, which is also clearly visible in the snapshot. The analysis of the FEM simulations illustrating in Figure 7 allows concluding that the differences in the dispersion curves for both, three-layer and single-layer media are less pronounced for the higher frequency range (above about 120 kHz), because in this case, the wave propagates mainly in the steel plate, passing by the influence of the concrete part. Thus, the damage visualization in analyzed specimens would not be successful in this case. On the other hand, lower frequencies result in poorer image resolution. As the compromise, the excitation frequency equal to 100 kHz was chosen for further investigations aimed at damage detection and imaging.

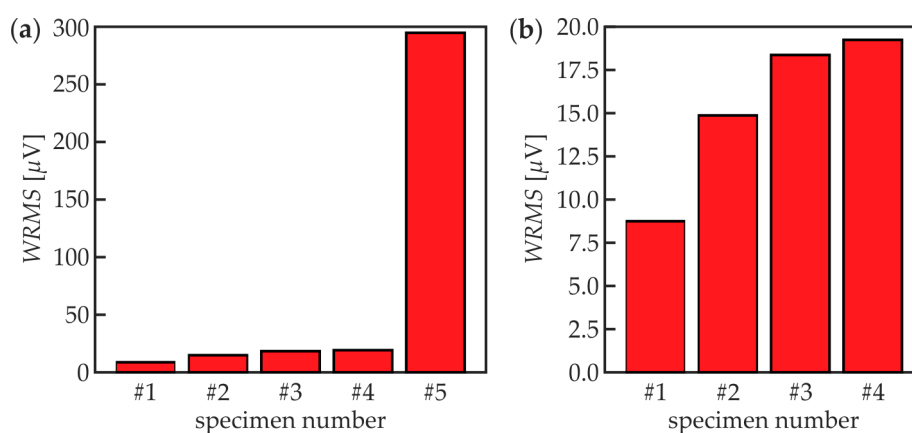
Figure 8. Weighted root mean square (WRMS) values of experimental signals collected in P5 point: (a) specimens #1–#5 and (b) specimens #1–#4.

The non-destructive diagnostics of specimens #1–#5 was conducted in two stages: identification and imaging. The aim of the damage identification was to detect, whether there are any defects in the adhesive joint between the concrete beam and the steel plate. The root mean squares values were calculated for the time signals excited by the actuator located in point P5 and measured by the sensor located in point P3 (see Figure 3c). This means that the wave propagated through the whole length of the specimen. The calculations were performed for the time of averaging assumed as $t_a = 1$ ms, with a linear weighting factor ($m = 1$, $w_r = r$). The results for all specimens are presented in Figure 8a. It is clearly visible that the WRMS value for specimen #5 (single-layer steel plate) is significantly higher than in others. In the case of specimen #5, the point of excitation was located on the free steel plate, characterized by the relatively small material damping. For specimens #1–#4, the wave was excited on the area where the steel plate had a good connection with the adhesive layer and concrete part (i.e., materials with higher damping) what resulted in the instantaneous leak and dissipation of energy in the bottom part of the specimen. For this reason, a close-up of the chart for the specimens #1–#4 is shown in Figure 8b. The correlation between WRMS value and the size of the defect is clearly visible, with the greater the damaged area, the higher WRMS value. This relationship occurs because the wave energy is magnified by the multiple reflections of propagating waves at the boundaries of defects. It is also worth noticing that the WRMS increased significantly between intact #1 and damaged #2 specimen (71%) but the further growth of defect surface did not result in the significant growth of WRMS. The damaged area of specimen #4 was 2.5 times bigger than in specimen #3 but the growths in comparison with #1 were equal to 116% and 129%, respectively. Concluding, the comparative analysis of WRMS values gave the answer about the presence of the defect, however, it did not provide the information about the size and location of damaged areas.

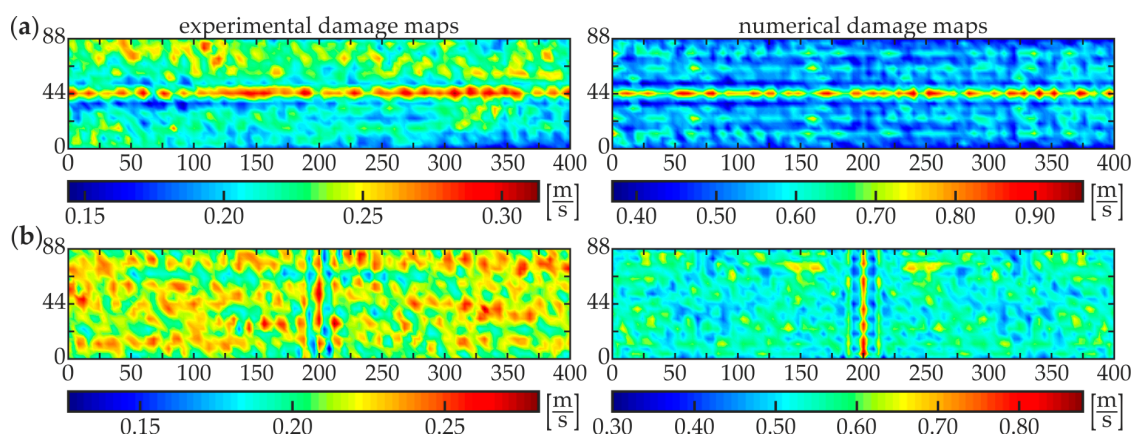
Figure 9. Experimental and numerical WRMS damage maps for specimen #1: (a) Excitation P3 and (b) Excitation P4.

The second stage, i.e., damage imaging, was performed to identify the exact position and size of the damaged area of each specimen. The WRMS map in the form of the two-dimensional defect representation over the scanned area was prepared based on the experimental investigations and numerical simulations on 3-D FEM models (see Figures 3c and 4b). The parameters of the calculations were assumed to be the same as for damage identification stage ($t_a = 1$ ms, $w_r = r$). The results for specimens #1–#5 are presented below. Figure 9 shows the WRMS maps for the intact composite beam (specimen #1). Regardless of the location of the excitation point, the visualizations reveal that no internal defects were detected inside the analyzed adhesive joint. The values in each experimental and numerical map are concentrated over a certain value. The horizontal lines with magnified values in images for excitation P3 (Figure 9a), such as the vertical lines for excitation P4 (Figure 9b) are the effects of the specimen and the load symmetry. Some interesting conclusions can be derived from the

adhesion and debonding. The only difference between both specimens is that the value of WRMS is significantly higher for the steel plate (see color bars in Figures 9 and 13).

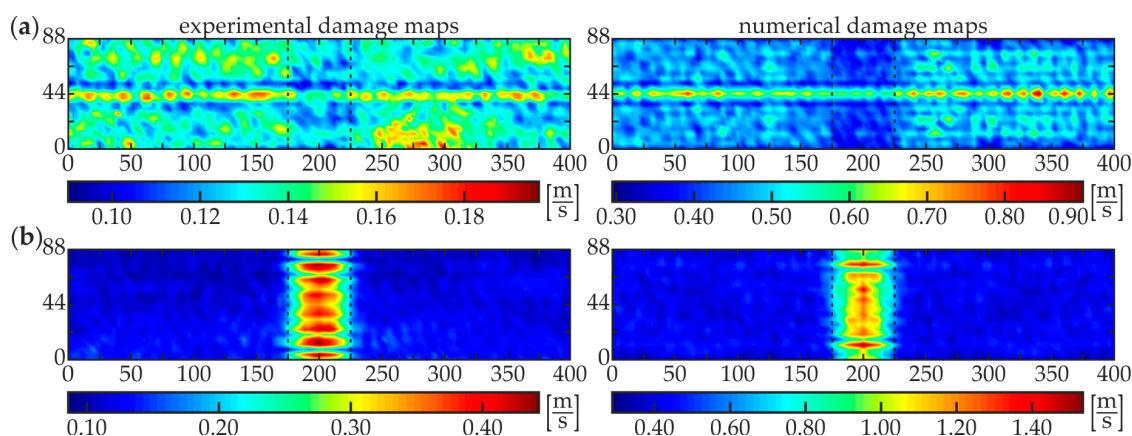
Figure 10. Experimental and numerical WRMS damage maps for specimen #2: (a) excitation P3 and (b) excitation P4.

analysis of the results for specimen #2 with a partial debonding (Figure 10). It is clearly visible that the map obtained for the excitation applied in point P3 (Figure 10a) results in the moderate defect imaging when compared with the excitation in point P4 (Figure 10b). The reason is that the wave excited in point P3 (in the area of good adhesion) strongly leaks into concrete, so the wave energy is damped significantly before meeting the boundaries of the defect, thus it has no possibility to be clearly visualized. It was already possible to conclude in the stage of damage identification (the high WRMS value for specimen #5 indicated on this effect, see Figure 8a). However, the damaged area is somehow detectable and it is characterized by slightly smaller WRMS values than the remaining part of the sample. The energy of the wave excited by the actuator P4 is concentrated in the damaged area and the damage map has a high quality. The properly boded areas have much lower WRMS values because the waves transmitted to the three-layer medium are highly damped.

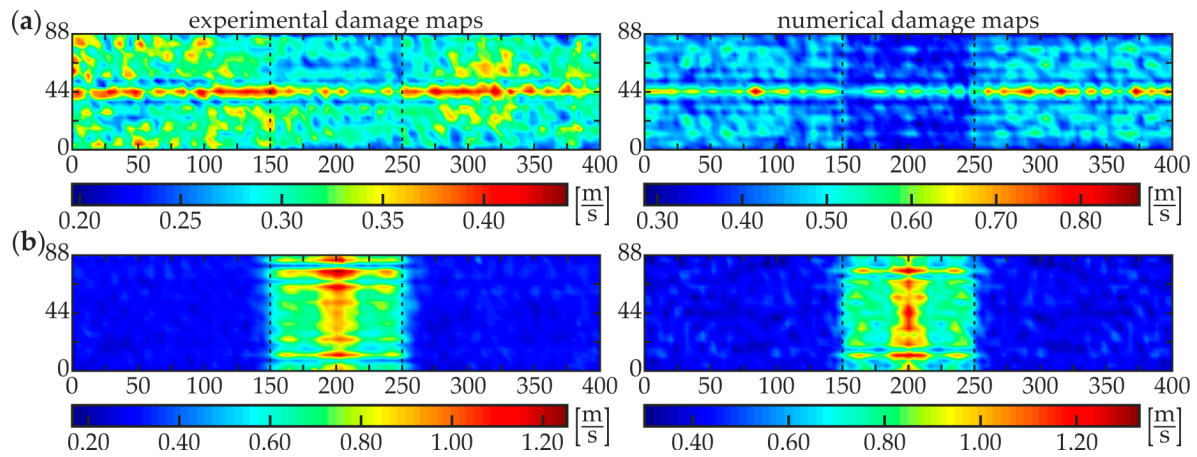
Figure 11. Experimental and numerical WRMS damage maps for specimen #3: (a) excitation P3 and (b) excitation P4.

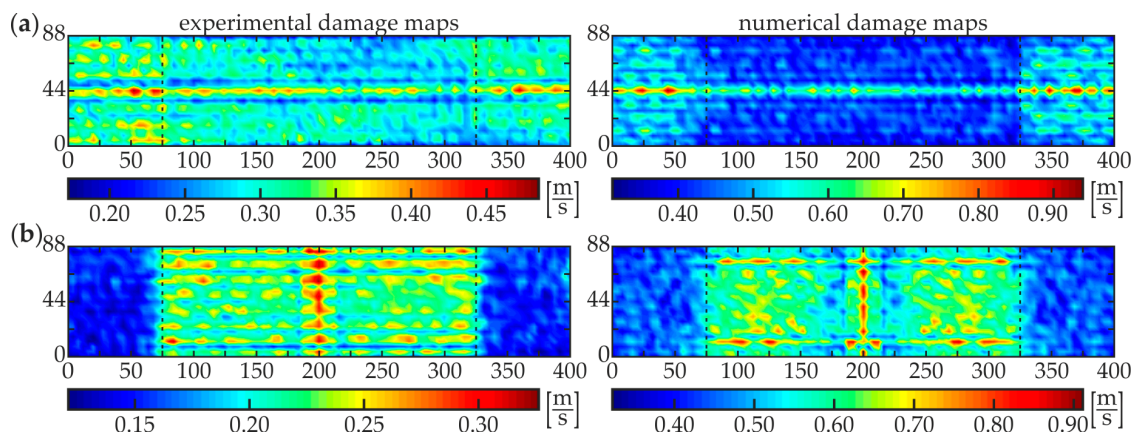
Figure 12. Experimental and numerical WRMS damage maps for specimen #4: (a) excitation P3 and (b) excitation P4.

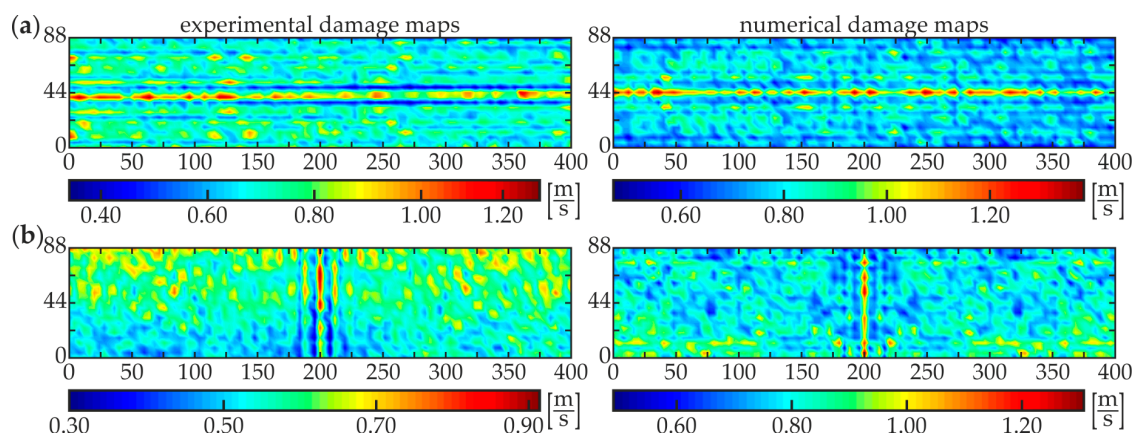
Figure 13. Experimental and numerical WRMS damage maps for specimen #5: (a) excitation P3 and (b) excitation P4.
