Article

Detection and Imaging of Debonding in Adhesive Joints of Concrete Beams Strengthened with Steel Plates Using Guided Waves and Weighted Root Mean Square

Department of Mechanics of Materials and Structures, Faculty of Civil and Environmental Engineering, Gdansk University of Technology, Narutowicza 11/12, 80-233 Gdansk, Poland; magdalena.rucka@pg.edu.pl (M.R.); s168197@student.pg.edu.pl (M.K.)

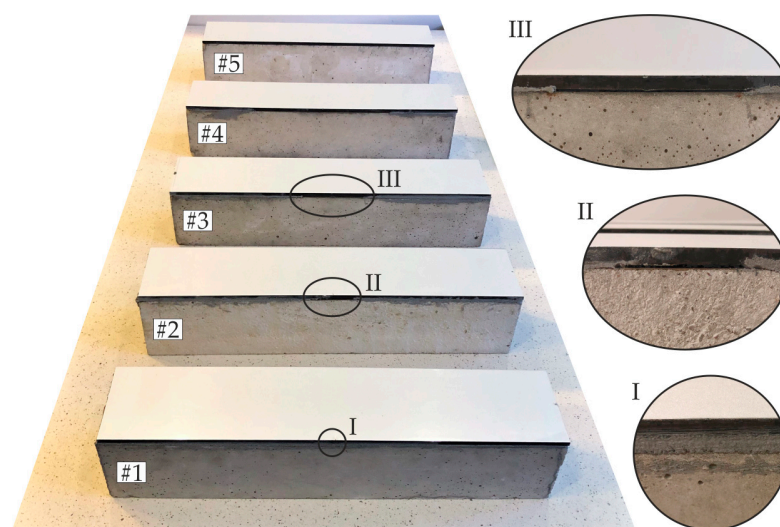
Figure 2. Photograph of prepared specimens (#1–#5) with close-up views of adhesive films in beams #1, #2, and #3.

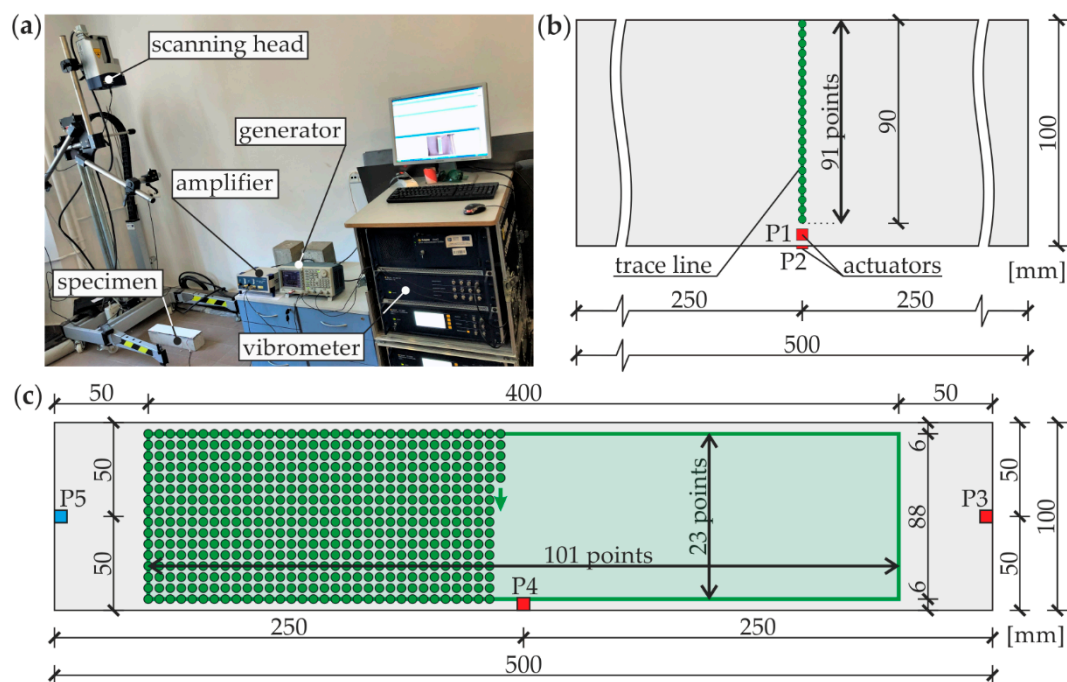
Figure 3. Experimental investigations: (a) setup for scanning laser Doppler vibrometry (SLDV) measurements; (b) scheme of measurements for dispersion curves determination; and (c) scheme for damage identification and visualization measurements.

The experimental measurements of guided waves were carried out by the scanning laser Doppler vibrometry (SLDV) method using the set-up presented in Figure 3a. The input wave signal was generated by the arbitrary function generator AFG 3022C (Tektronix, Inc., Beaverton, OR, USA) and magnified with the use of the high-voltage amplifier PPA 2000 (EC Electronics, Krakow, Poland). The excitation of the guided wave field was provided by the plate piezoelectric actuators NAC2024

The samples #1 and #5 were firstly tested to determine dispersion curves in a single-layer and three-layer medium, according to the scheme presented in Figure 3b. For this purpose, the propagation of antisymmetric and symmetric modes was induced by actuators P1 and P2, respectively, both attached to the steel plate. The input signal had the form of a wave packet obtained by the Hanning window modulation of the single-cycle sine function. To obtain a wide frequency spectrum for both excitation types, measurements were conducted five times with the different carrier frequency, equal to 50, 100, 150, 200, and 250 kHz, consecutively. The time-domain wave signals were acquired in 91 points spaced evenly over a straight line with a length of 90 mm, resulting with a resolution equal to 1 mm. The influence of potential reflections of propagating waves at the boundaries, induced by the short path length in relation with beam thickness, was further eliminated by analyzing only the initial part of the collected signals. The main investigations aimed at damage imaging in all beams #1–#5 were conducted with respect to the scheme shown in Figure 3c. Each specimen was tested twice, changing the location of the excitation point (P3 and P4). Excitation signal was a five-peak wave packet obtained from a sinusoidal burst with a central frequency equal to 100 kHz. The signals of propagating waves were collected in 2323 points distributed on the top surface of the steel plate, covering the area of $440 \times 88 \text{ mm}^2$. The scanning was conducted point by point in the regular mesh of 23 rows and 101 columns with a resolution of 4 mm in both directions.

ends of each beam to excite and acquire wave signals in points P3 and P5, respectively (Figure 3c). The excitation signal was created by the arbitrary waveform generator AFG 3022C (Tektronix, Inc., Beaverton, OR, USA) and then amplified by the high-voltage amplifier A400DI (FLC Electronics AB, Partille, Sweden). The collection of signals was provided by the digital oscilloscope PicoScope 4824 (Pico Technology, St Neots, Great Britain) with a sampling frequency of 20 MHz.

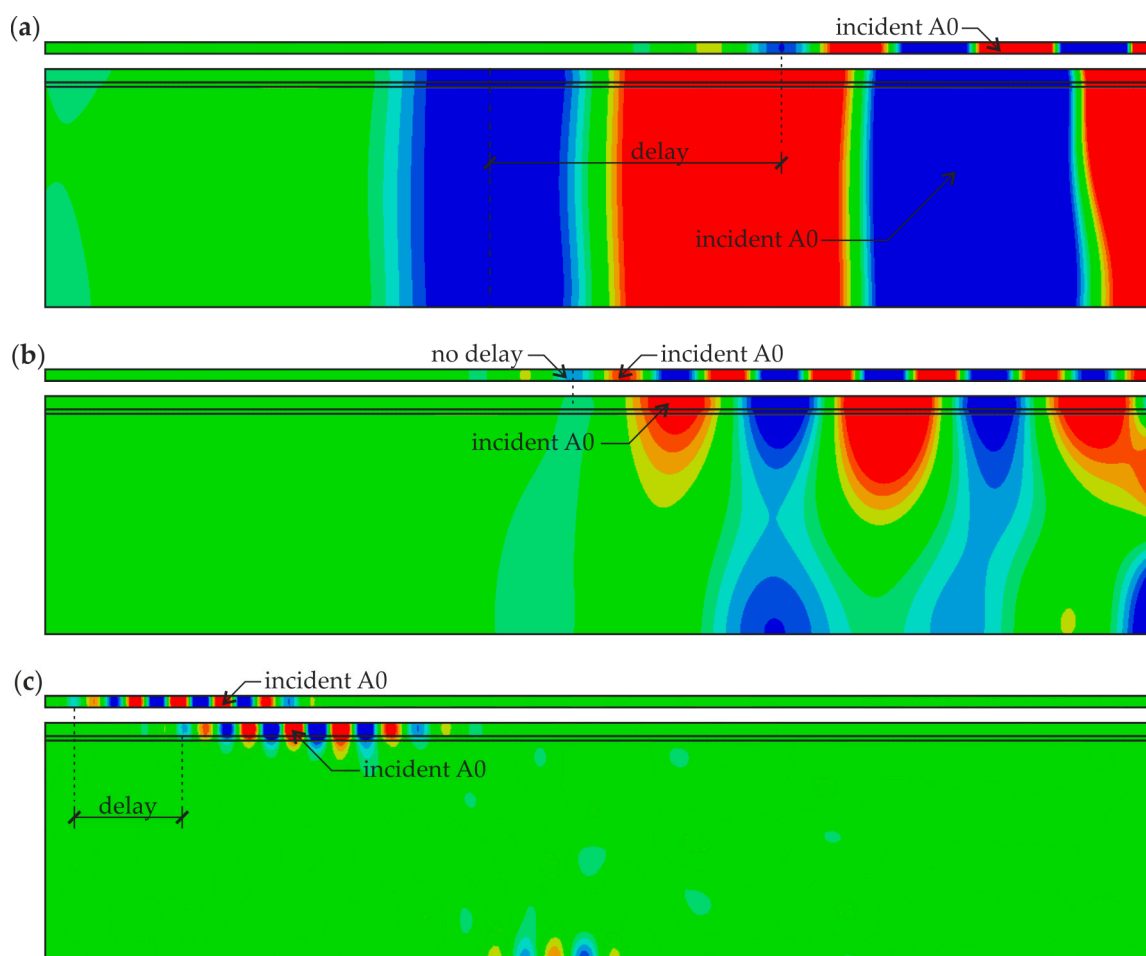
Figure 7. Numerical wave fields in 2-D finite element method (FEM) models of specimens #1 and #5 ($t = 0.17$ ms) for different excitation frequencies: (a) 10 kHz; (b) 23 kHz; and (c) 100 kHz.

In addition to the analysis of the time signals, the guided wave fields representing the propagation of A_0 mode for specimens #1 and #5 for a specific time instance 0.17 ms are shown in Figure 7. It is visible that the incident wave with the frequency of 10 kHz propagates faster in beam #1 compared with plate #5 (Figure 7a), what stays in the agreement with the comparison of dispersion curves. What is also important, the wave propagates through the three-layer medium as a single waveguide,

although the wave was excited only in the steel plate. It is possible because the A_0 wavelength is large enough (271 mm), compared to the overall sample thickness (108 mm). The length of the A_0 mode in beam #1 is significantly smaller (74 mm), but much greater than the thickness of the plate (6 mm). For the frequency equal to 23 kHz (Figure 7b) the wave packets in both specimens propagate with similar velocity. The distribution of the wave field through the thickness of specimen #1 is not uniform, the amplitude decreases with the depth because the wavelength (107 mm) is slightly smaller than the specimen thickness. The interesting situation takes place when the excitation frequency increases to 100 kHz (Figure 7c). The wave propagation velocity in specimen #1 is smaller compared with specimen #5 (what is confirmed by the dispersion curves), but the wave propagates mainly in the steel plate and adhesive film. The reason is that the wavelength is now much smaller (22 mm) than the overall specimen thickness. For the concrete part, only the Rayleigh waves can be observed propagating at the interface between concrete and adhesive and the bottom boundary. The length of the wave propagating in plate #5 is comparable with the one present in the beam #1 and equal to 20 mm, which is also clearly visible in the snapshot. The analysis of the FEM simulations illustrating in Figure 7 allows concluding that the differences in the dispersion curves for both, three-layer and single-layer media are less pronounced for the higher frequency range (above about 120 kHz), because in this case, the wave propagates mainly in the steel plate, passing by the influence of the concrete part. Thus, the damage visualization in analyzed specimens would not be successful in this case. On the other hand, lower frequencies result in poorer image resolution. As the compromise, the excitation frequency equal to 100 kHz was chosen for further investigations aimed at damage detection and imaging.

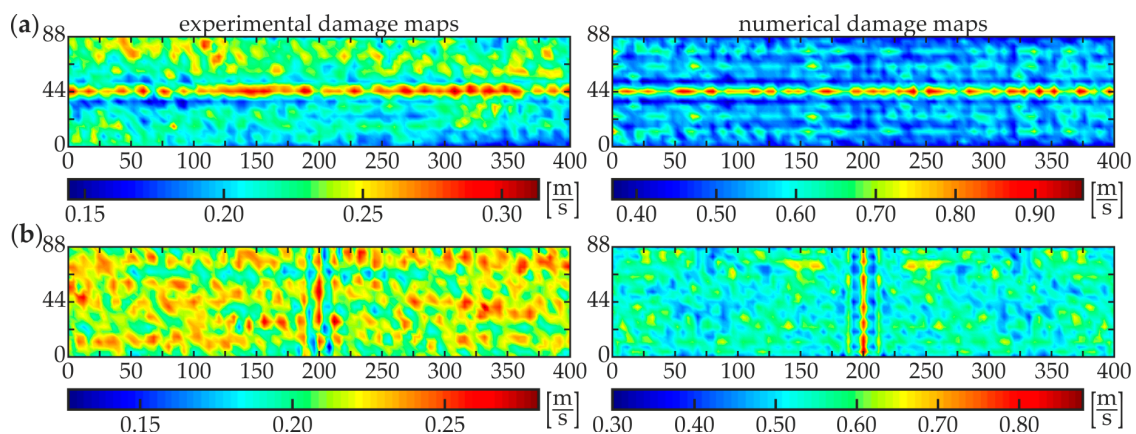
Figure 9. Experimental and numerical WRMS damage maps for specimen #1: (a) Excitation P3 and (b) Excitation P4.

The second stage, i.e., damage imaging, was performed to identify the exact position and size of the damaged area of each specimen. The WRMS map in the form of the two-dimensional defect representation over the scanned area was prepared based on the experimental investigations and numerical simulations on 3-D FEM models (see Figures 3c and 4b). The parameters of the calculations were assumed to be the same as for damage identification stage ($t_a = 1$ ms, $w_r = r$). The results for specimens #1–#5 are presented below. Figure 9 shows the WRMS maps for the intact composite beam (specimen #1). Regardless of the location of the excitation point, the visualizations reveal that no internal defects were detected inside the analyzed adhesive joint. The values in each experimental and numerical map are concentrated over a certain value. The horizontal lines with magnified values in images for excitation P3 (Figure 9a), such as the vertical lines for excitation P4 (Figure 9b) are the effects of the specimen and the load symmetry. Some interesting conclusions can be derived from the

A good agreement of experimental and numerical results is observed, however, the quality of the numerical visualization for the excitation in point R3 is richer compared with the experimental one. This may be caused by the noise present in the experimental signals. Similar conclusions can be derived from the analysis of damage maps of scanning for the two other partially damaged beams: #3 (Figure 11) and #4 (Figure 12). The WRMS maps for the fully debonded joint #5 (Figure 13) are similar to the ones obtained for the intact composite beam #1 (cf. Figure 9). This convergence allows stating that the damage visualization is possible only when the area of scanning covers both areas of good

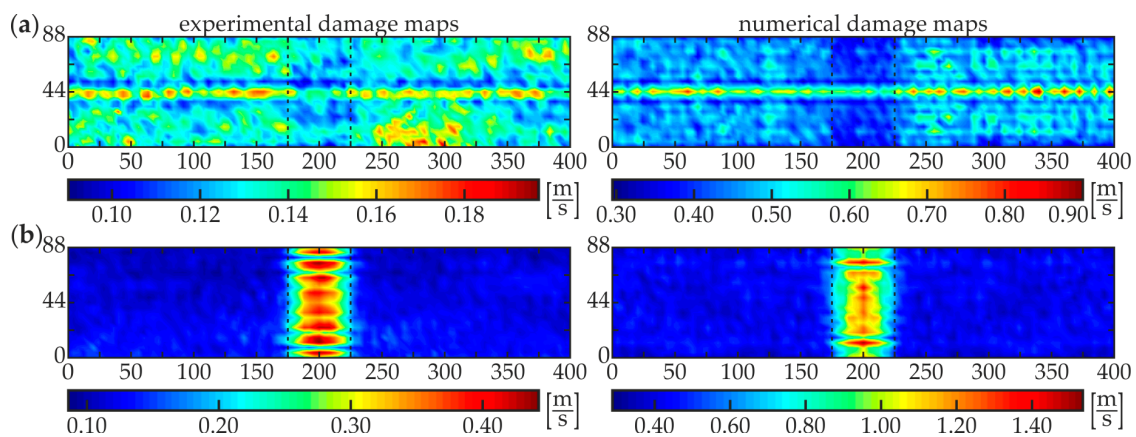
Figure 10. Experimental and numerical WRMS damage maps for specimen #2: (a) excitation P3 and (b) excitation P4.

analysis of the results for specimen #2 with a partial debonding (Figure 10). It is clearly visible that the map obtained for the excitation applied in point P3 (Figure 10a) results in the moderate defect imaging when compared with the excitation in point P4 (Figure 10b). The reason is that the wave excited in point P3 (in the area of good adhesion) strongly leaks into concrete, so the wave energy is damped significantly before meeting the boundaries of the defect, thus it has no possibility to be clearly visualized. It was already possible to conclude in the stage of damage identification (the high WRMS value for specimen #5 indicated on this effect, see Figure 8a). However, the damaged area is somehow detectable and it is characterized by slightly smaller WRMS values than the remaining part of the sample. The energy of the wave excited by the actuator P4 is concentrated in the damaged area and the damage map has a high quality. The properly boded areas have much lower WRMS values because the waves transmitted to the three-layer medium are highly damped.

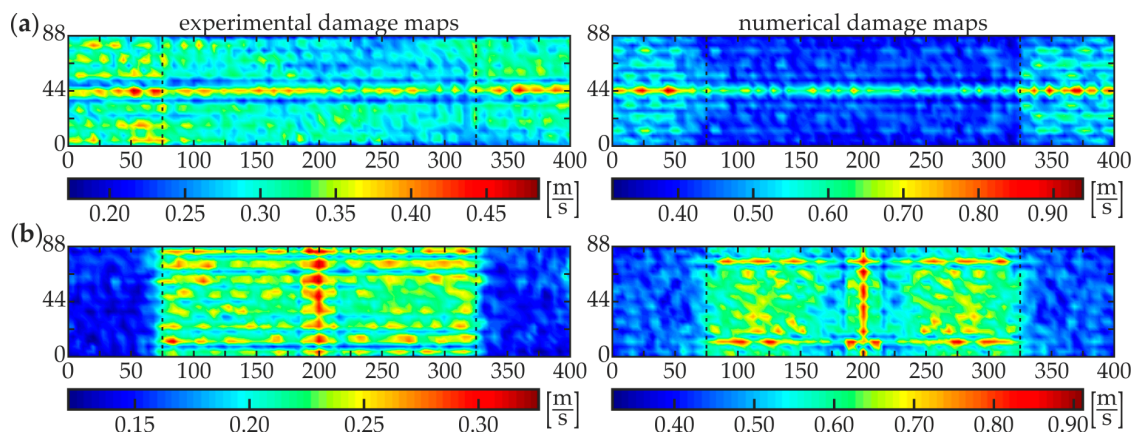
Figure 12. Experimental and numerical WRMS damage maps for specimen #4: (a) excitation P3 and (b) excitation P4.
