# Orbital blowout trauma occurring at the workplace – clinical, biomechanical and legal aspects

Skorek A, Kłosowski P, Żerdzicki K, Skorek P, Lemski P, Zmuda-Trzebiatowski M. Orbital blowout trauma occurring at the workplace – clinical, biomechanical and legal aspects. *J Pre-Clin Clin Res.* 2020; 14(2): 39–43. doi: 10.26444/jpccr/123656

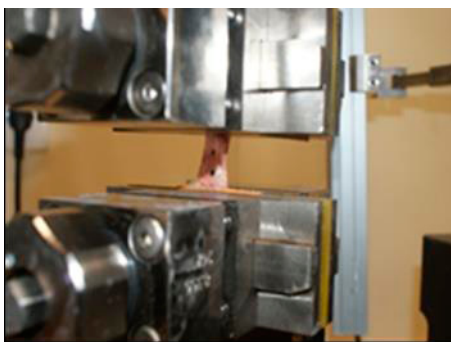
**Figure 1.** Mechanical bone examination using a Zwick Z020 strength testing machine with a video extensometer

**Laboratory tests.** In order to determine the value of the Young's modulus, fragments of bones were collected from the upper and medial orbital walls from fresh corpses during medico-legal autopsy. After preparation of specimens, examinations of the mechanical properties were carried out at the Department of Structural Mechanics using a Zwick Z020 testing machine with video extensometer (Figs. 1 and 2). The values of the Young's modulus obtained remained within the range 0.12 GPa – 3.6 GPa (according to the patient). The mean value adopted for further studies was 1.2 GPa. Based on the data from literature, the value of 150 MPa was adopted as a strain threshold, above which there occurs damage/fracture of bones) [6, 7, 8]. Consent for the study was obtained from the Bioethics Committee.

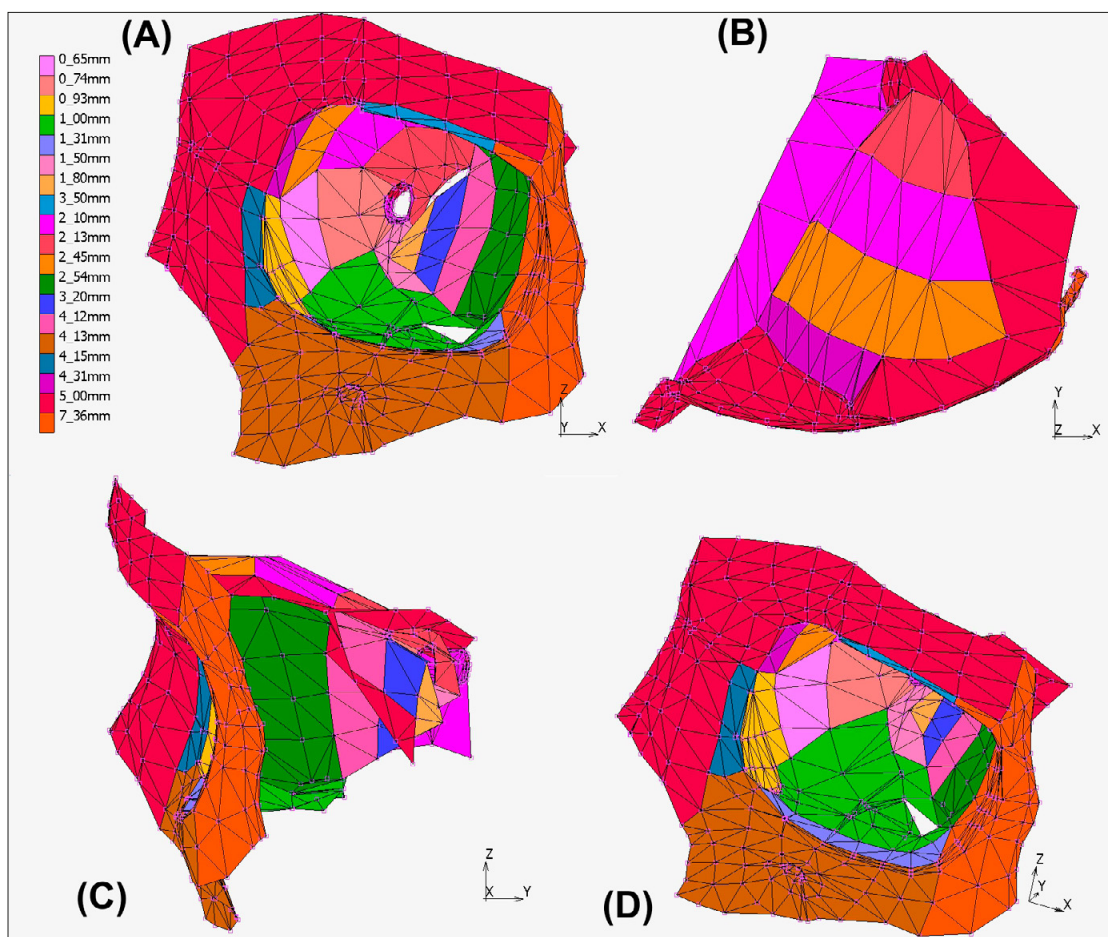
Figure 2. Numerical model of orbital bone structures

**Numerical finite element model of the eye orbit.** Using software AutoCAD 2012, a numerical model of the left orbit, together with the surrounding bones, was created, consisting of 969 triangular elements. In the model, the lower orbital fissure, optic nerve canal and the nasolacrimal duct outlet were taken into consideration. The model was created based on a computed tomography model of the facial skeleton performed in patients reporting to the Clinical Emergency Department for neurological reasons (including headache, vertigo syndrome, stroke). The authors excluded CT scans patients with past injuries and surgeries in the area of the facial skeleton, as well as diseases of the nose/sinuses and metabolic diseases. (These CT scans were most available, together with wide patients profiles – age, gender, free of additional diseases). Subsequently, the model was imported

The computer model was subjected to overloads in time, in a dynamic calculation option. According to studies by other researchers, it was assumed that the maximum force occurred after approximately  $1.3 \cdot 10^{-3}$ s, while the complete cessation of the force was obtained after approximately  $2.6 \cdot 10^{-3}$ s. [6, 7, 10]. In the first experiment, the model was assessed after using force applied to the nodal points located in the inferior wall (6 points located at the margin with the force of 2,400N to each point), and the lateral wall (3 nodal points with the force of 4,800N to each point). The total force was 28,800N. Both blows were shifted in time, i.e. the maximum force of the first blow (to the inferior wall) took place after the time of  $t = 1.3 \cdot 10^{-3}$ s, whereas of the second blow (to the lateral wall) – after the time of  $2.6 \cdot 10^{-3}$ s from the beginning of the test. Changes of strains within the orbital bone walls were observed. In the second experiment, the damage zone was evaluated in a model of a blow only to the inferior wall (6 points located at the margin with the force of 2,400N to each point). The total force was 14,400N. The force vector was directed along the long axis of the eye orbit, determined by the axis of the optic nerve.

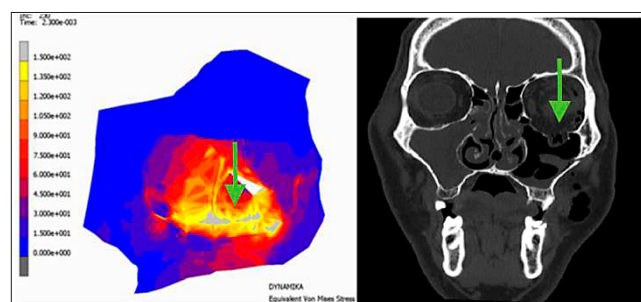
Figure 3. Patient after eye socket injury. CT image fracture in the lower wall with displacement of the orbital contents to the maxillary sinus (arrow). A comparable image obtained in the numerical model (arrow)

**Clinical material.** The radiological image (CT) and clinical data concerning 9 patients (Tab. 1) treated at the Otolaryngology Clinic due to orbital blowout trauma, were assessed. The traumas occurred at the workplace, and based on an interview with each patient it was confirmed that it was related with a double blow (the first to the lower orbital margin – with a blunt tool, metal splinter, construction element, whereas the second blow – an ordinary head blow from the ground, associated with falling), or an isolated blow to the inferior wall. The CT image was assessed in the horizontal and frontal planes to determine the location of fractures. The location of fractures was evaluated according to their location with respect to the outer rim of the orbit, inferior and lateral walls, and the infraorbital nerve canal. The radiologic image was compared with the pattern obtained on a numerical model (Figs. 3 and 4).
