# Weldability of Underwater Wet-Welded HSLA Steel: Effects of Electrode Hydrophobic Coatings

Jacek Tomków

Division of Welding Engineering, Faculty of Mechanical Engineering and Ship Technology, Gdańsk University of Technology, Gabriel Narutowicza 11/12, 80-233 Gdańsk, Poland; jacek.tomkow@pg.edu.pl

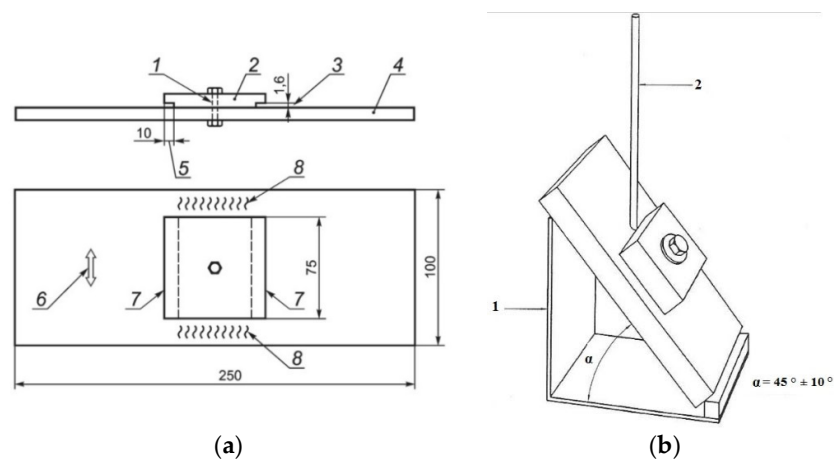
**Figure 1.** Control thermal severity (CTS) specimen: (a) scheme of CTS test; 1—hole 13 mm diameter, 2—top plate, 3—root notch gap, 4—bottom plate, 5—root notch depth, 6—rolling direction, 7—test welds, 8—anchor welds; (b) the location of the specimen during welding; 1—jig, 2—covered electrode.

For this research, the control thermal severity (CTS) test was selected, which resulted from the fact that fillet welds are the most commonly used in underwater-welded structures. Additionally, the CTS test assesses susceptibility to cold cracking in all regions of welded joints. A scheme of the CTS specimens is presented in Figure 1a. The specimen was housed in a special jig. The test welds were deposited symmetrically in the flat position (PA) in a single pass and in a single direction, across the full width of the block (Figure 1b).

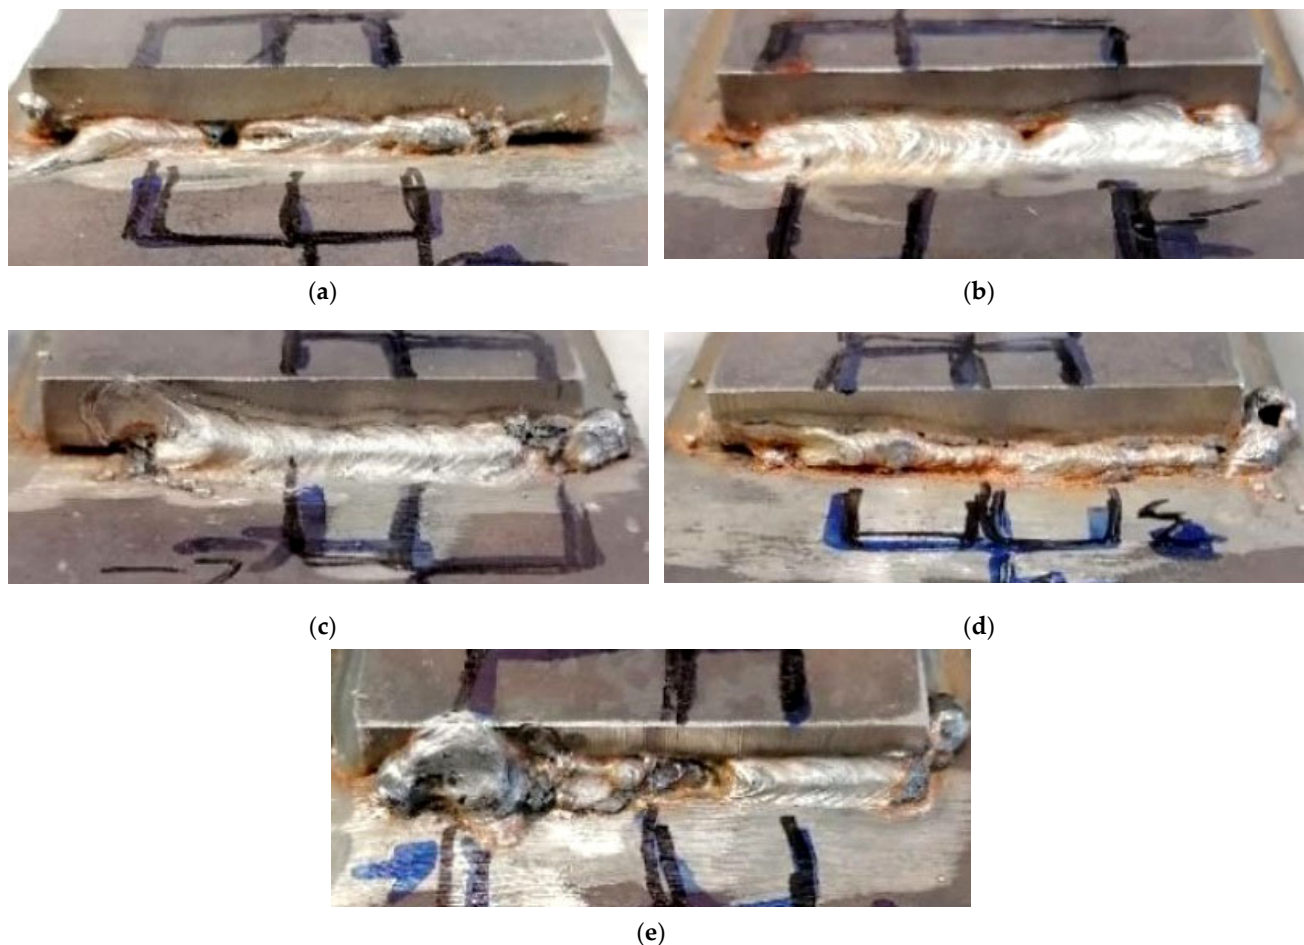
**Figure 2.** The exemplary results of the visual test (VT): (a) weld 1—specimen 1 (non-modified electrode), pores, weld length 60 mm; (b) weld 2—specimen 2 (underwater electrode), weld length 70 mm; (c) weld 1—specimen 3 (concrete impregnate), spatter, weld length 60 mm; (d) weld 2—specimen 4 (liquid foil), lack of fusion, undercuts, shape defects, weld length 70 mm; (e) weld 1—specimen 5 (paraffin wax), shape defects, pores, weld length 70 mm.

Exemplary photos of the VT are presented in Figure 2. The lines mark places identified for sample cutting in further investigations. The VT focused on the selection of

cutting locations for further investigations, due to the fact that underwater wet welding in most cases is treated as a repair method. Our observations showed differences between specimens performed using electrodes with different surface coatings. Both test welds in specimens 1 and 2 are characterized by their proper geometry. However, pores were observed in one weld in each specimen (Figure 2a,b). Welding of specimen 3 generated excessive spatter (Figure 2c), which was not observed for other specimens. The worst results were observed for the specimen welded using electrodes coated with liquid foil. The width of the weld was two-fold smaller than in other specimens. Additionally, a lack of fusion and undercuts was observed (Figure 2d). The biggest difference between two welds in the same specimen was observed for specimen 5. Weld 2 performed with higher heat input and was characterized by its proper geometry. Moreover, no imperfections were observed. The VT for weld 1 showed many imperfections, such as shape defects and pores, which started in the middle of the weld (Figure 2e). Guo et al. [49] proved that the heat input value is crucial to the quality of offshore welded steel joints. Additionally, in the author's previous investigations [25], it has been shown that higher heat input values lead to improvement of the quality of S460N steel wet-welded joints.

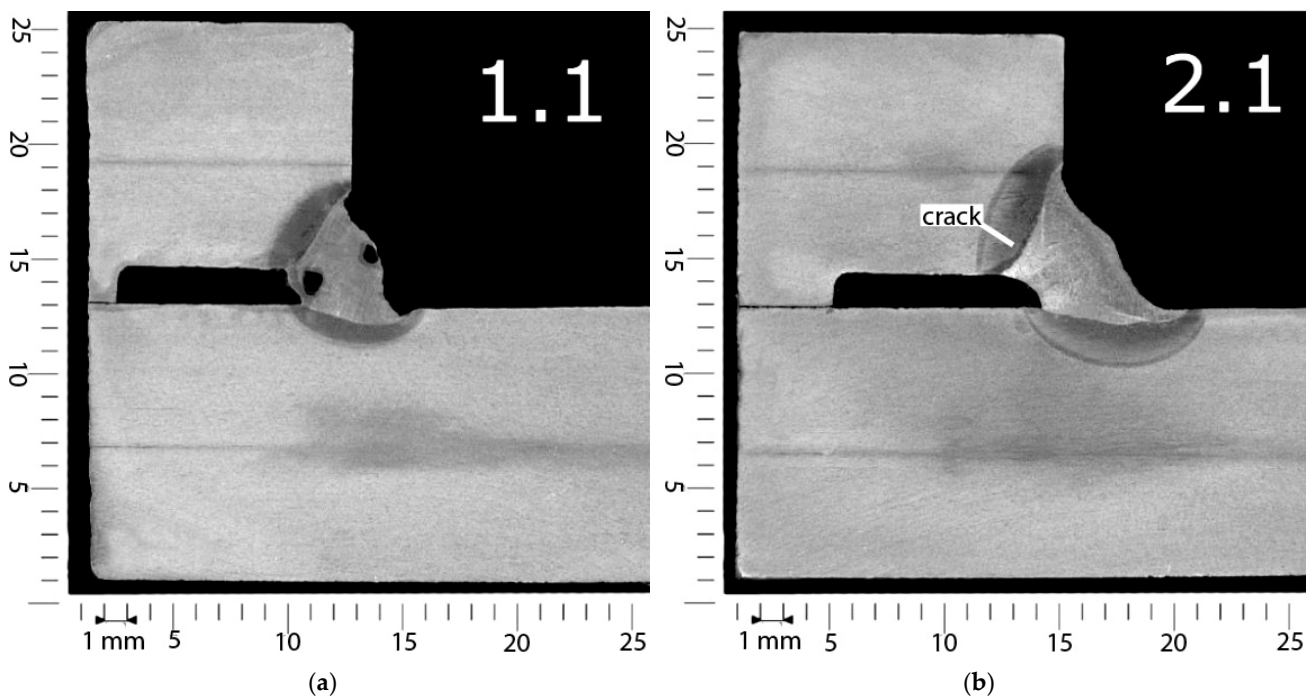
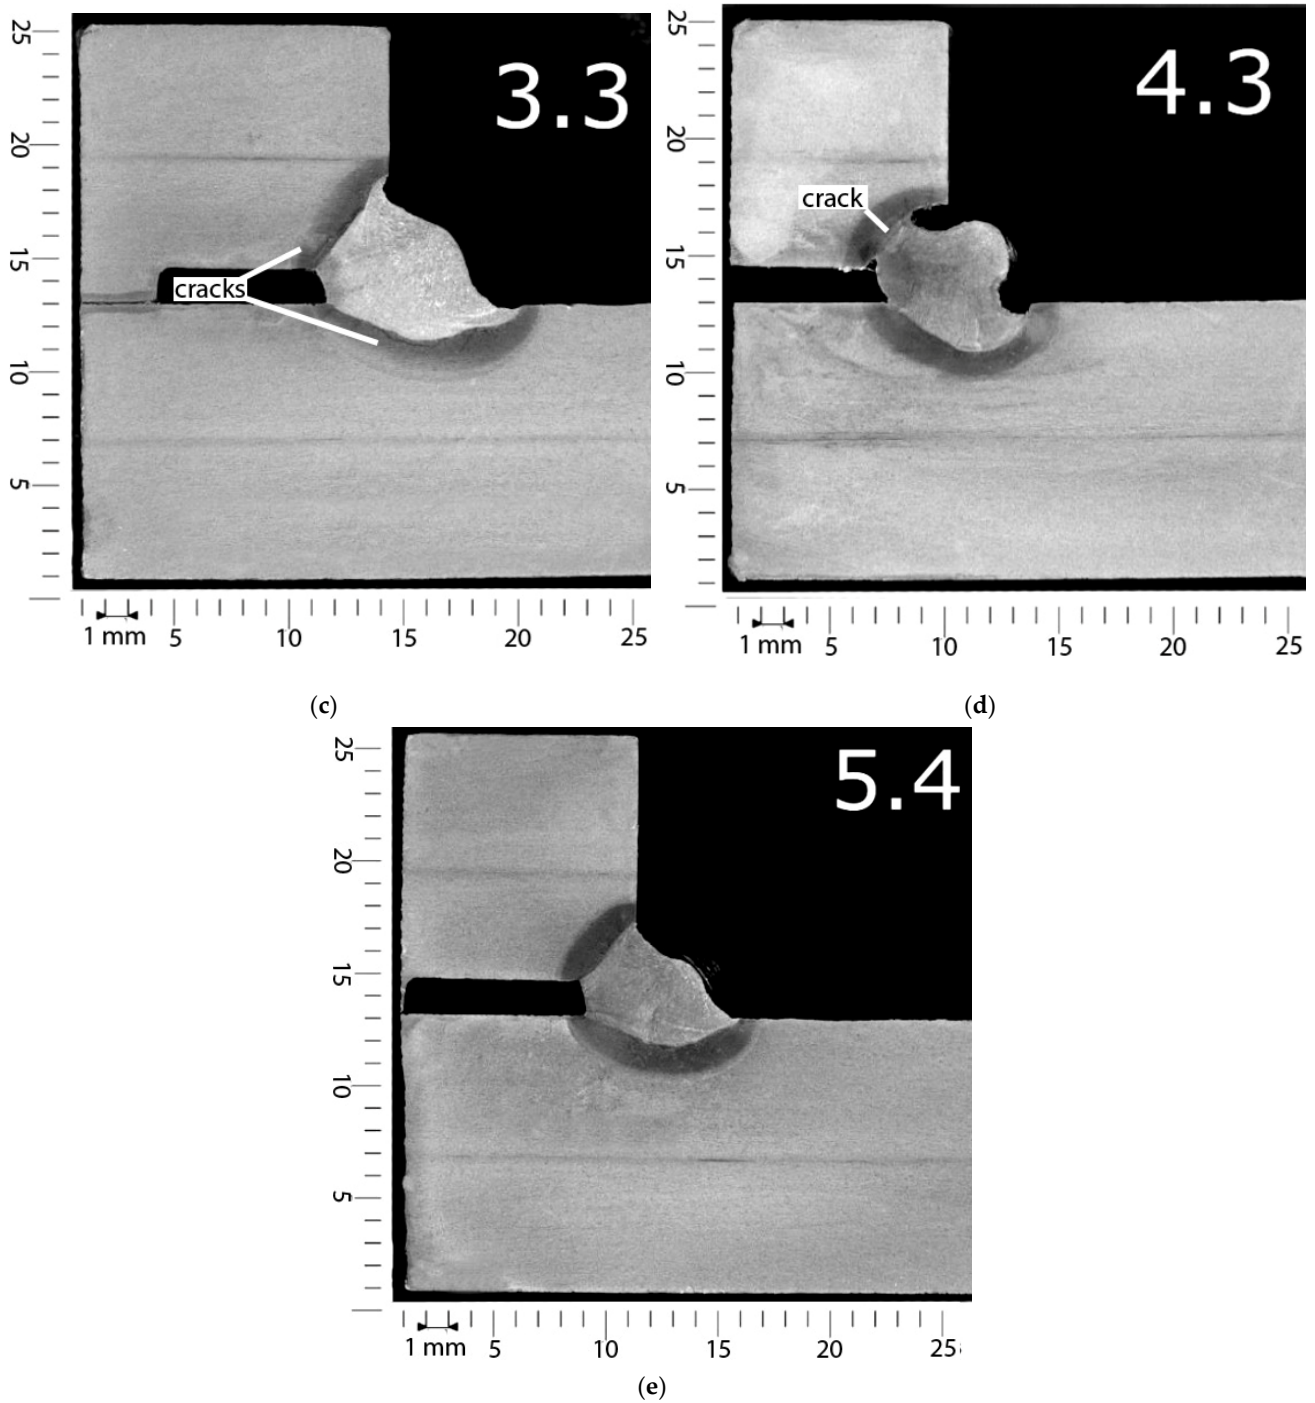
**Figure 3.** Exemplary results of macroscopic testing: (a) weld 1—specimen 1 (non-modified electrode), pores and undercuts; (b) weld 1—specimen 2 (underwater electrode), cracks in the heat-affected zone (HAZ); (c) weld 2—specimen 3 (concrete impregnate), cracks in the HAZ and undercuts; (d) weld 2—specimen 4 (liquid foil), cracks in the HAZ and deep undercuts; (e) weld 2—specimen 5 (paraffin wax), no imperfections.

Exemplary macroscopic photos are presented in Figure 3. The macroscopic observations also showed differences in specimens welded with different electrodes. Specimen 1, welded using non-modified electrodes, is characterized by the existence of porosity in the weld, which proved the results of VT (Figure 3a). Additionally, undercuts were observed. However, no cracks occurred. These cracks were observed in weld 1 (Figure 3b), which was performed using underwater electrodes (specimen 2). These cracks were located in the HAZ, parallel to the fusion line. This location is characteristic of cold cracks occurring in wet welding conditions, as stated for the investigated S460N steel in previous investigations [39]. Cracks were observed in joints welded (specimen 3) using electrodes coated with concrete impregnate (Figure 3c). These cracks were longer and wider than in specimen 2. Additionally, small undercuts occurred in two welds of this specimen. The biggest imperfections were observed in specimen 4, performed with the use of liquid-foil-coated electrodes. The quality of both welds was poor, with cracks and deep undercuts observed in each cross-section (Figure 3d). The macroscopic observations of specimen 5 showed no imperfections in three out of four observed cross-sections (Figure 3e). The last cross-section was cut from locations characterized by many imperfections (Figure 2e), so the macroscopic test confirmed the poor quality of the joint in this location.

Macroscopic tests showed the presence of many imperfections in all welded joints, which is typical for underwater conditions [5,7,9]. The most often observed were undercuts and cracks. Garg et al. [50] stated that increasing the cooling rate results in an increasing number of undercuts in electric welded joints. The high cooling rate in wet welding conditions leads to the presence of undercuts in all specimens. The macroscopic tests of CTS specimens showed differences in comparison to the pad weld observations performed in previous investigations [39]. No cracks were observed for pad welds. The presence of cold cracks in joints with filled welds resulted from the different thermal conditions. These differences are connected to the different shapes of the specimens and the presence of notches in CTS samples [42].

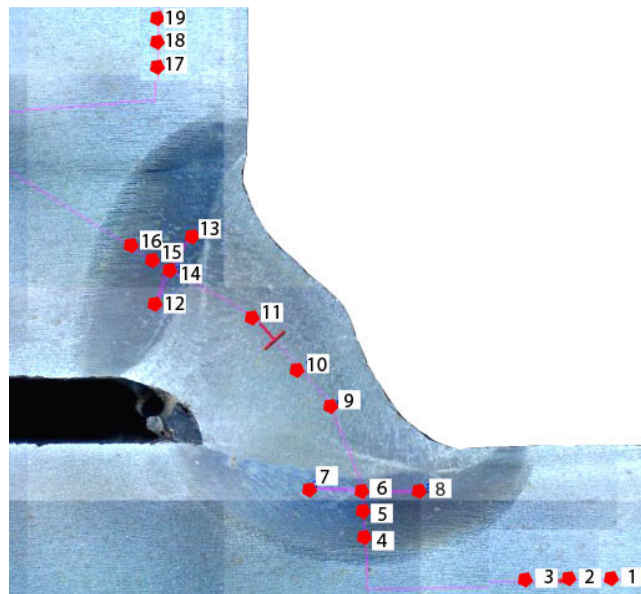
**Figure 4.** The distribution of measurement points.

Hardness measurements were performed in one cross-section from the test weld at 19 points: 3 in the weld metal, 6 in the BM, and 10 in the HAZ (5 in each side of the joint). A schematic of the distribution of the measurement points is presented in Figure 4.

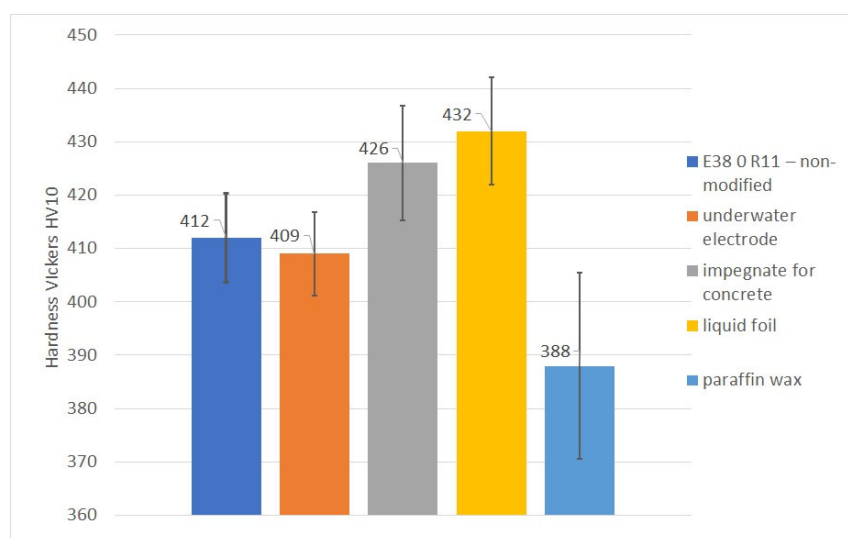
**Figure 5.** The average HV10 hardness values in the HAZ.

Hardness measurements showed that the HAZ hardness values in specimen 1 (non-modified electrode) and specimen 2 (underwater electrode) were similar, with both being in the range of 400–430 HV10. Previous investigations performed for pad welds [39] showed that the average hardness for non-modified electrodes was 479 HV10 and for underwater electrodes was 472 HV10. This resulted from the greater dilution in pad welds than in welded joints with fillet welds, as stated in the literature by Sun et al. [52]. The same differences between pad welds and CTS specimens were observed for other specimens welded using different electrodes. Additionally, it was observed that usage of concrete impregnate and liquid foil resulted in increased hardness. The hardness of specimen 3 increased to 448 HV 10, while that of specimen 4 increased to 454 HV 10. The measurements of specimen 5, which was welded with electrodes, confirmed the results of previous experiments [39]. The hardness in the HAZ of the joint welded using an electrode with paraffin was significantly lower. Moreover, some measurements were lower than 380 HV10, which is minimum value required for joints welded in air. It had been proven previously [25] that higher-quality S460N steel joints are characterized by lower HAZ hardness. The same effect was observed in the presented investigations. Previous investigations [39] showed that high HAZ hardness could be observed in structures characterized by the presence of a greater number of cold cracks. This suggests that the different hydrophobic coatings investigated in this paper may result in differing susceptibility of HSLA steels to cold cracks. The Vickers HV10 hardness measurement results are listed in Table 5. Values higher than 380 HV10 are shown in bold. It was proven that paraffin wax as a coating on covered electrodes provides significantly decreases the hardness in the HAZ. The average hardness was higher than 380 HV10, however that value is recommended for air welding, in which the cooling rate is much lower than in

wet welding. A graphical comparison of average HAZ hardness values is presented in Figure 5.

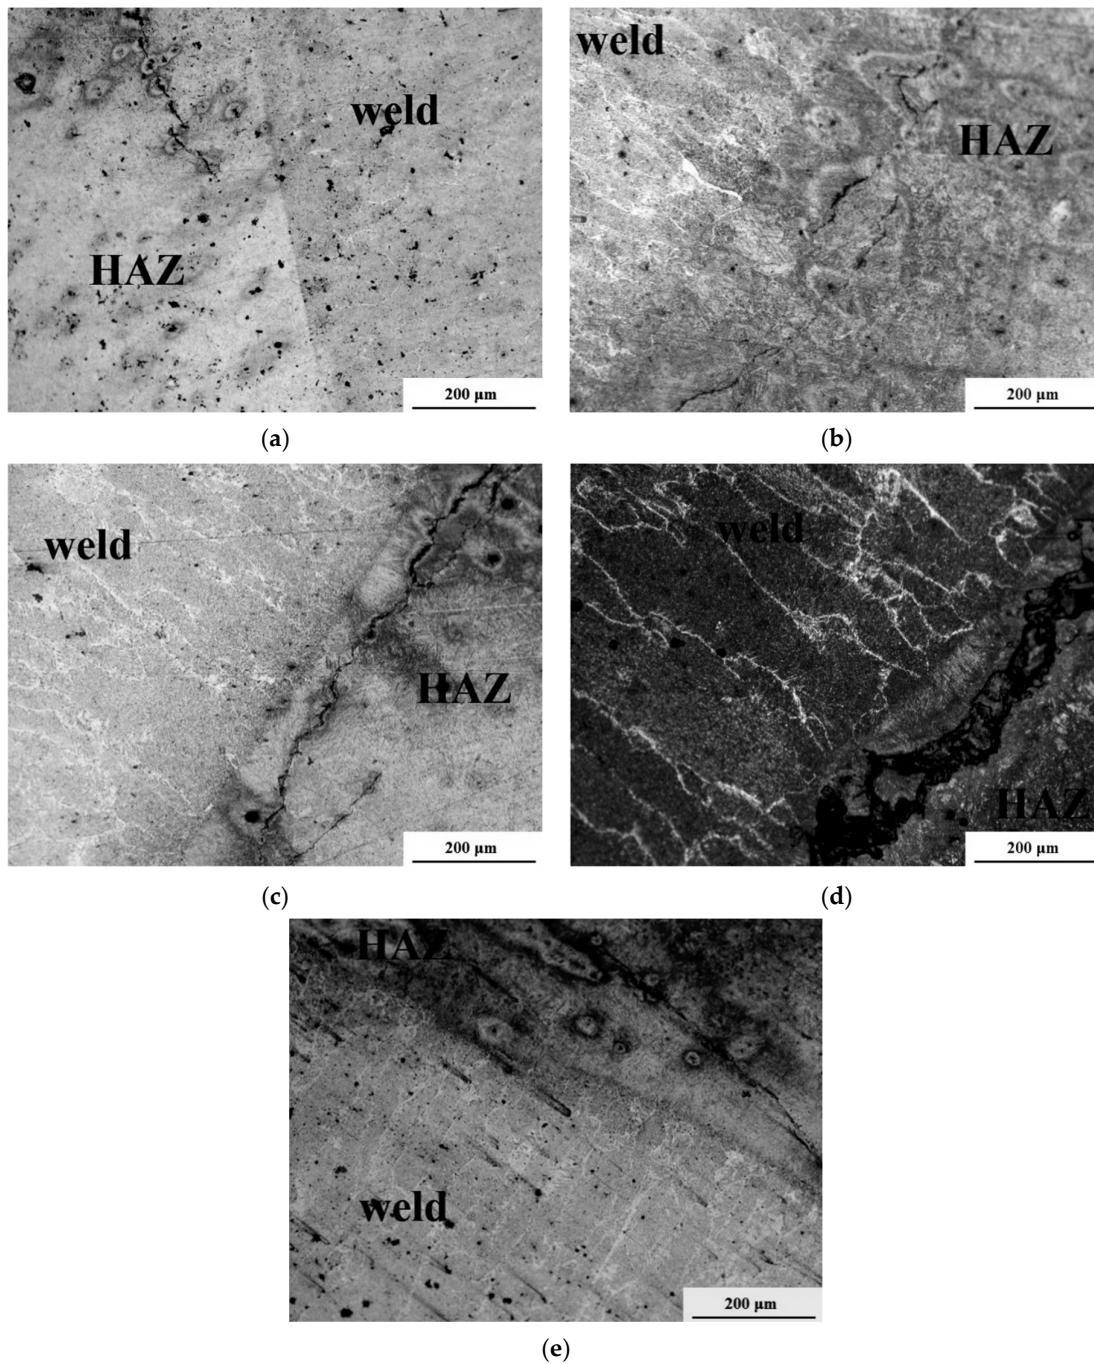
**Figure 6.** Optical micrographs of: (a) specimen 1 (non-modified electrode); (b) specimen 2 (underwater electrode); (c) scheme 3 (concrete impregnate); (d) specimen 4 (liquid foil); (e) specimen 5 (paraffin wax).

The microstructures are shown in Figure 6. The main aim of the microscopic test was to evaluate the specimens for the occurrence of cold cracks. It had been proven in previous investigations [39] that the use of electrodes coated with concrete impregnate and liquid foil generated 85–95 mL/100g diffusible hydrogen in deposited metal. In comparison, the non-modified electrode generated 75 and the underwater electrode 65 mL/100g diffusible hydrogen. However, the use of paraffin wax decreased the hydrogenation below 50 mL/100g diffusible hydrogen. These results and the hardness measurements presented in Section 3.3 suggest differences in specimens welded with different filler materials. From each specimen, four cross-sections were observed in the HAZ and in the weld metal. Each joint was characterized by typical microstructures for the underwater-welded HSLA joints [5,9,25]. The weld metal presented a dendritic structure. The HAZ consists of brittle structures such as martensite and bainite. There were no significant microstructural differences in specimens 1–4. In specimen 5, the dimension of coarse-grained martensite area in HAZ was the lowest. Microscopic observations of specimen 1, which was welded with non-modified electrodes, showed long cracks in the HAZ running parallel to the fusion line along 30–40% of its length. (Figure 6a). Additionally, short cracks were found

in the weld metal. Lower numbers of cracks were observed in the HAZ of the specimen welded using underwater electrodes (Figure 6b). These cracks ran through 15–20% of the fusion line length. Both specimens were characterized by similar hardness in the HAZ. The differences in the number of cracks resulted from different hydrogen amounts in the deposited metal [38]. No cracks were found in the weld metal. Microscopic tests showed that concrete impregnate as an electrode coating leads to increased numbers of cracks, both in the HAZ and the weld metal (Figure 6c). HAZ cracks ran parallel and vertical to the fusion line. They started in the weld root and propagated along 70–80% of the fusion line length. The worst results were found during observations of test welds in specimen 4 (Figure 6d). Cracks in the HAZ were wide and long (90–100% of the fusion line length). However, the number of cracks in the weld was smaller than in specimen 3. It can be stated that liquid foil and concrete impregnate cannot be used as protective coatings during wet welding of HSLA steels. Microscopic testing of the specimen welded using electrodes coated with paraffin wax showed much different results than for other hydrophobic substances. No cracks were found in the weld metal. In the HAZ, only one short crack running parallel to the fusion line was found (Figure 6e). Microscopic observations proved that cold cracks occurred in wet-welded joints. A number of cold cracks resulted from the presence of brittle structures in the HAZ, characterized by high hardness, with the highest amount of diffusible hydrogen in the deposited metal [39]. It was also proven that HSLA steels are materials in which the high cooling rate leads to creation of the brittle martensitic microstructure [53].
