# Weldability of Underwater Wet-Welded HSLA Steel: Effects of Electrode Hydrophobic Coatings

**Abstract:** The paper presents the effects of waterproof coatings use to cover electrodes on the weldability of high-strength, low-alloy (HSLA) steel in water. With the aim of improving the weldability of S460N HSLA steel in water, modifications of welding filler material were chosen. The surfaces of electrodes were covered by different hydrophobic substances. The aim of the controlled thermal severity (CTS) test was to check the influence of these substances on the HSLA steel weldability in the wet welding conditions. The visual test, metallographic tests, and hardness Vickers HV10 measurements were performed during investigations. The results proved that hydrophobic coatings can reduce the hardness of welded joints in the heat-affected zone by 40–50 HV10. Additionally, the number of cold cracks can be significantly reduced by application of waterproof coatings on the filler material. The obtained results showed that electrode hydrophobic coatings can be used to improve the weldability of HSLA steel in underwater conditions.

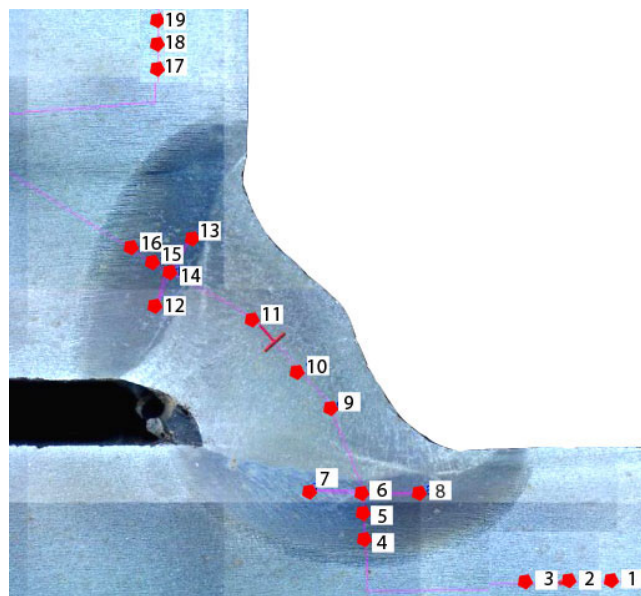
**Figure 4.** The distribution of measurement points.

Hardness measurements were performed in one cross-section from the test weld at 19 points: 3 in the weld metal, 6 in the BM, and 10 in the HAZ (5 in each side of the joint). A schematic of the distribution of the measurement points is presented in Figure 4.

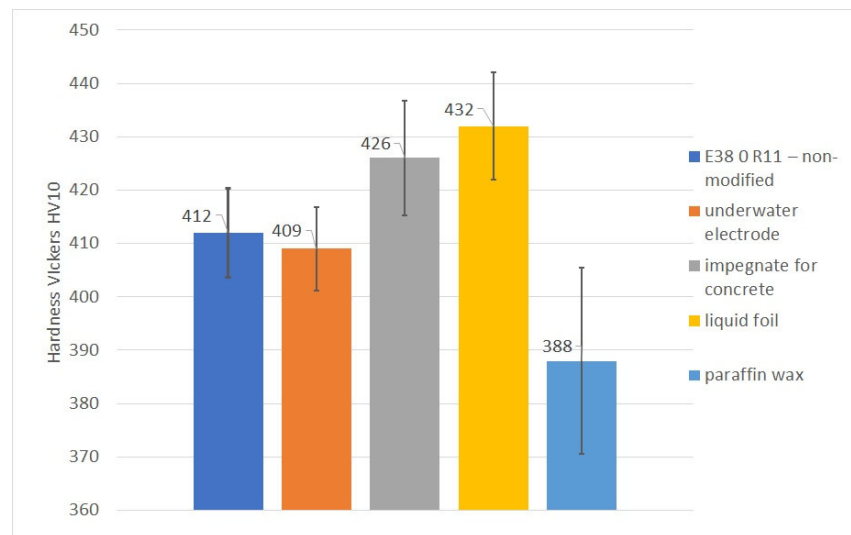
**Figure 5.** The average HV10 hardness values in the HAZ.

Hardness measurements showed that the HAZ hardness values in specimen 1 (non-modified electrode) and specimen 2 (underwater electrode) were similar, with both being in the range of 400–430 HV10. Previous investigations performed for pad welds [39] showed that the average hardness for non-modified electrodes was 479 HV10 and for underwater electrodes was 472 HV10. This resulted from the greater dilution in pad welds than in welded joints with fillet welds, as stated in the literature by Sun et al. [52]. The same differences between pad welds and CTS specimens were observed for other specimens welded using different electrodes. Additionally, it was observed that usage of concrete impregnate and liquid foil resulted in increased hardness. The hardness of specimen 3 increased to 448 HV 10, while that of specimen 4 increased to 454 HV 10. The measurements of specimen 5, which was welded with electrodes, confirmed the results of previous experiments [39]. The hardness in the HAZ of the joint welded using an electrode with paraffin was significantly lower. Moreover, some measurements were lower than 380 HV10, which is minimum value required for joints welded in air. It had been proven previously [25] that higher-quality S460N steel joints are characterized by lower HAZ hardness. The same effect was observed in the presented investigations. Previous investigations [39] showed that high HAZ hardness could be observed in structures characterized by the presence of a greater number of cold cracks. This suggests that the different hydrophobic coatings investigated in this paper may result in differing susceptibility of HSLA steels to cold cracks. The Vickers HV10 hardness measurement results are listed in Table 5. Values higher than 380 HV10 are shown in bold. It was proven that paraffin wax as a coating on covered electrodes provides significantly decreases the hardness in the HAZ. The average hardness was higher than 380 HV10, however that value is recommended for air welding, in which the cooling rate is much lower than in

wet welding. A graphical comparison of average HAZ hardness values is presented in Figure 5.
