Effect of Thermal Treatment and Erosion Aggressiveness on Resistance of S235JR Steel to Cavitation and Slurry

Alicja K. Krella ^{1,*}, Dominika E. Zakrzewska ¹, Marta H. Buszko ¹ and Artur Marchewicz ¹

Institute of Fluid Flow Machinery PAS, Fiszerka 14, Gdańsk, Poland; dzakrzewska@imp.gda.pl (D.E.Z.); mbuszko@imp.gda.pl (M.H.B.); artur.marchewicz@imp.gda.pl (A.M.)

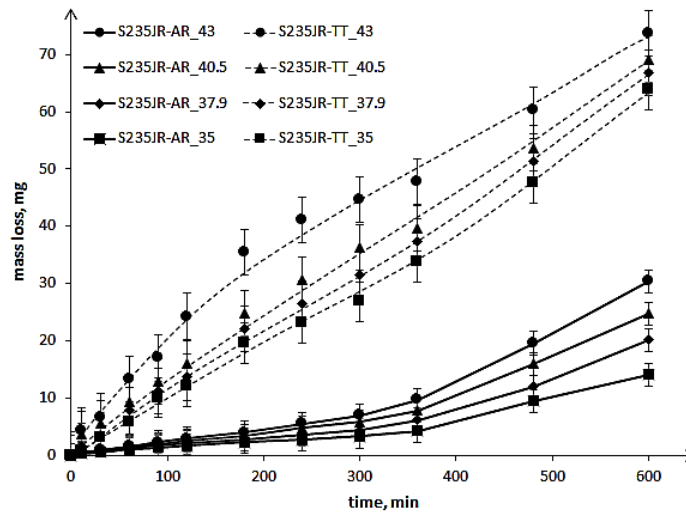
Figure 6. Cavitation erosion curves of S235JR steel in as-received state and after thermal treatment.

The results of cavitation erosion tests are shown in the form of the cavitation erosion curves (Figure 6) and the cavitation erosion rate curves (Figure 7).

These curves show that a decrease in steel hardness and an increase in flow velocity increased the mass losses and erosion rates. These results are consistent with the expectation and investigation obtained by Kahraman et al. [6]. The decrease in steel hardness by 34.2 HV as a result of thermal treatment caused an increase in mass loss after the entire tests by about 43 mg to about 49.7 mg, depending on the test conditions. Thus, the high impact of the hardness of this steel on the erosion resistance was confirmed, although the tests carried out were tests of cavitation erosion, not slurry. However, an

increase in flow velocity did not cause a proportional increase in mass loss of the tested steel, either in the as-received state or after thermal treatment (Figure 6). Moreover, the shape of the cavitation erosion curves indicates the different degradation processes. In the case of the S235JR-AR steel, the cavitation erosion curves indicate two main erosion periods: the first one lasting about 300 min and the second starting from about 360 min. While in the case of the S235JR-TT steel after thermal treatment, the mass losses increased more or less evenly throughout the cavitation erosion tests. This also confirms a high effect of the hardness of this steel on the degradation process.

In the case of the cavitation erosion tests conducted at the highest flow velocity of 43 m/s, the hardness of the S235JR-AR steel increased up to 194 HV at a depth of 35 μm, but the maximum value was 197 HV at a depth of 235 μm (Figure 10a). Such a hardness peak underneath the surface was also obtained in the tests of Fe–Cr–Ni–Mn stainless steels [19,20]. This makes that the maximum strain hardening effect determined from Equation (1) was 10% at a depth of 235 μm (Figure 10b). Moreover, the hardening effect was noted down to a depth of 4 mm. In the case of the S235JR-TT steel tested for resistance to cavitation erosion in these conditions, the maximum increase in hardness was only about 8% (157 HV) at a depth of 235 μm and the hardening effect was noted down to a depth of 2.5 mm. Thus, the initial hardness of the steel prior to the cavitation test had an effect on the hardenability. Steel with lower initial hardness underwent less hardening, and steel with higher initial hardness - stronger. Moreover, as the strengthening of the surface layer increased, the mass loss (Figure 6) and the erosion rate (Figure 7) decreased.

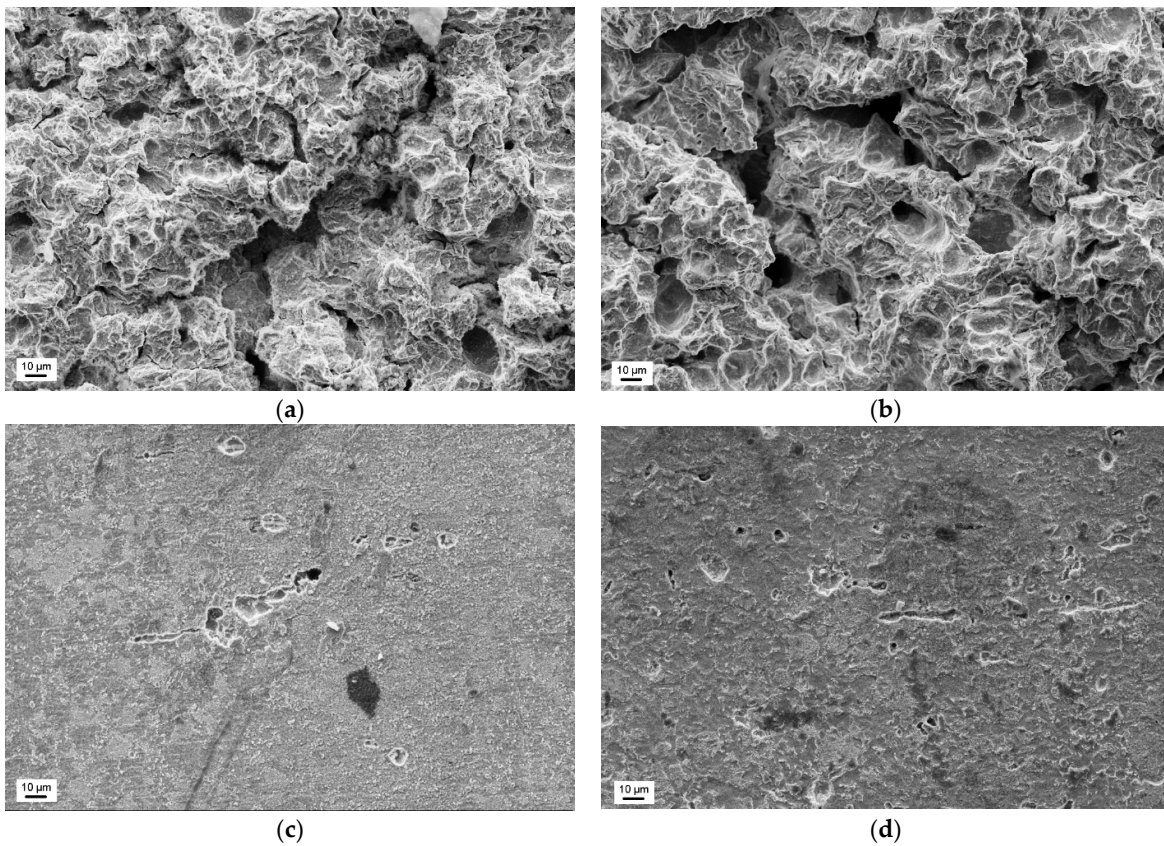
Figure 16. Surface damages developed during cavitation erosion tests carried out at a flow velocity of 35 m/s in the high erosion zone of (a) S235JR-AR steel and (b) S235JR-TT steel, and in the low erosion zone of (c) S235JR-AR steel and (d) S235JR-TT steel.

Damages to the surface of hard S235JR-AR and soft S235JR-TT steels in the strongly eroded zone and tested at a flow velocity of 35 m/s have the form of pits or so-called

cavitation tunnels, voids and cracks developing in a ductile mode (Figure 16a,b). Cracks are a bit wider for soft S235JR-TT steel, indicating the effect of the steel hardness. Although the diameter of some voids or pits can be determined, all damages overlapped. Besides, the damage mentioned above is greater for soft S235JR-TT steel, which complies with the roughness measurements (Figures 12 and 13) and steel hardness. Ductile fracture is in line with the steel grade (low carbon steel) and low hardness (178.7 ± 3.5 HV and 144.5 ± 2.9 HV, respectively) and ferritic-pearlitic structure. In the case of the low erosion zone (Figure 16c,d), the damage is mainly in the form of pitting, but several short cracks are also observed. The damage density is much lower on the surface of the S235JR-AR steel, which had a higher hardness. The pits are well seen and can be divided into two groups: the first with a diameter up to $10 \mu\text{m}$ and the second with a bigger diameter (above $10 \mu\text{m}$). The pits of the first group are much deeper than those of the second. This indicates that the pitting of the first group was the result of shearing by micro-jets impacted at high speed. Such pits do not occur on the surface of hard S235JR-AR steel. Considering that the tests were carried out at the same condition, the S235JR-AR was more resistant to such impacts because of steel hardness.
