Article

Non-Destructive Diagnostics of Concrete Beams Strengthened with Steel Plates Using Modal Analysis and Wavelet Transform

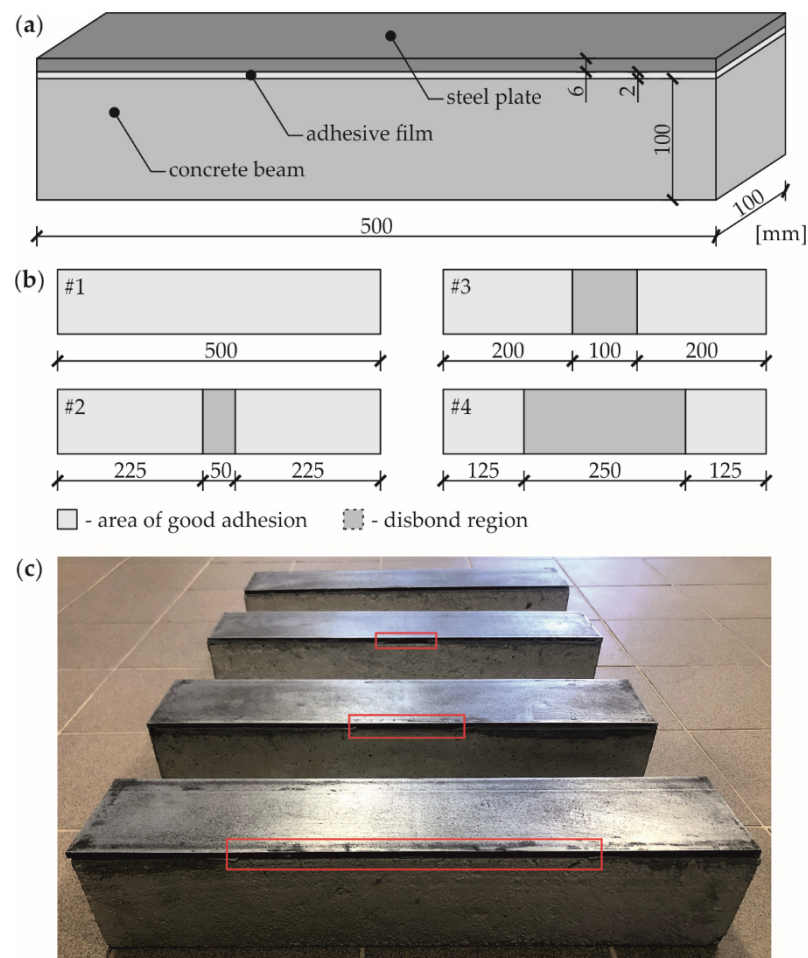
Figure 1. Object of research: (a) Specimen geometry; (b) variants of defects; (c) photograph of experimental samples.

The object of research was a multilayer sample (Figure 1a) consisting of a concrete beam (class C30/37) with a square cross-section of $100 \times 100 \text{ mm}^2$, and a length of 5000 mm, an adhesive film with a thickness of 2 mm and a steel plate with dimensions of $6 \times 100 \times 5000 \text{ mm}^3$. The material characteristics are given in Table 1. Four specimens (Figure 1b) were prepared: An intact composite beam (with no damage, #1) and three beams (#2-4) with the increasing percentage of debonding, 10%, 20% and 50%, consecutively. Each defect was arranged as a lack of an adhesive film by sticking a Teflon (PTFE) tape to the appropriate area of the joint. Before preparation of each sample, the contacting surfaces of the concrete beam and steel plate were accurately cleaned using Loctite-7063 cleaner (Henkel, Dusseldorf, Germany). Immediately after that, both elements were joined using Sikadur 30 Normal adhesive (Sika, Baar, Switzerland). The surface of the beam was primed with glue and then the adhesive layer was applied in a domed shape. This allowed the elimination of any possible air voids from the joints during attaching the plate to the concrete beam. The prepared samples are presented in Figure 1c.

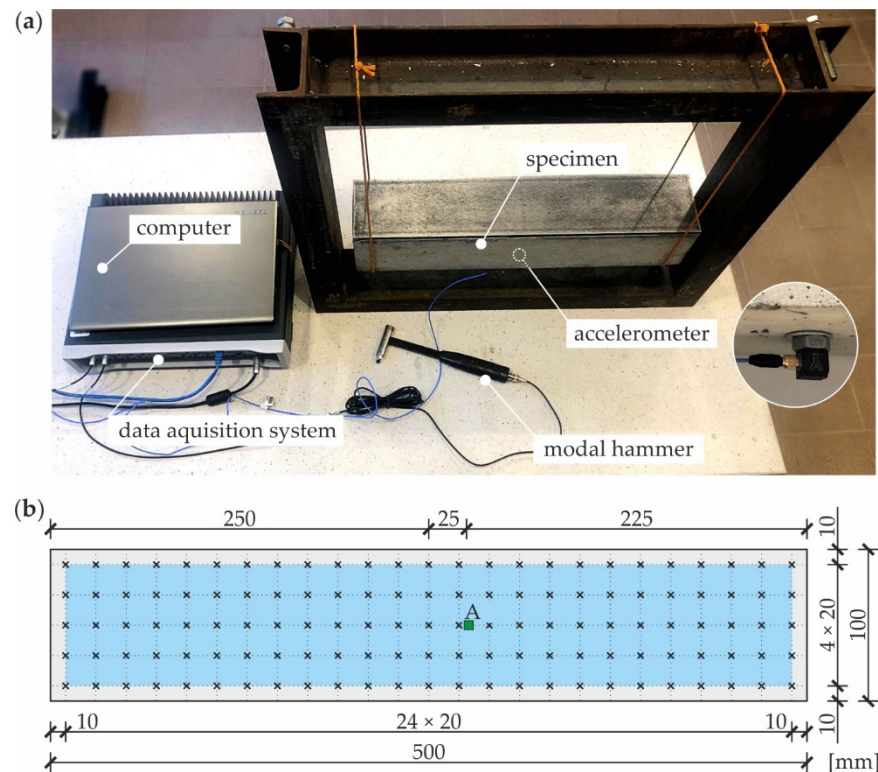
Figure 2. Experimental setup (a) and scheme of measurement grid (b).

Dynamic parameters of the tested specimens (i.e., natural frequencies and modal shapes) were determined using the experimental modal analysis (EMA) approach, in which both excitation and response signals were measured. In the study, an impact test was conducted with the use of a modal hammer. The experimental setup for EMA is shown in Figure 2a. The specimen was suspended from both sides on elastic strings to simulate free boundary conditions. Piezoelectric accelerometer 356A15 (PCB Piezotronics, Inc., Depew, NY, USA) was used for the measurement of vibrations. The properties of the sensor used are as follows: sensitivity $10.2 \text{ mV}/(\text{m}/\text{s}^2)$, measurement range $\pm 490 \text{ m}/\text{s}^2$, resonant frequency $\geq 25 \text{ kHz}$ and frequency range $2\text{--}5000 \text{ Hz}$. The accelerometer was attached to the bottom surface of the beam at point A located 25 mm from the center. The dynamic pulse load was induced by the modal hammer 086C03 (PCB Piezotronics, Inc., Depew, NY, USA) with the following parameters: sensitivity $2.25 \text{ mV}/\text{N}$, measurement range $\pm 2224 \text{ N}$, resonant frequency $\geq 22 \text{ kHz}$. A medium tip was applied with the hammer enabling the excitation of vibrations within the frequency range up to approximately 2800 Hz. A single measurement was performed at each of 125 points. The points of impact, marked in Figure 1b, were distributed on the top surface of the specimen in a regular square grid having 5 rows and 25 columns, resulting with a resolution of 20 mm in both directions. Data acquisition and signal conditioning were performed by LMS SCADAS portable system (Siemens, Leuven, Belgium). Natural frequencies and modal shapes were determined based on the frequency response function (the accelerance in this case) given as the ratio of an output acceleration signal to an input force signal [33,40,41]. The estimation of modal

parameters was performed using a peak picking method. Mode shapes were determined by measuring the peak amplitude of the imaginary part of the frequency response function.

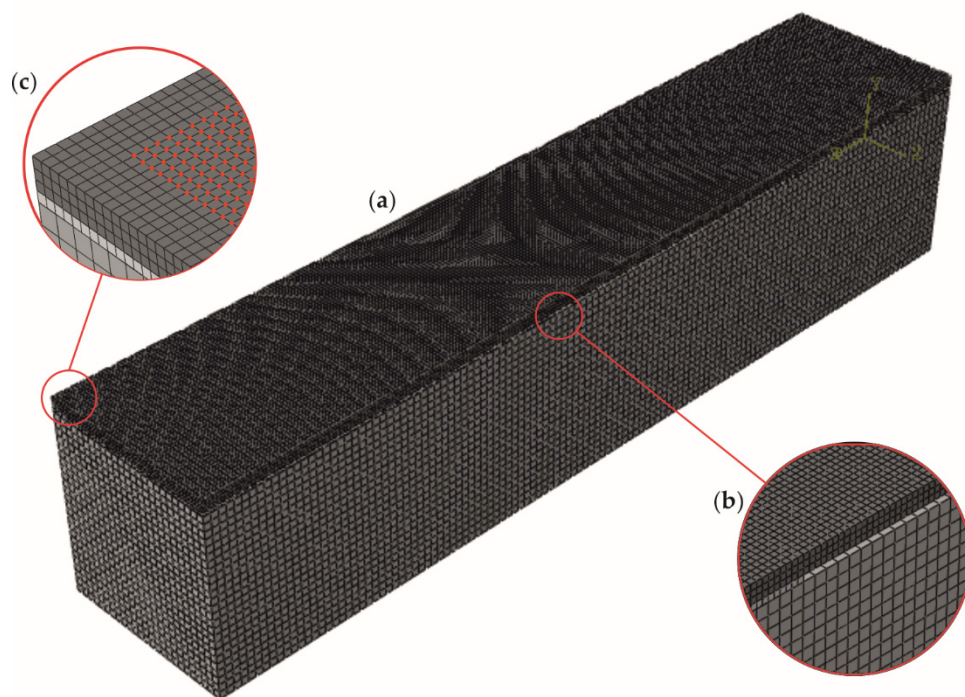
Figure 3. Numerical model (a) with a close-up of damage (b) and measurement grid (c) based on the #3 model.

The numerical calculations were conducted with the use of the finite element method (FEM) in Abaqus software. Modal analysis was performed on the three-dimensional numerical models (Figure 3a) prepared based on the geometry and materials of the physical samples. Material parameters (Table 1) were used to apply a linearly elastic, isotropic, homogeneous material model to all structural elements (steel plate, adhesive film, and concrete beam), all being independent parts. The rigid surface-to-surface *tie* connection was used for bonding the contacting regions of each part. Three-dimensional eight-node linear brick finite elements with reduced integration (C3D8R) were used to mesh all parts. The mesh grid has a size of $2 \times 2 \times 2 \text{ mm}^3$ (for steel plate and adhesive film) and $4 \times 4 \times 4 \text{ mm}^3$ (for the concrete beam). The debonding in models #2–4 was modelled as a gap in the adhesive film (see Figure 3b), which relates to the lack of glue in the physical samples. The frequency procedure (linear perturbation theory) was performed to determine the natural frequencies and the corresponding mode shapes. The results (normalized displacements) were read from a regularly gridded square mesh with a global size of 2 mm located on the upper surface of a steel plate, covering a central area of $80 \times 480 \text{ mm}^2$ with a margin of 10 mm at all edges (see Figure 3c). The additional coarser mesh was assumed with the size of 20 mm to coincide with the experimental measurements (cf. Figure 2b).

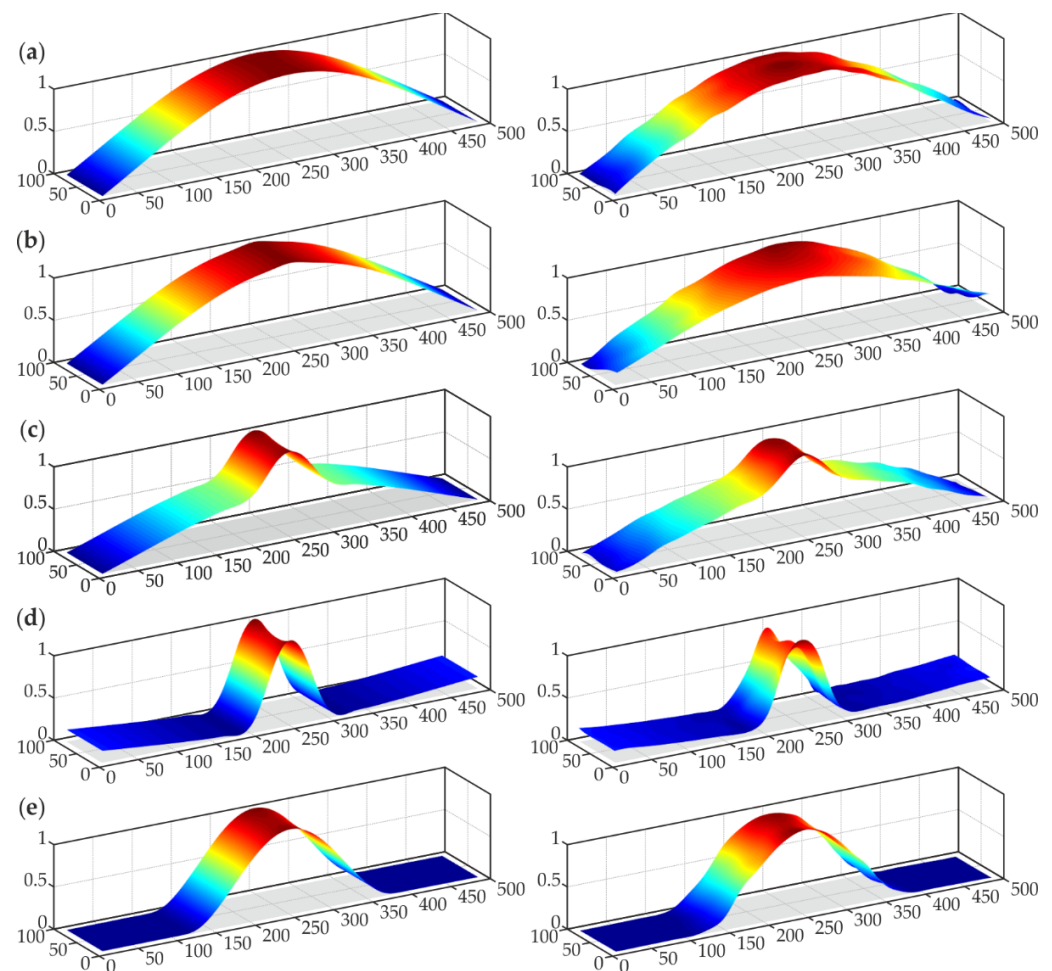
**Figure 4.** Normalized numerical (left column) and experimental (right column) mode shapes (dimensions in [mm]): (a) sample #1, mode 1; (b) sample #2, mode 1; (c) sample #3, mode 1; (d) sample #3, mode 2; (e) sample #4, mode 1.

It can be observed that the value of the first natural frequency slightly decreased with the size of debonding between beams #1–3. For sample #4, the decrease became dramatic, because the area of the defect covered 50% of the whole joint, thus the steel plate could oscillate as an independent part. It is not surprising that there were no disturbances in the first mode shape for beam #1 without damage (Figure 4a). For sample #2 (Figure 4b), the defect was barely visible in the numerical mode, whereas the experimental one did not reveal any disruption, thus its exact size could not be assessed. On the other hand, both modes of beam #3 (Figure 4c,d) gave useful information about the presence and approximate size of the damage. The deformation in the area of debonding was greater than in the good adhesion part of the joint. It has to be noted that mode 1 corresponds to

the global character of vibrations, the displacements are comparable in the area of good adhesion and debonding. Nevertheless, mode 2 has the local character, because vibrations in the debonding region are significantly higher than in the adjacent part of the specimen. The first mode shape of beam #4 (Figure 4e) also revealed the presence of the defect. What is interesting, no significant deformation was detected in the area of the properly prepared joint while comparing with the damaged part. This effect was not observed for the previous samples, where the oscillations had a global character. For beam #4, it can be stated that the first mode corresponded to the independent oscillation of the steel plate, thus the oscillations could be considered local. This difference stayed in agreement with the fact of a clear difference in the first eigenfrequency between beam #4 and the remaining ones. Summarizing, the analysis of mode shapes could provide an initial assessment of damage presence, especially in the case of large damage; however, further data processing is required to better visualize the defects.

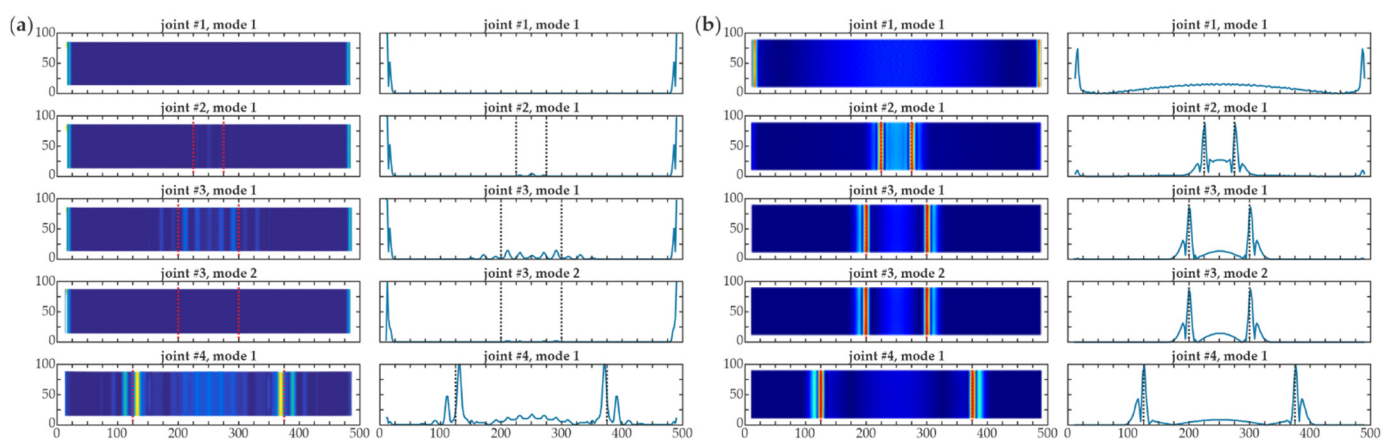
Figure 5. Influence of boundary effect to damage imaging (numerical results mesh 2 mm, no additional interpolation) for all joints #1–#4 (dimensions in [mm])—map and central cross section: (a) continuous wavelet transform (CWT) without extrapolation, wavelet *gaus4*, $s = 2$; (b) CWT with extrapolation, wavelet *gaus4*, $s = 2$.

Continuous wavelet transform was used to identify the actual shape and position of debonding areas in the adhesive joints. The prepared maps presenting mode shapes were separated into five vectors situated along the length of the specimen (cf. Figure 2b), creating five single lines. For each line, the calculations of the CWT were conducted independently, using a program written in MATLAB® environment [44]. Firstly, to avoid boundary effects, extrapolation was applied. Figure 5 shows the efficiency of extrapolation in the elimination of the potential edge effects. In raw data (Figure 5a, no extrapolation) the intensification of CWT values is observed near the edges, thus the damage identification becomes problematic. This is because edge values are relatively high compared to the ones indicating the presence of defects. The performed extrapolation allowed eliminating this effect, resulting in sufficient damage imaging. It is also worth noting that edge effects are more visible for smaller defects.

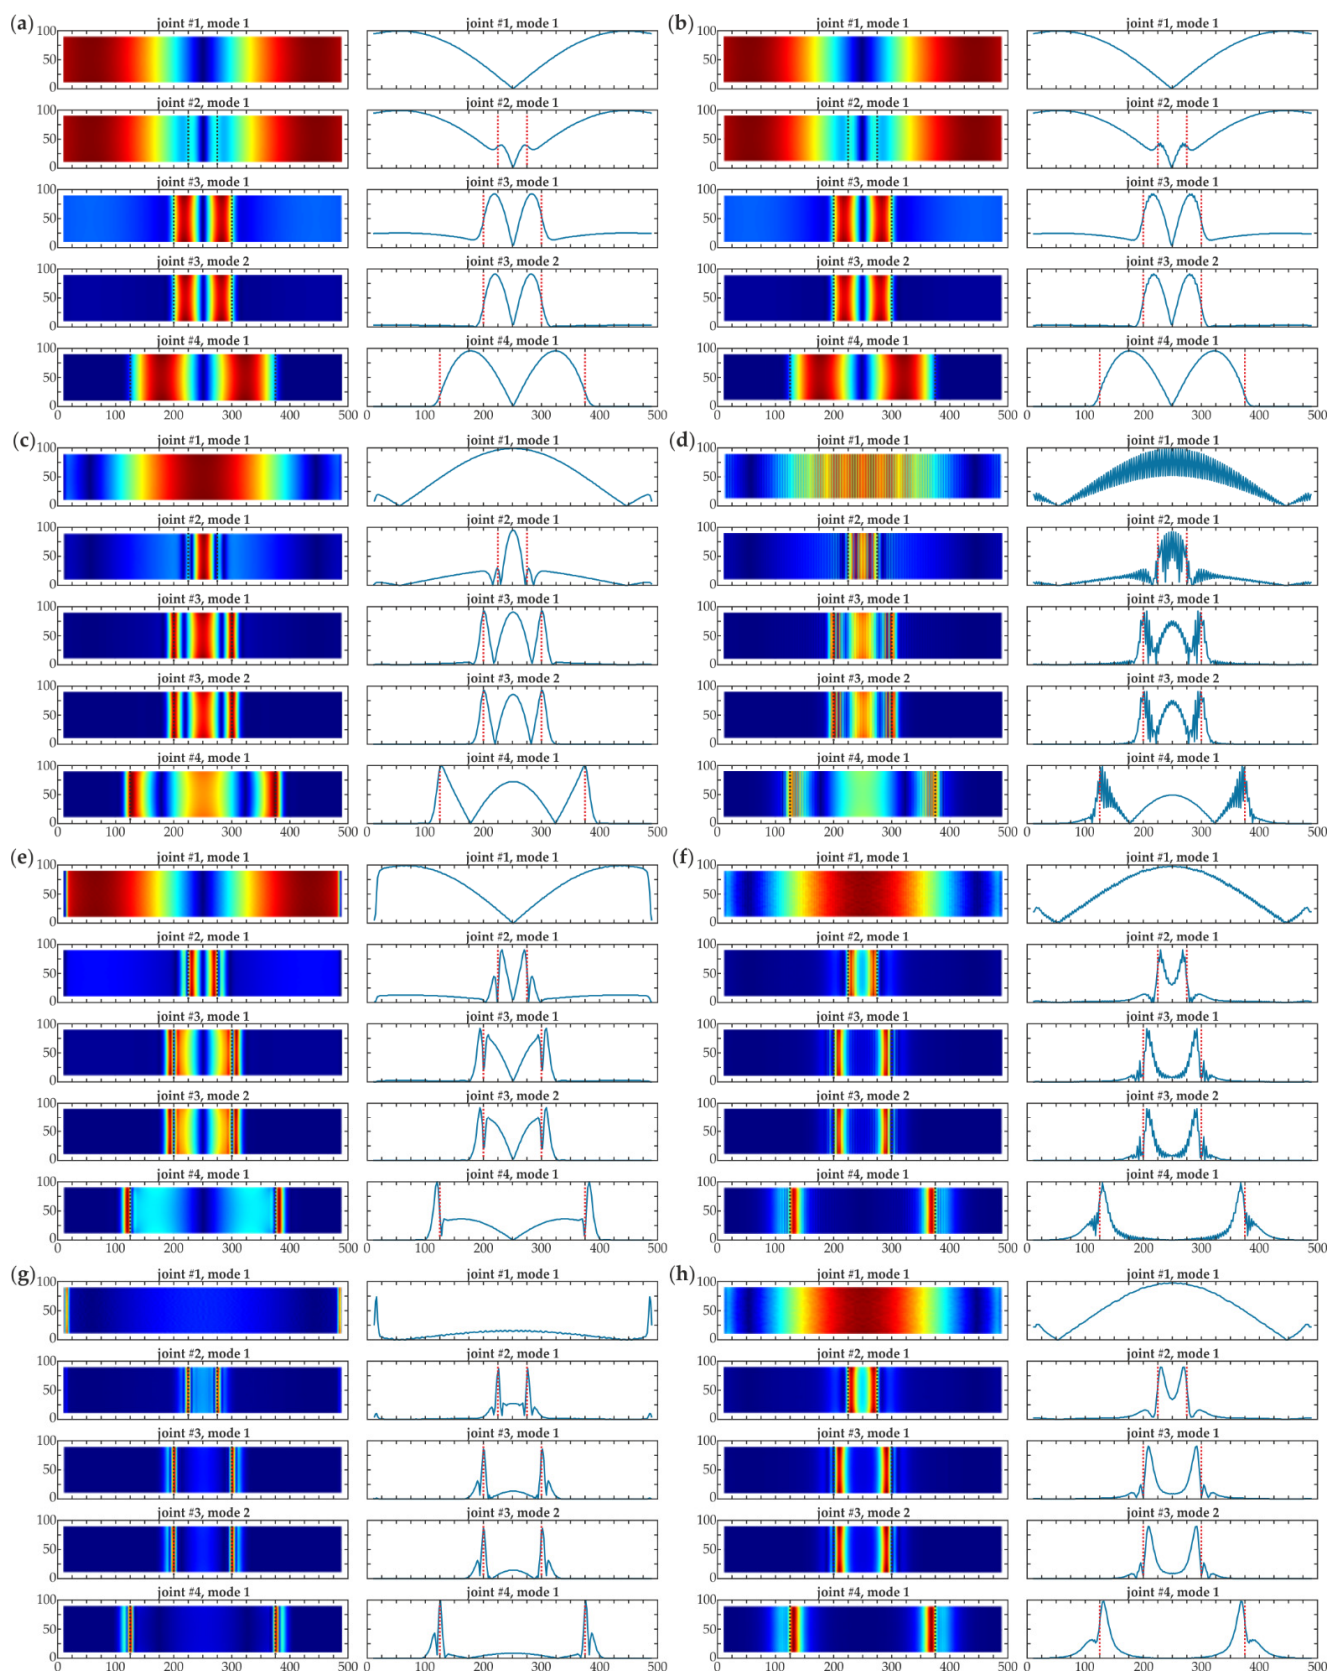
Figure 6. Damage imaging for numerical results (mesh 2 mm, no additional interpolation) for all joints #1–#4 (dimensions in [mm])—map and central cross section: (a) CWT, wavelet *gaus1*, $s = 2$; (b) first derivative; (c) CWT, wavelet *gaus2*, $s = 2$; (d) second derivative; (e) CWT, wavelet *gaus3*, $s = 2$; (f) third derivative; (g) CWT, wavelet *gaus4*, $s = 2$; (h) fourth derivative.

Secondly, calculations of wavelet transform were performed for each extrapolated vector. Finally, the expansion of the data was eliminated by cutting the results to the original size. As an initial step, the numerical results collected using a fine mesh (2 mm grid) were analyzed. The calculations of wavelet transforms were conducted using Gaussian wavelets with one to four vanishing moments. The fine scale $s = 2$ was initially set. To be compared with CWT, the conventional derivatives of the corresponding orders were determined. The comparison of both approaches is shown in Figure 6, where the damage maps are presented together with their cross-sections in the central part. Damage areas were marked on the charts. It is essential to note that the agreement between CWTs and derivatives is visible.

The maps were similar in both approaches, the cross-sections were also comparable in shape for all wavelets. However, the derivatives included a considerable noise component that made the quality of the maps poorer and disrupted the possibility of the exact location of the damage. This observation allowed emphasizing the advantage of the CWT; the CWT maps had better quality when compared to the conventional derivatives, thanks to the smoothing function that reduced the noise. Thus, the derivatives were not used for further investigation. It is important to note that wavelets with a higher number of vanishing moments are more practical in the determination of the exact shape and position of defects. The damaged areas were revealed by *gaus1* wavelet; however, the defects could be incorrectly detected in intact sample #1. Nevertheless, CWT values for intact beam #1 are significantly lower than for damaged ones. This difference is not observed due to the individual scaling of each map (mutual scale could disturb the legibility of the results). What is more, the variability of CWT values in the area of debonding could suggest that there were multiple defects. These effects were not present for Gaussian wavelet with four vanishing moments that emphasized only the edges of the defect and flattened the areas with the same quality of adhesion. For this reason, the *gaus4* wavelet could be stated as the most effective for damage detection.

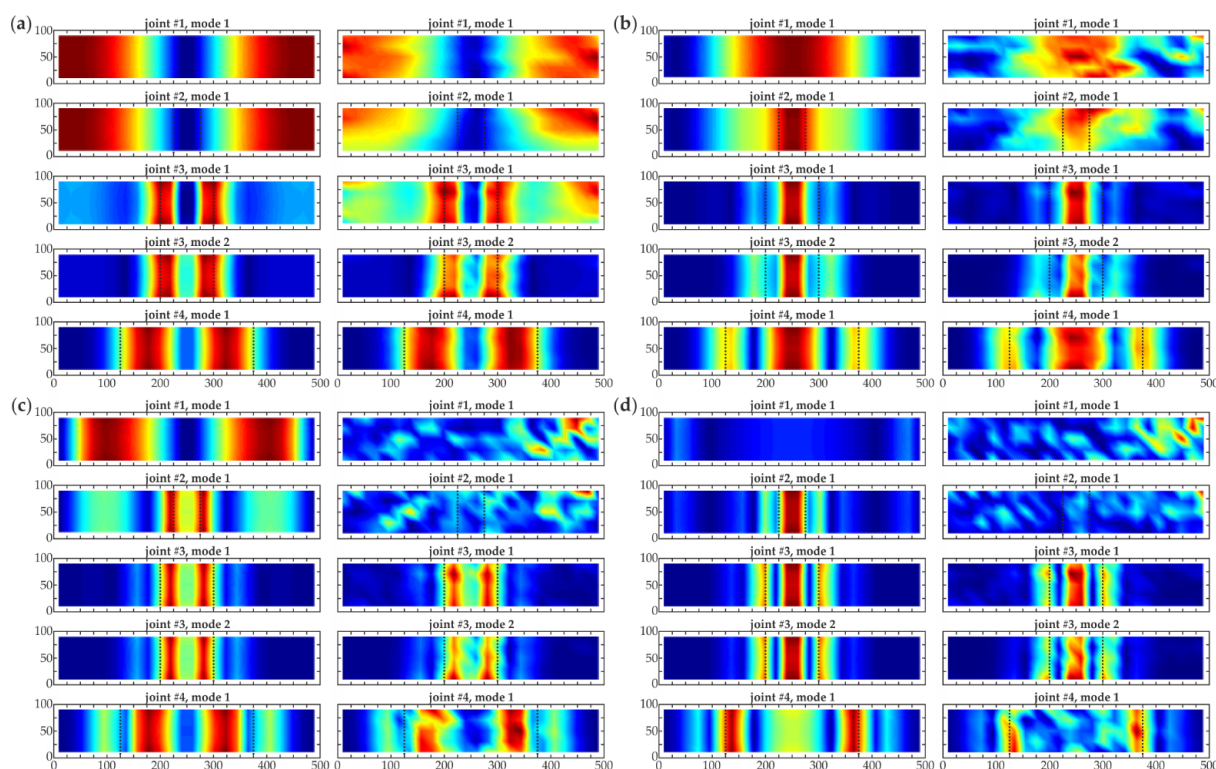
Figure 7. Comparison of CWT damage imaging for numerical (left column) and experimental (right column) results (grid 20 mm, no interpolation) for all joints #1–#4 (dimensions in [mm], scale $s = 2$) using different wavelets: (a) *gaus1*; (b) *gaus2*; (c) *gaus3*; (d) *gaus4*.

The second part of the analysis was the comparison between the numerical and experimental data. The results were obtained for a grid of 20 mm chosen based on the original mesh in experimental measurements (no additional interpolation was applied). As before, Gaussian wavelets were used with the constant scale $s = 2$. The CWT maps are shown in Figure 7. A good agreement between experimental and numerical maps was evident. Most of the maps were similar. However, the experimental results were demonstrably affected by the signal noise that deteriorated the quality of the obtained visualizations. As the degree of the wavelet increased, the influence of the noise became more visible, highlighting the differences between the experimental and numerical results, mainly for beams #1, #2 (the inconsistency between the maps obtained using *gaus3* and *gaus4* wavelets was clear). This effect made the localization of the debonding difficult, especially for the smallest damage (i.e., 5 cm (beam #2)), for which there was no possibility to detect the defect. As stated in the previous paragraph, the fourth order Gauss wavelet was the most powerful in the damage imaging. However, the quality of the maps was lower than those presented in Figure 6 due to the application of a coarser grid.

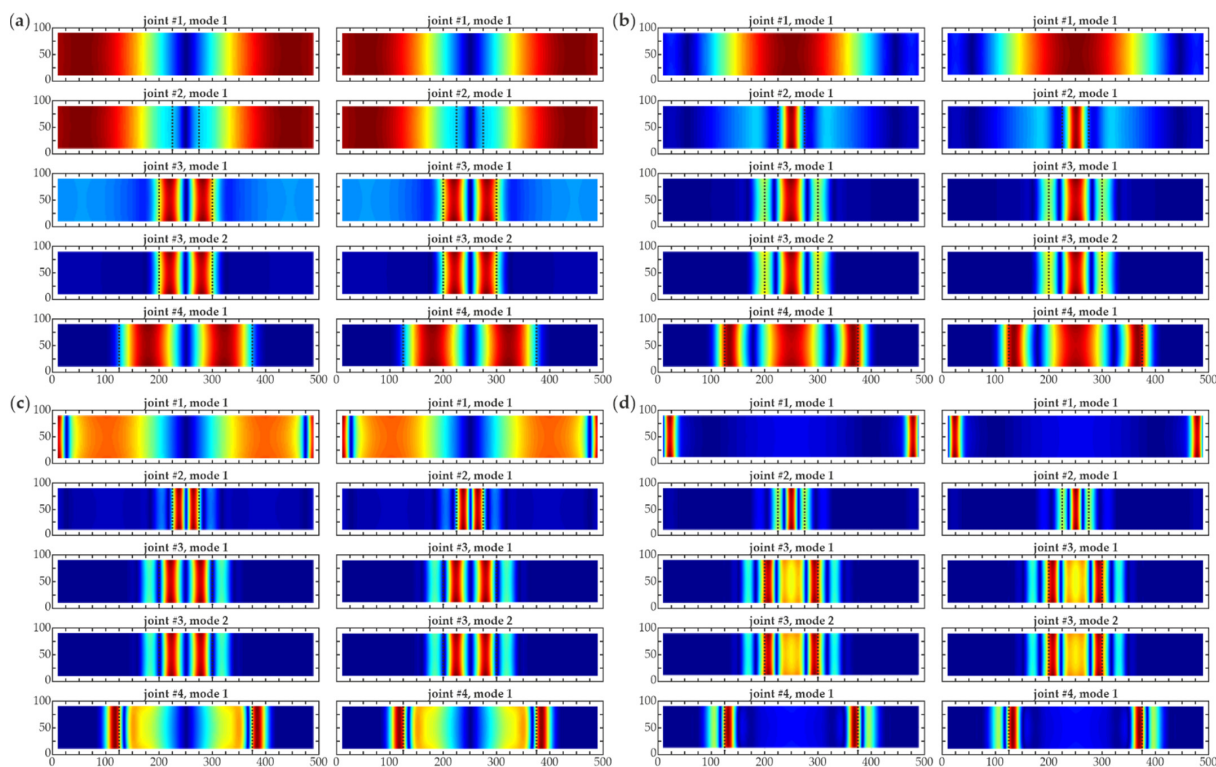
Figure 8. Comparison of CWT damage imaging for numerical results (left column—mesh 2 mm, no additional interpolation and right column—grid 20 mm interpolated to 2 mm, both for scale $s = 8$) for all joints #1–#4 (dimensions in [mm]) using different wavelets: (a) *gaus1*; (b) *gaus2*; (c) *gaus3*; (d) *gaus4*.

Additional interpolation was applied to the data measured on a 20 mm grid as an attempt to enhance the quality of the obtained maps. Firstly, the propriety of the proposed interpolation was verified based on the numerical results. The spline interpolation with the destined step of 2 mm was performed in MATLAB®. Taking into account the decrease in the step value, the scale for CWT calculations was increased to $s = 8$. Figure 8 presents the comparison of CWT maps obtained from originally fine mesh (2 mm) and interpolated from 20 to 2 mm. The accordance is clearly visible, proving the correctness of the performed interpolation. Furthermore, the numerical and experimental maps obtained using the above described interpolation are presented in Figure 9. It is firstly important to note that interpolation improved the quality of damage imaging for numerical data. The maps showed the debonding regions more clearly, the images were sharper, especially for the *gaus4* wavelet (Figure 9d). On the other hand, despite making the images sharper, the interpolation made the defect shape in the experimental maps more irregular, which may have been caused by the noise in the measured signals. The effect was much more visible for the higher-order wavelets (*gaus3*, *gaus4*), for which the boundaries of debonding regions became illegible. This was because high-order wavelets revealed small but sharp disturbances, which for experimental data could be both damage boundaries and noise, affecting the signals similarly. Based on this observation, it can be stated that the interpolation of noisy data collected in a coarse grid can enhance the quality of CWT damage visualization; however, high-order wavelets were not useful in this situation.

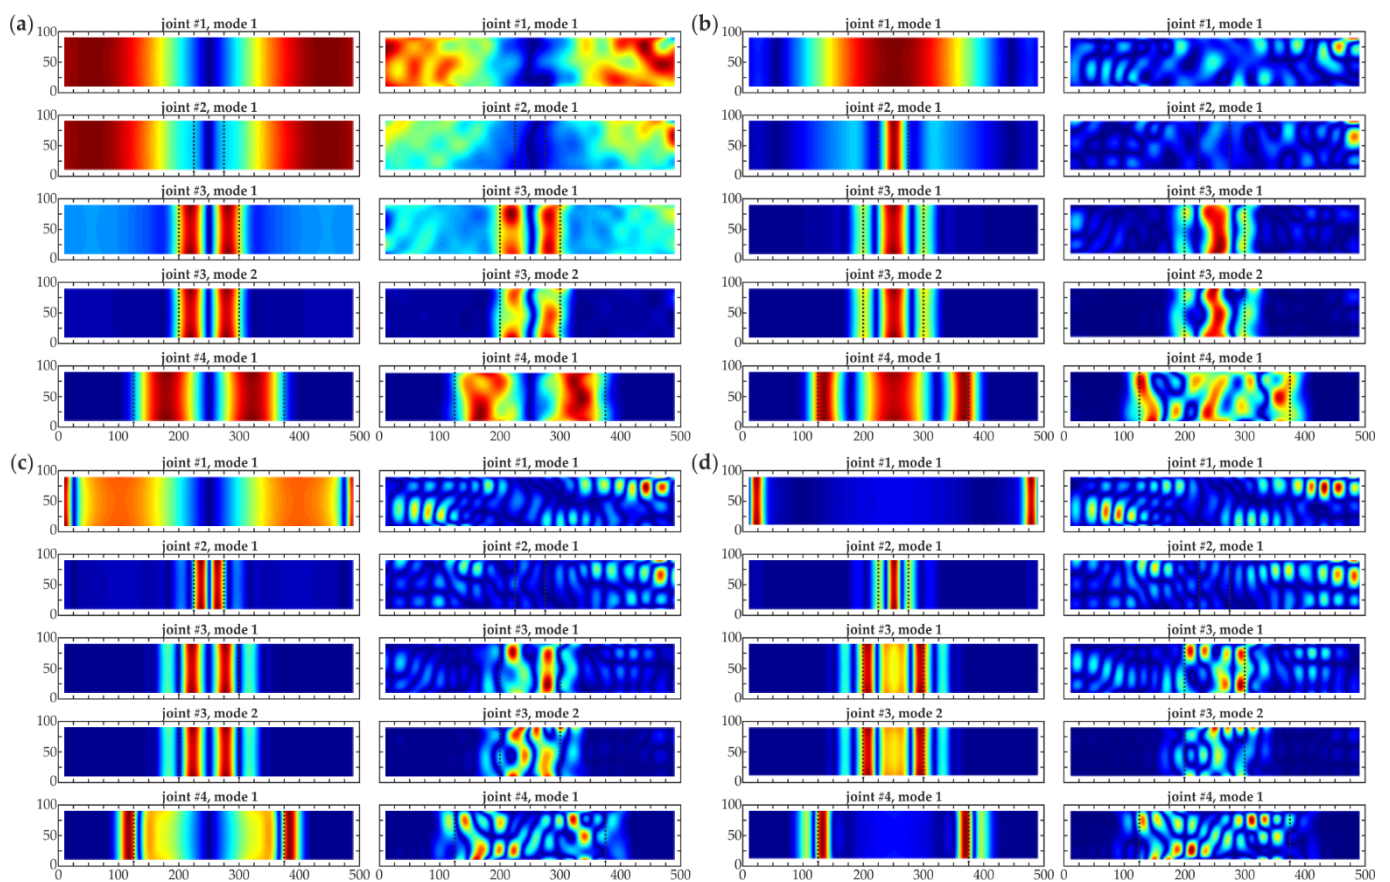
Figure 9. Comparison of CWT damage imaging for numerical (left column) and experimental (right column) results (grid 20 mm interpolated to 2 mm) for all joints #1–#4 (dimensions in [mm], scale $s = 8$) using different wavelets: (a) *gaus1*; (b) *gaus2*; (c) *gaus3*; (d) *gaus4*.

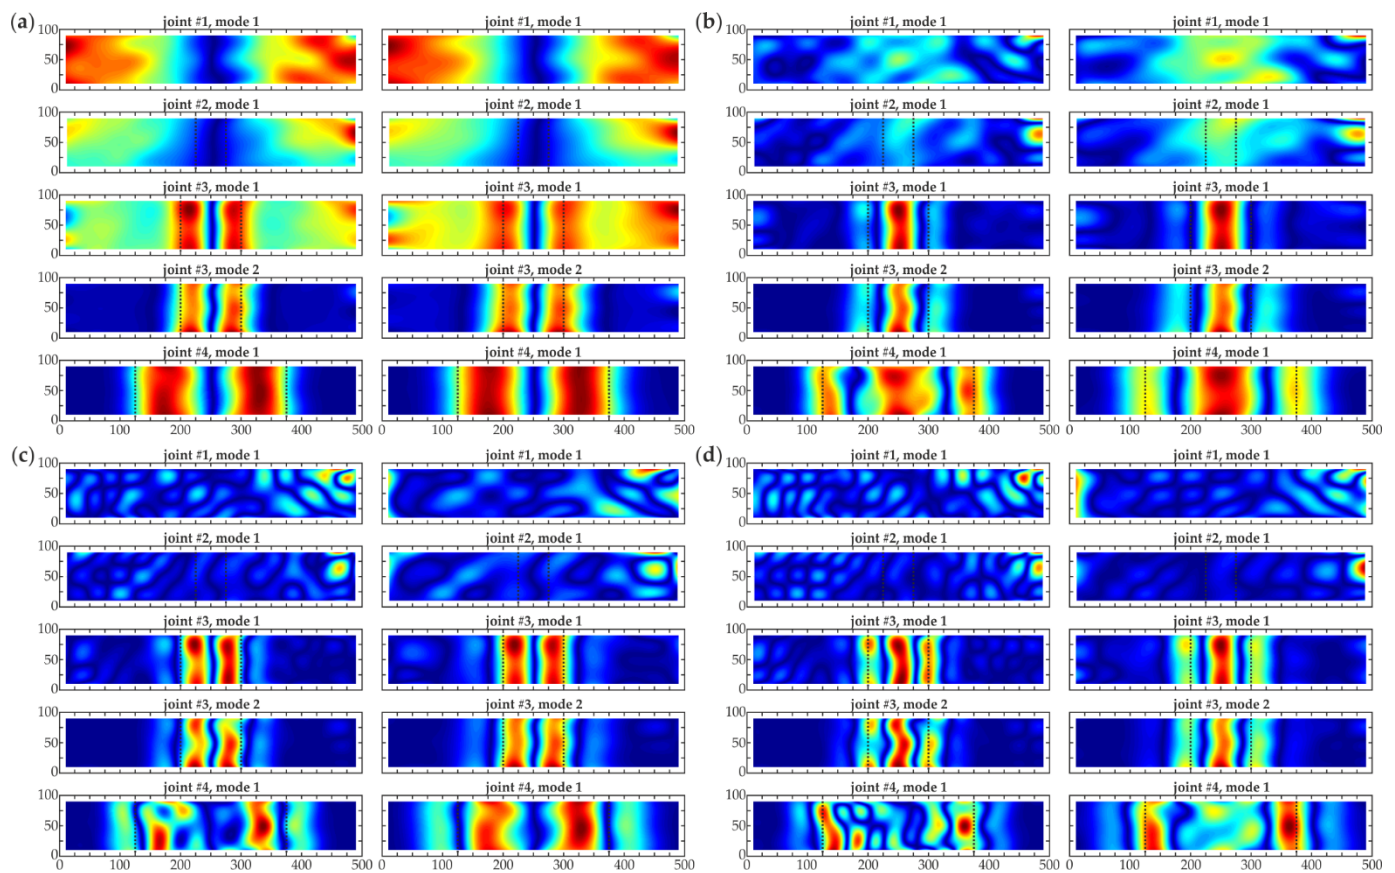
Figure 10. CWT damage imaging for experimental results (grid 20 mm interpolated to 2 mm) for all joints #1–#4 (dimensions in [mm]) using different wavelets for scales $s = 16$ (left column) and $s = 24$ (right column): (a) *gaus1*; (b) *gaus2*; (c) *gaus3*; (d) *gaus4*.

However, it was possible to change the scale to better visualize the damage in the experimental data. Figure 10 shows the CWT damage maps on the interpolated mesh (resulting grid of 2 mm) for multiplied scales, being doubling and tripling of the initial scale, i.e., $s = 16$ and $s = 24$. The positive influence of the increasing scale was evident. The shape of the debonding areas was clearly visible for both improved scales when compared to the initial value (cf. Figure 9), especially for high order wavelets. Larger scales highlighted the defects and allowed precise damage localization since they neglected the subtle signal noise. Some irregularities resulting from the noisy character of the experimental signals were visible. Comparing both increased scales, better results were obtained for the higher scale $s = 24$. However, the smallest defect (debonding of 5 cm) was still not detected.
